**Tree Management Report
for Hwy 1 264th Street to
Whatcom Road - Bradner
Road Rest Area**

2024-02-29 | Revision #0

Submitted to: Ministry of Transportation &
Infrastructure

Prepared by McElhanney

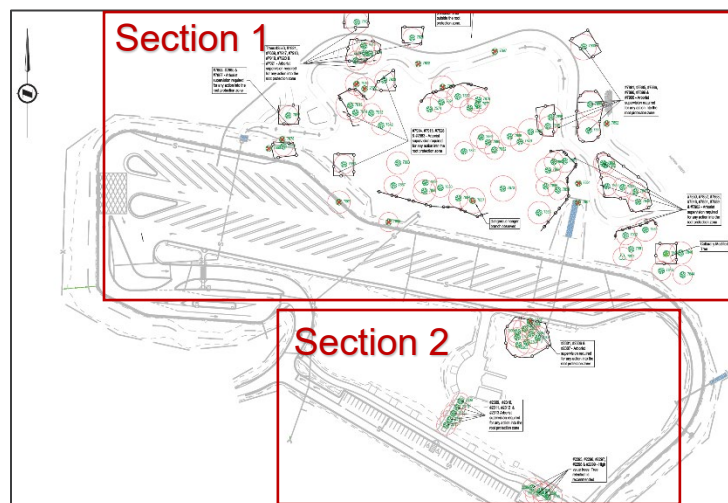
Figure 2. Tree Inventory

A total of 93 trees were inventoried. In the following [Figure 1](#), the distribution of trees along the subject site can be observed. In the north area marked as a section 1, 69 significant trees were assessed. Additional trees were assessed in section 2 on request.

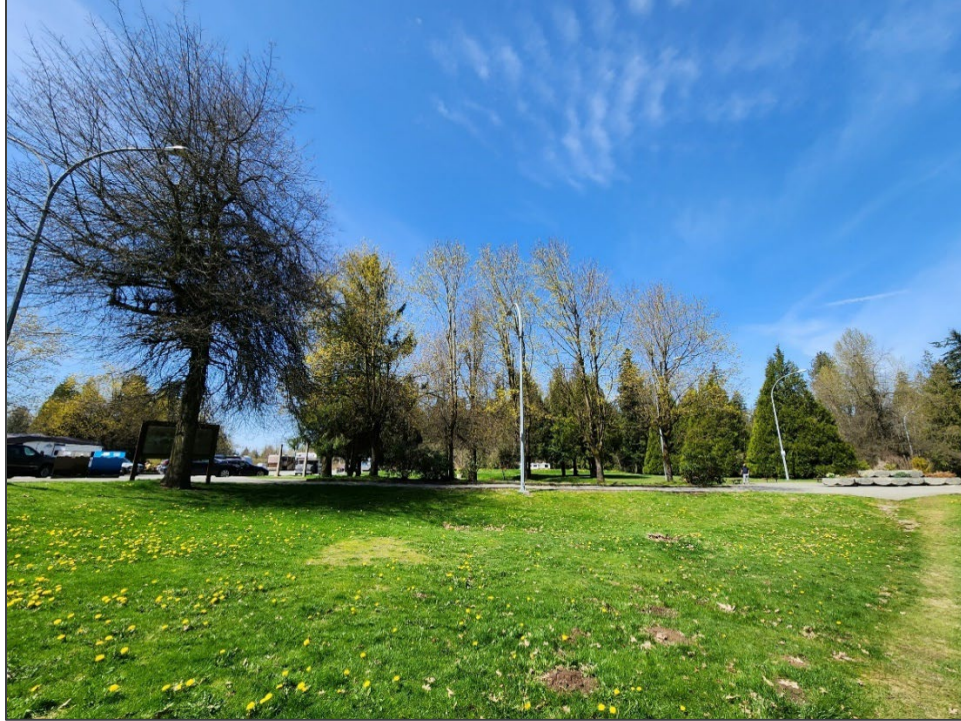
Trees 2309 to 2313, located southwest of the existing washroom facility, were observed to have been planted as part of previous landscaping works.

Photo 1. Trees #2309-2313. Group of trees located center of section 2

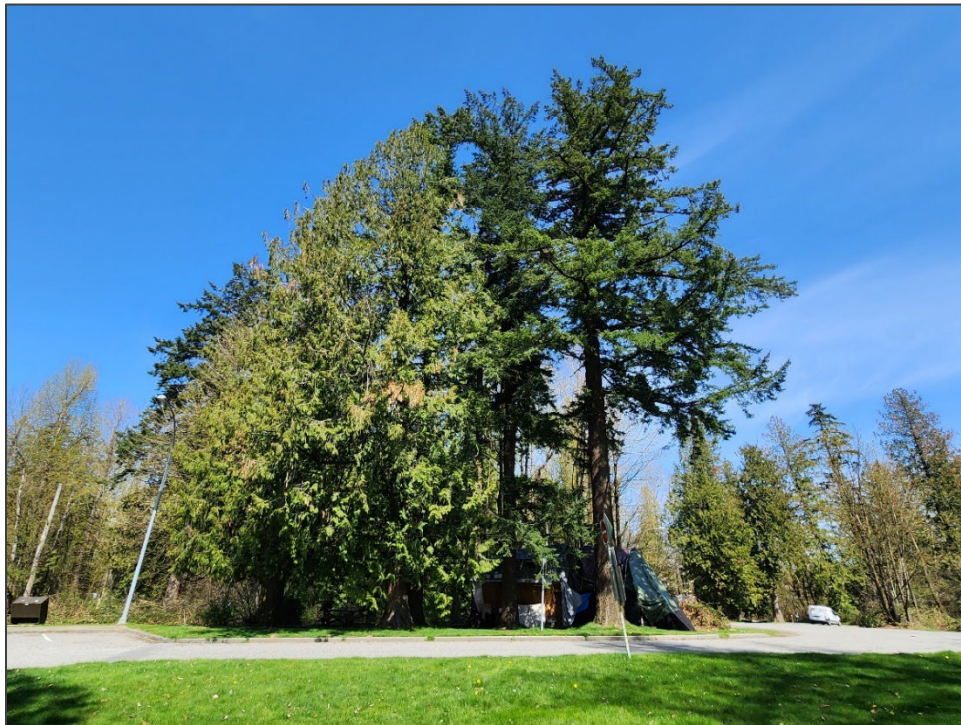
Trees #2299 #2298, #2297, #2296 & #2295 High-value trees. Retention is recommended. Integrating paths that minimize the impact on existing trees would be an interesting option.

- Designs will attempt as best they can to avoid these trees. It looks like the GPS location you have for some of these trees may be showing a little too far north

Photo 2. Trees 2295-2299. Group of trees located east of section 2

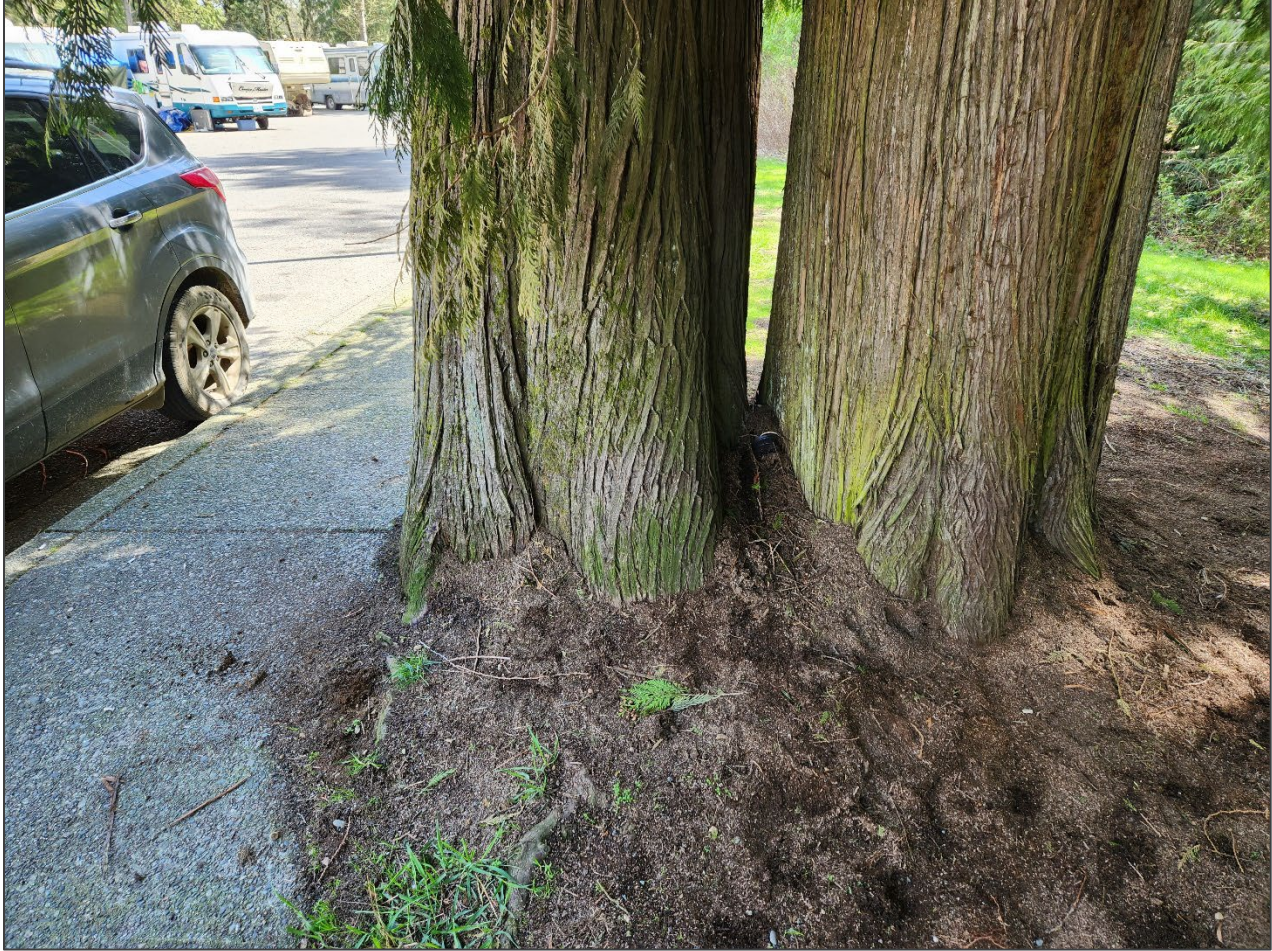
Tree #2307 will be heavily impacted. It's considered a High-value tree. It's located over the existing sidewalk. I want to analyze project options for its retention.

- Impacts to 2307 and 2306 will be unavoidable as there will be 6-8 inches of grade change at the sidewalk. We have noted these two trees for removal on drawings. To avoid the trees and retain them, we would need to re-grade the whole truck parking area

Photo 3. #2306 & #2307. Tree with potential to be impacted by the proposed sidewalk

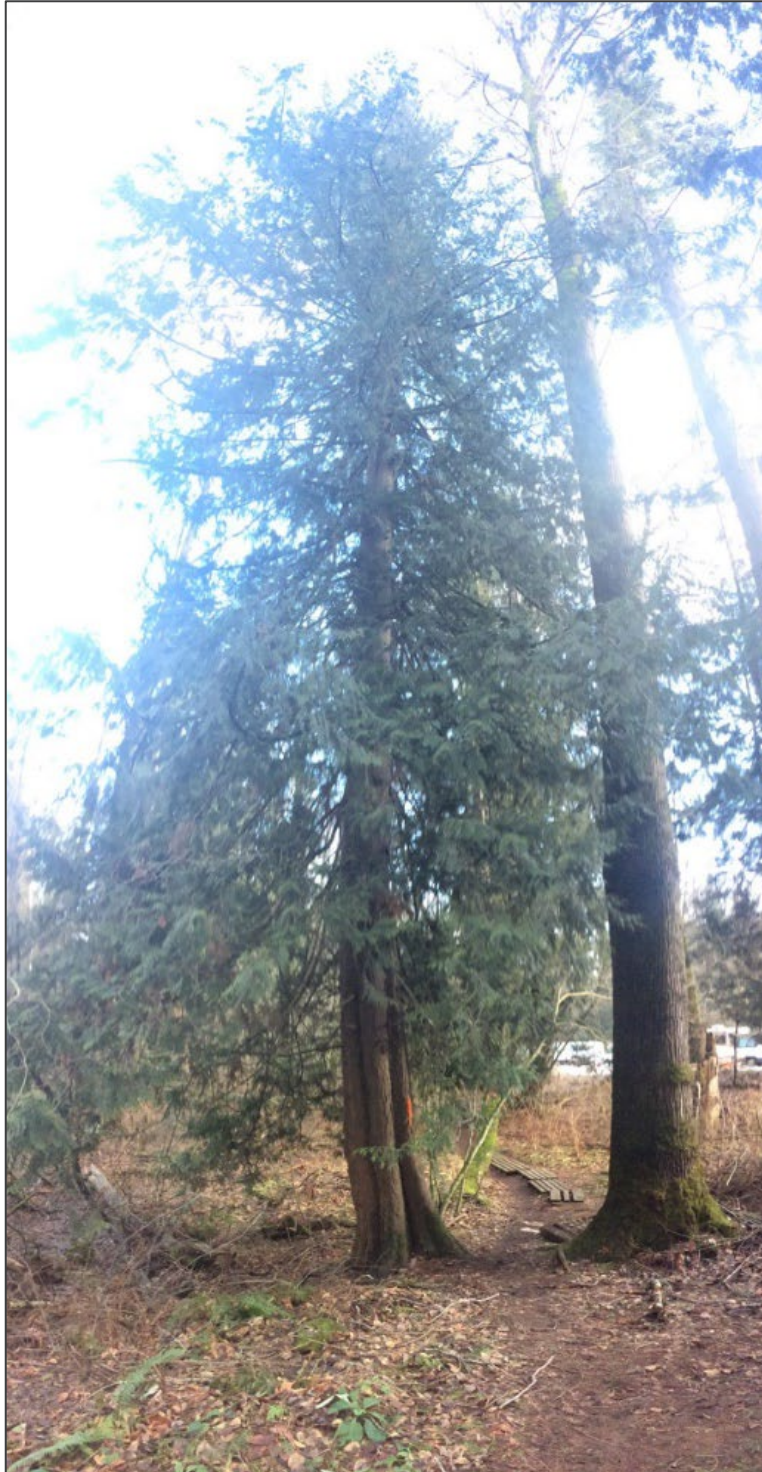
Photo 4. Tree #7869 with potential to be impacted by proposed sidewalk and grading.
