**Tree Management Report:**

2024-04-18 | Revision #2

**264th Street to Whatcom  
Road, Abbotsford, BC**

**Project #7 – King Road  
Realignment**

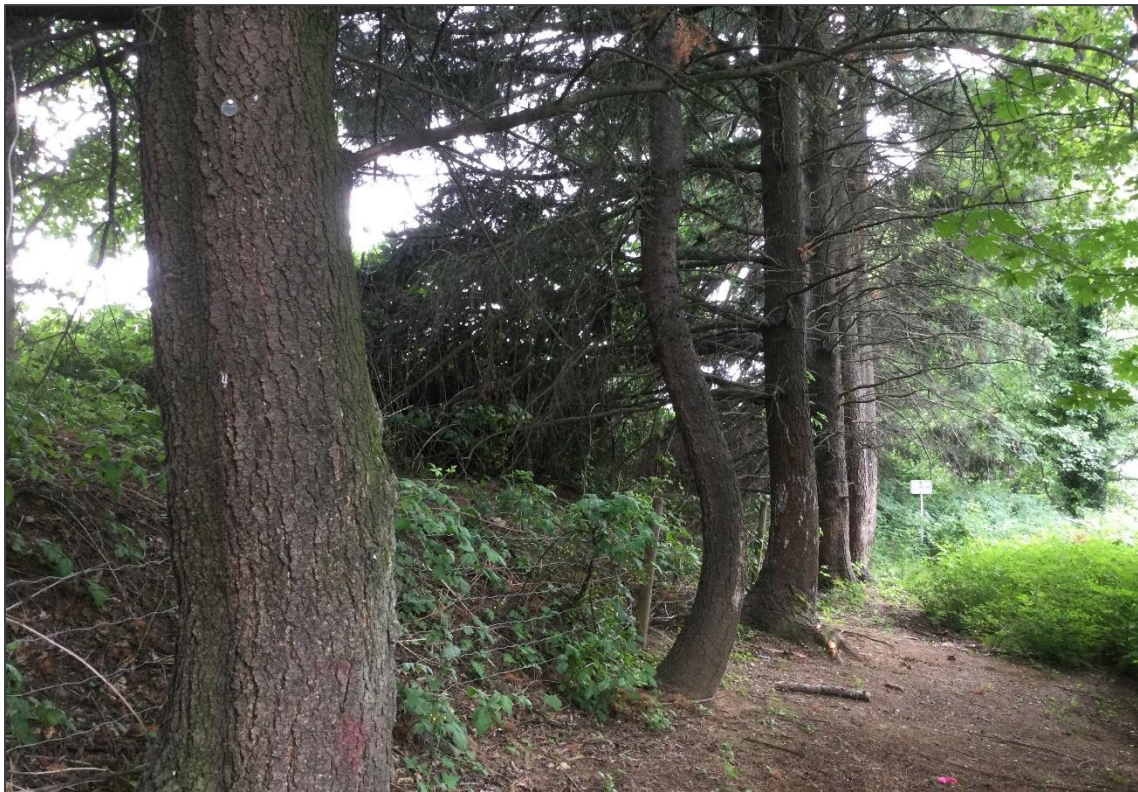
*Photo 2. Eight Douglas-fir trees in fair/good health and structure between tags #2791 & 2792.*

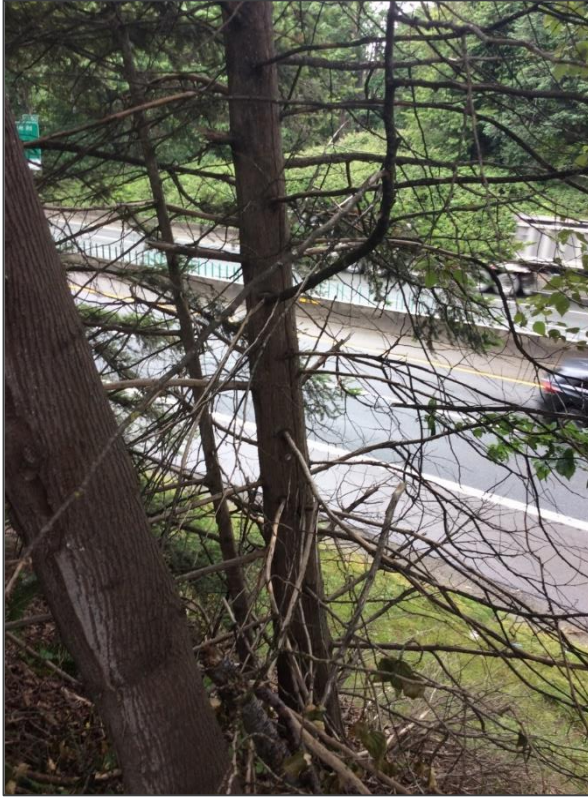
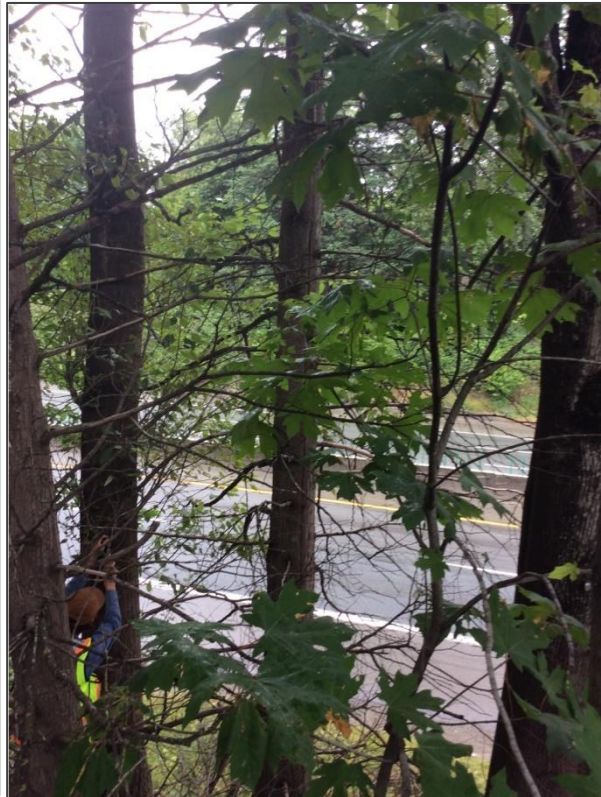
2829	Western redcedar	<i>Thuja plicata</i>	29	13	0	1.16	Dead	Poor	Dead tree by road	Hazard tree	Remove
2830	Western redcedar	<i>Thuja plicata</i>	28	12	0	1.12	Dead	Poor	Dead tree, dead top	Hazard tree	Remove
2831	Bigleaf maple	<i>Acer macrophyllum</i>	23	12	4	4	Fair/good	Fair/good	Asymmetric canopy. Leaning 6° SE		Retain
2832	Douglas-fir	<i>Pseudotsuga menziesii</i>	52	21	6	6	Fair/good	Fair/good			Retain
2833	Douglas-fir	<i>Pseudotsuga menziesii</i>	30	19	4	4	Fair	Fair/good	Necrotic 1/2 low tree		Retain
2834	Douglas-fir	<i>Pseudotsuga menziesii</i>	36	21	5	5	Fair/good	Fair/good	Ok tree		Retain
2835	Bigleaf maple	<i>Acer macrophyllum</i>	81	21	5	5	Fair/good	Fair/good	Tridominant from base		Retain
2836	Bigleaf maple	<i>Acer macrophyllum</i>	29	14	2	2	Fair/good	Fair/good	Ok tree, codominant with bark included reaction wood base		Retain
2837	Douglas-fir	<i>Pseudotsuga menziesii</i>	51	24	6	6	Fair/good	Fair/good	Ok tree		Retain

*Photos 3 & 4. Trees #2829 & #2830 respectively, two dead trees recommended for removal along Hwy 1.*

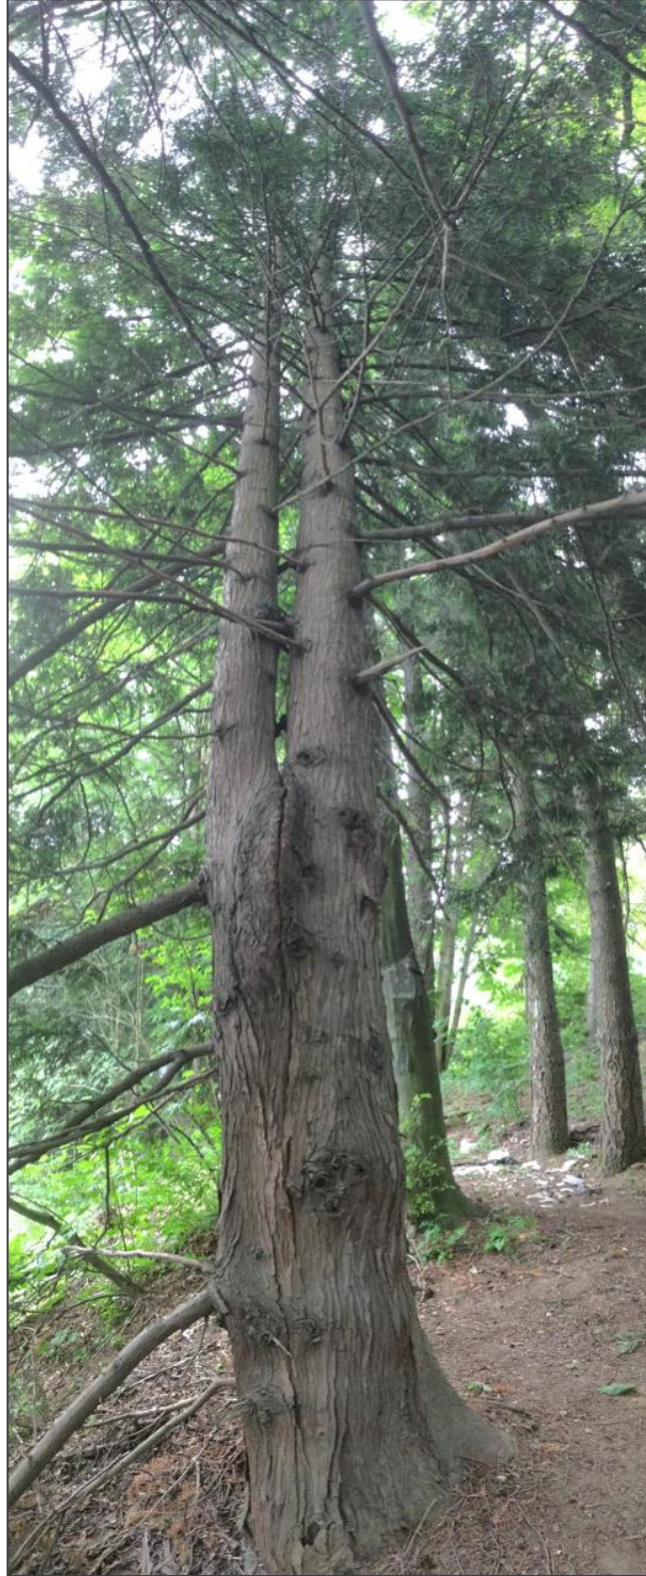
2796	Western redcedar	<i>Thuja plicata</i>	50	21	3	3	Fair/good	Poor	Danger tree. Longitudinal crack along included bark from 0.2m to 2m above soil line where primary stem union located	Hazard tree	Remove
2797	Western redcedar	<i>Thuja plicata</i>	36	21	3	3	Fair/good	Fair/good	Row of 5 Fd to tree 2798. Dbh range 25 to 46cm.few branches tending N		Retain
2798	Douglas-fir	<i>Pseudotsuga menziesii</i>	46	22	3	3			Row of 5 Fd to 2797		Retain
2799	Bigleaf maple	<i>Acer macrophyllum</i>	34,33	21	5	5	Good	Fair	Codominant with included bark. Well balanced crown.		Retain

*Photo 5. Tree #2796, a tree with a longitudinal crack extending from near soil line to primary stem union, recommended for removal along Hwy 1.*
