February 17, 2023
PGL File: 0346-65.01

Ministry of Transportation and Infrastructure
310 – 1500 Woolridge Street
Coquitlam, BC
V3K 0B8

RE: ARBORIST SUMMARY REPORT – REDROOFS ROAD AND DAY ROAD, SECHelt, BC

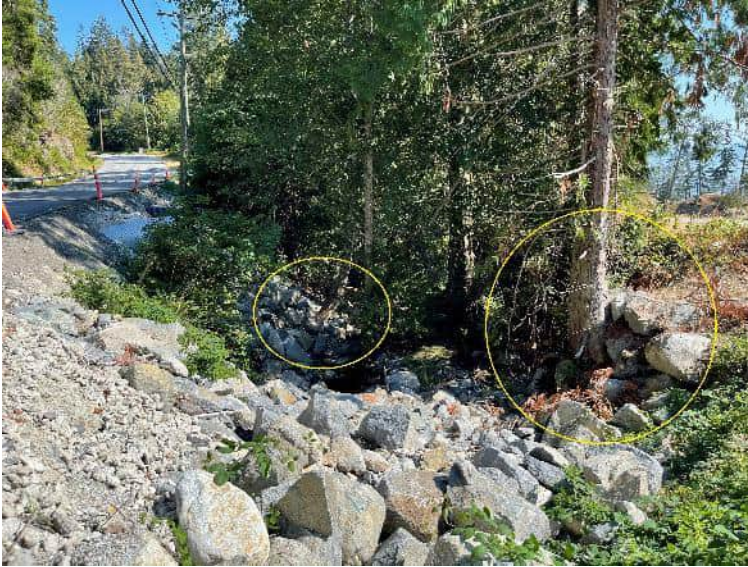
Photograph 20:

Impacts to trees on the downstream side of Redroofs Road appeared to be limited to an intermediate western redcedar on the west side of Kenyon Creek immediately adjacent to the culvert outfall, and a young red alder on the east side of the creek roughly 3–4m downstream of the redcedar tree (Photograph 20). Both trees have been partially buried at the base with what appears to be newly placed riprap. It is assumed that placement of the large rock also wounded the buried portion of the trees.

The western redcedar tree downstream of Redroofs Road appeared to be in moderate decline, which is likely more related to climatic changes (i.e., prolonged summer drought conditions with extreme heat) than the recent works completed along the banks of Kenyon Creek. The vitality of the red alder appeared to be normal with no visible dieback or stress. There is a chance that placement of the riprap around the base of these trees could have long-term effects (i.e., soil compaction, physical wounds creating point of entry for decay, etc.); however, no mitigation is recommended at this time. These two trees should be reviewed in two years to reassess vitality.

Tree resources downstream of Redroofs Road showing minor impacted trees

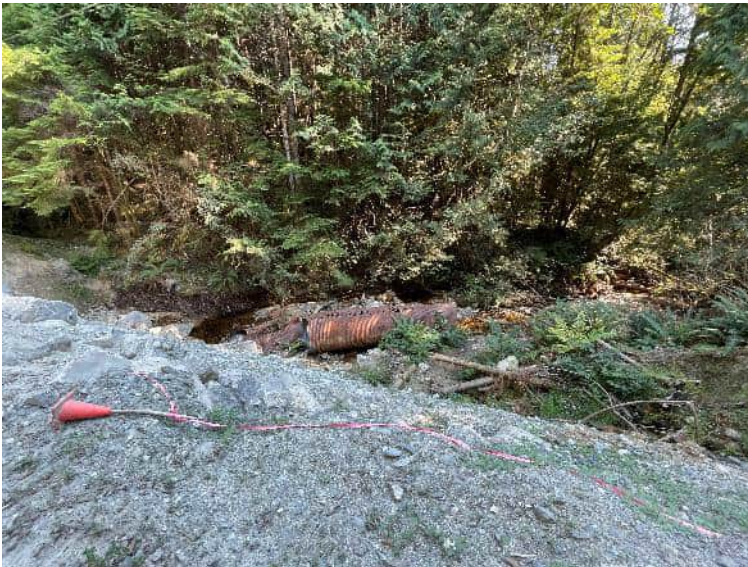
Photograph 21:

Trees outside of disturbance area on downstream side at Gough Creek Site

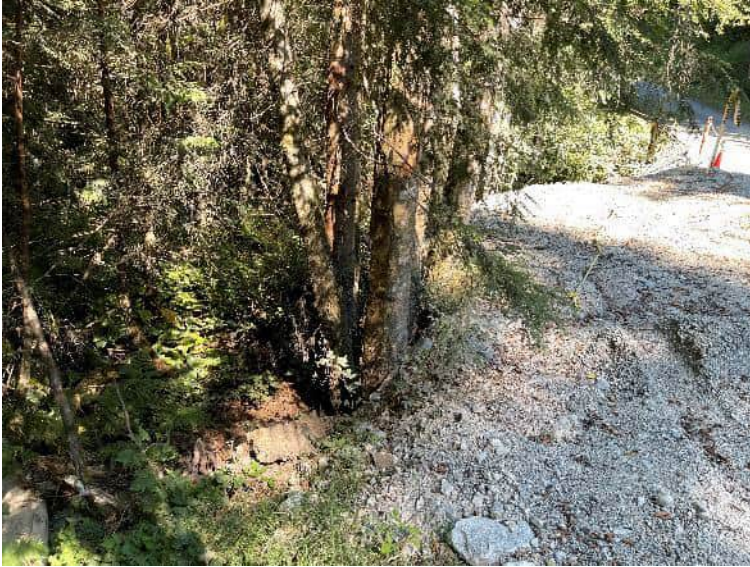
The most notable and prolonged impacts to trees on the upstream side of Day Road at the Gough Creek Site appeared to be partial burial of trees immediately adjacent to the road. The fill slope created from road repairs and/or widening extended down and around several red alder trees that occurred in this location (Photographs 22 through 25). The trees affected by the material placement appeared to be in good health at the time of review, although a few had some dieback in the upper portions of the canopy which was likely present prior to the flood event.

In the long-term, it is likely that the fill slope material will adversely affect the health of these trees. Soil compaction and burial could suffocate root systems, causing a gradual decline in tree vitality (i.e., over next few years). If the trees do decline, the likelihood of failure will increase. The likelihood of failed trees falling towards Day Road is high. Traffic frequency on Day Road is unknown, so the likelihood of a failure impacting a car and occupants is uncertain; however, it is very likely that a tree failure would result in disruption of traffic flow.

**Buried red alder trees on
upstream side of road at
Gough Creek Site**

At a minimum, the affected trees should be reviewed within the next two growing seasons to assess impacts, monitor potential decline, and prescribe mitigation measures, as needed. As a precautionary measure, the MOTI may consider removing the affected trees to roughly 1m above grade to mitigate expected future risks.

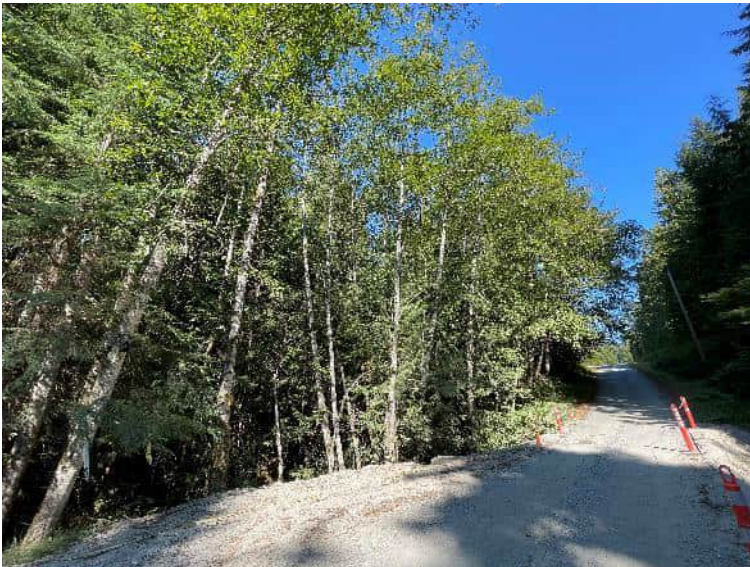
Photograph 25:

**Showing good vitality in buried
red alder trees on upstream
side of road at Gough Creek
Site**
