# Technical Memorandum

October 24, 2023  
File No. 22.0059

**Re: Post-Construction EM Review of Instream Works on Flume Creek**

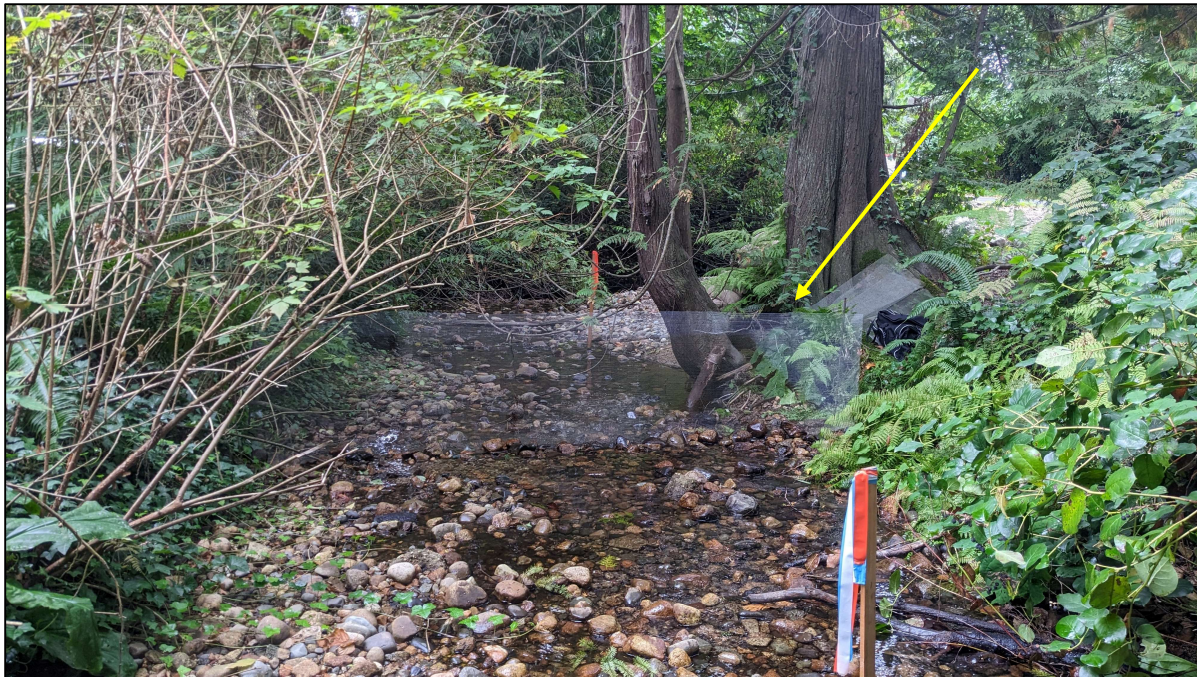
September 11, 2023

**Photo 1. Viewing the work zone behind the fish barrier net.**

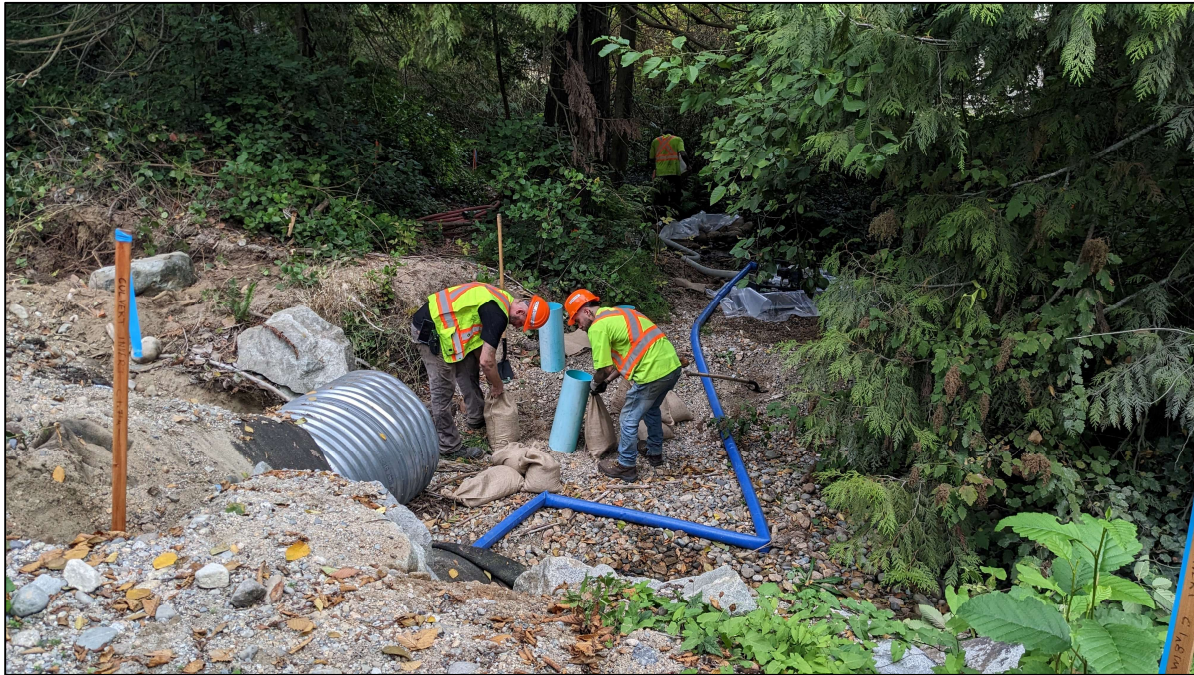
September 12, 2023

**Photo 2. Works occurring in the dry channel with the dewatering hose pumping water through the culvert.**

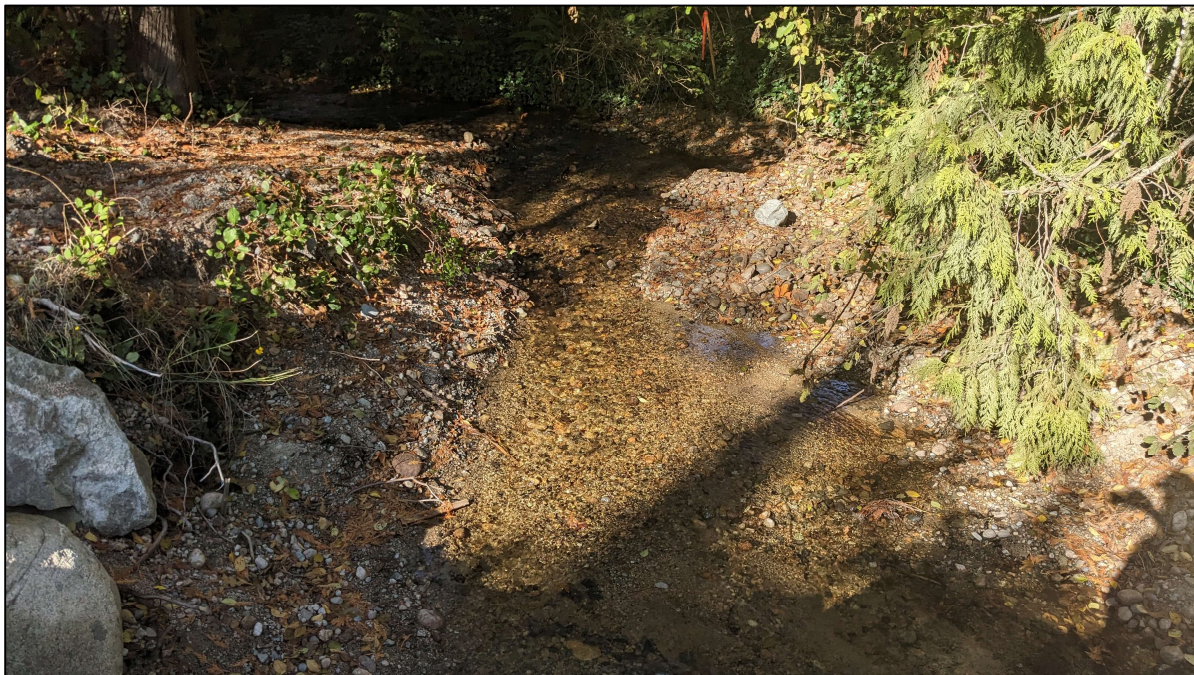
October 12, 2023

**Photo 3. Channel conditions post-construction.**
