February 17, 2023
PGL File: 0346-65.01

Ministry of Transportation and Infrastructure
310 – 1500 Woolridge Street
Coquitlam, BC
V3K 0B8

RE: ARBORIST SUMMARY REPORT – REDROOFS ROAD AND DAY ROAD, SECHULT, BC

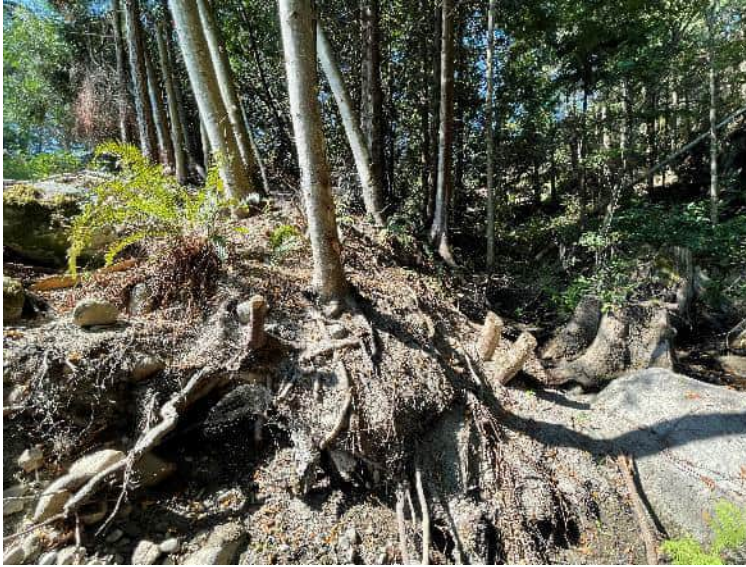
Photograph 1:

Bank erosion around base of
Tree #328

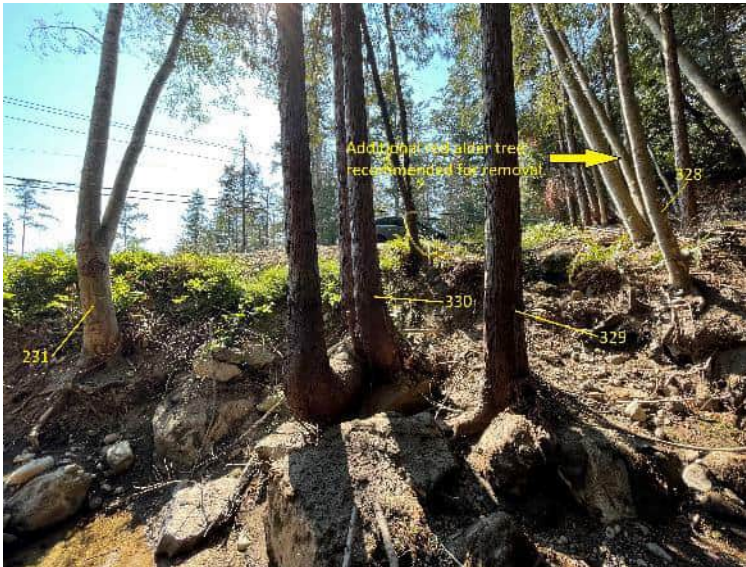
Photograph 2:

Showing Trees #328, #329,
#330, and #231, as well as
additional red alder tree
requiring removal

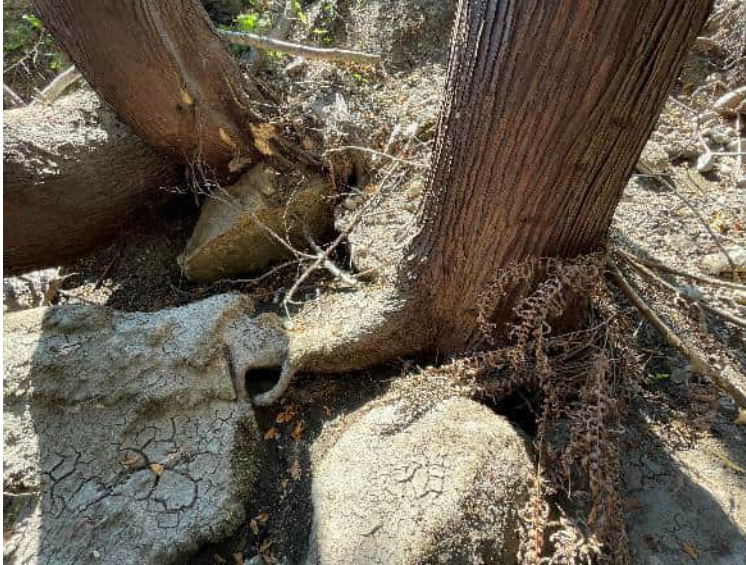
Photograph 3:

329	Cw	western redcedar	<i>Thuja plicata</i>	41	24	- In decline, most likely due to recent extreme heat/drought conditions in addition to flood disturbance and erosion. - Some roots exposed from erosion/flooding event. - Otherwise, appeared stable at time of field review. - Photographs 2 through 4.	- Redroofs Road - Construction workers and equipment during remedial works	Improbable	High	Unlikely	Severe	Low	Retain and monitor, unless in conflict with remedial works	N/A
330	Cw	western redcedar	<i>Thuja plicata</i>	39, 57, 39	24	- x3 codom stems with union at grade. - Growing out of creek bank and undercut. - Erosion from flooding event evident around base of tree. - Recent wounds on middle of stem; no advanced decay apparent. - All three stems were in decline, most likely due to recent extreme heat/drought conditions in addition to flood disturbance and erosion. - Photographs 2, 5 and 6.	- Redroofs Road - Construction workers and equipment during remedial works	Possible	High	Somewhat Likely	Severe	Moderate	Convert to wildlife stems ~3-4m above grade to mitigate risks (short and long-term)	Prior to commencement of construction

**Showing erosion disturbance
around base of Tree #329**

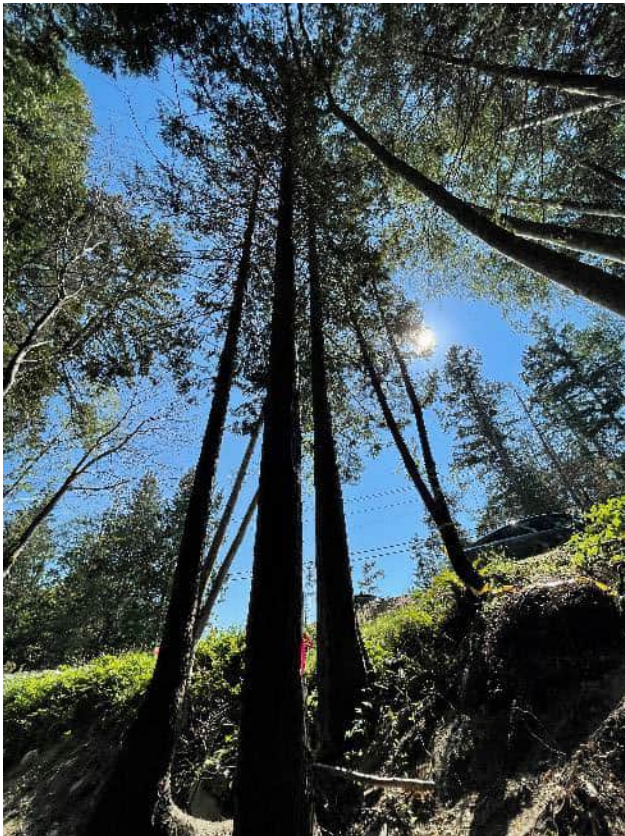
Photograph 4:

Thinning canopy in Tree #329

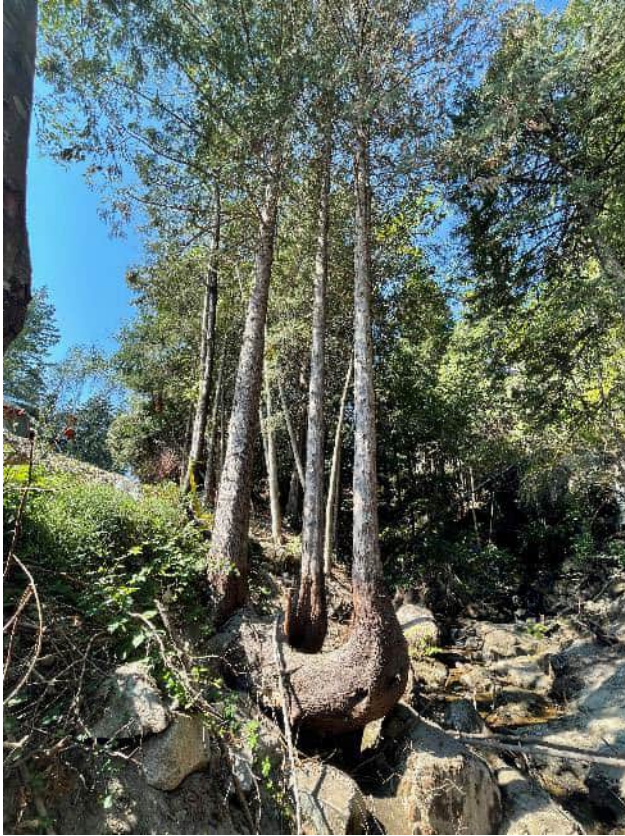
Photograph 5:

Triple-stemmed Tree #330 with thinning canopy and erosion around base of tree

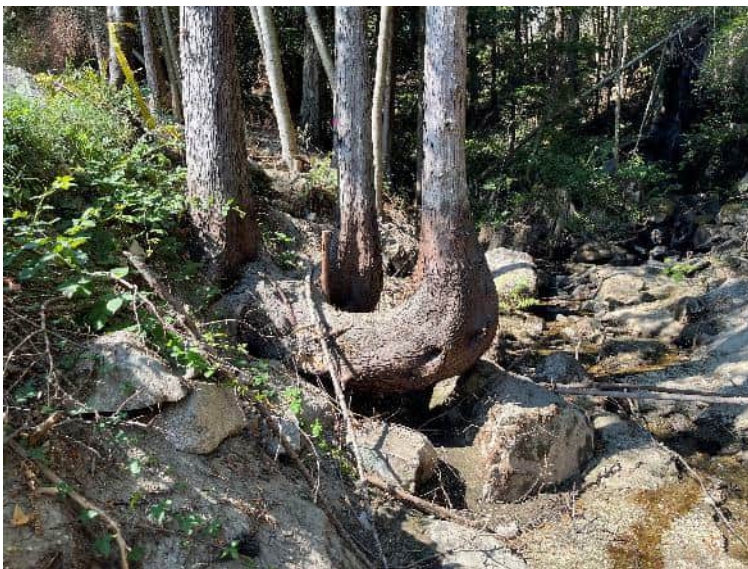
Photograph 6:

Erosion and undercut bank below Tree #330

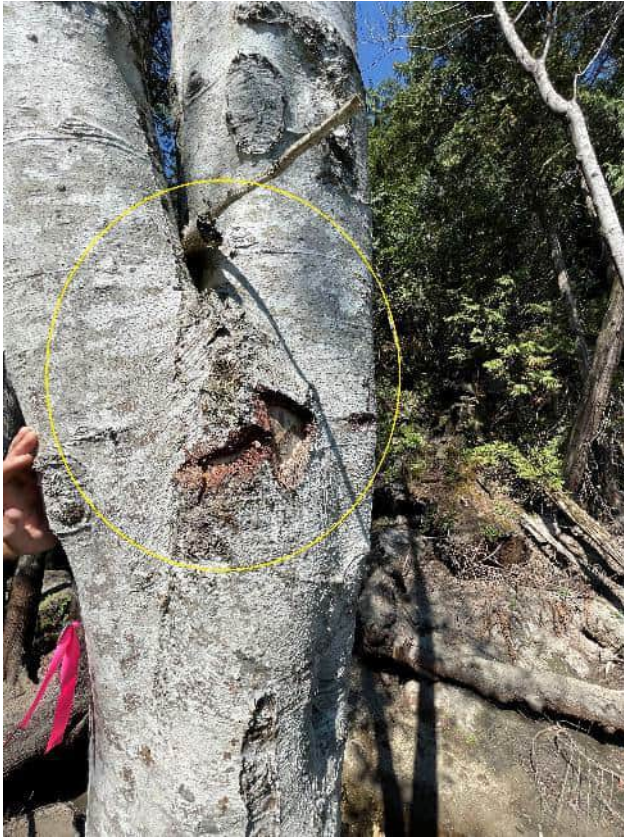
Photograph 7:

231	Dr	red alder	<i>Alnus rubra</i>	45	20	- x2 codom stems with union ~0.5m above dbh. - Included bark observed at union. - In decline with dieback evident in canopy. - Mid-slope with significant erosion around base of tree. - Eutrophic, self-corrected lean to west (over road). - Recent wounds on main stem; no advanced decay evident. - Pithing at base of tree observed. - Photographs 7 through 9.	- Redroofs Road - Construction workers and equipment during remedial works	Probable	High	Likely	Severe	High	Remove to mitigate risks and eliminate conflicts with remedial works	Prior to commencement of construction
232	Mb	bigleaf maple	<i>Acer macrophyllum</i>	26	20	- Standing dead; failed to leaf-out in 2022 growing season (may have been deceased prior to flooding event - timing uncertain). - Growing out of historically failed tree (nurse log). - Slight lean to northwest. - Likely direction of failure, should it occur, would be upstream and away from road. - Photograph 10 and 11.	- Redroofs Road - Construction workers and equipment during remedial works	Probable	Medium	Somewhat Likely	Severe	Moderate	Remove to mitigate risks and eliminate conflicts with remedial works	Prior to commencement of construction

**Included bark at codom union
of Tree #231 with recent
wound**

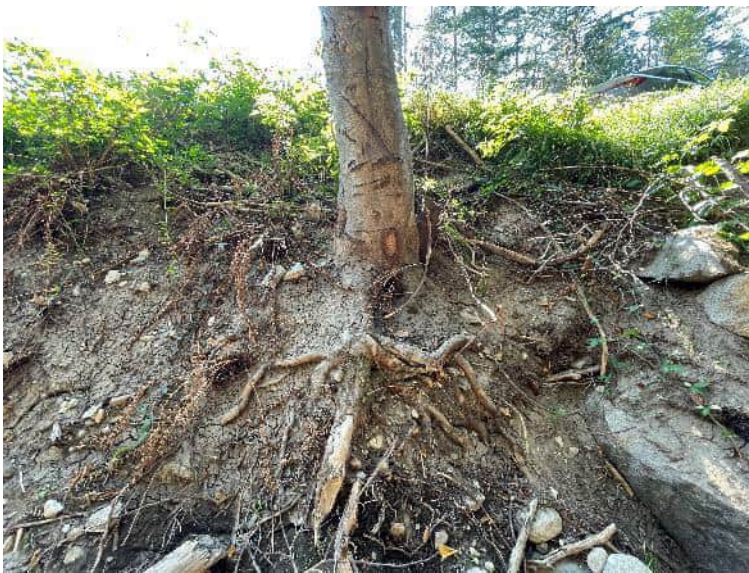
Photograph 8:

**Showing significant erosion
around base of Tree #231**

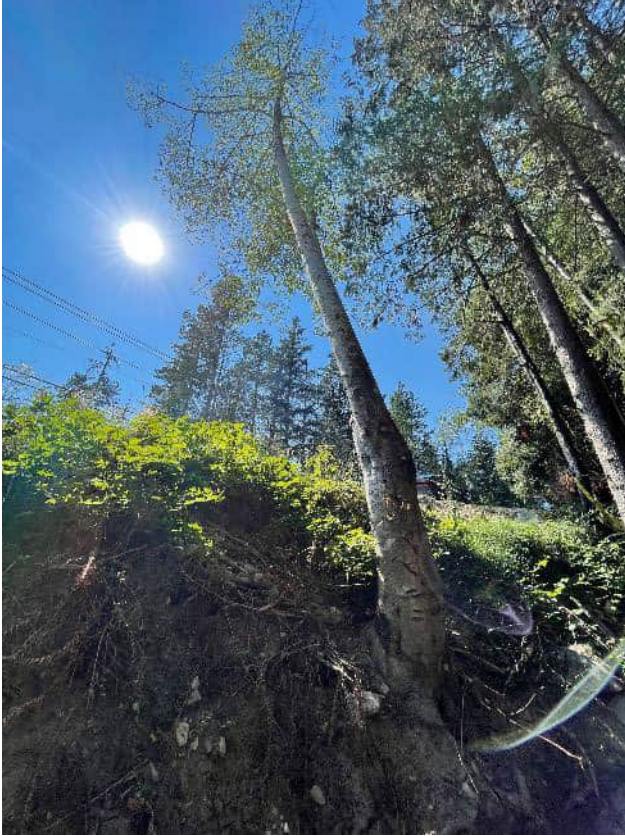
Photograph 9:

**Showing dieback in upper
canopy of Tree #231**

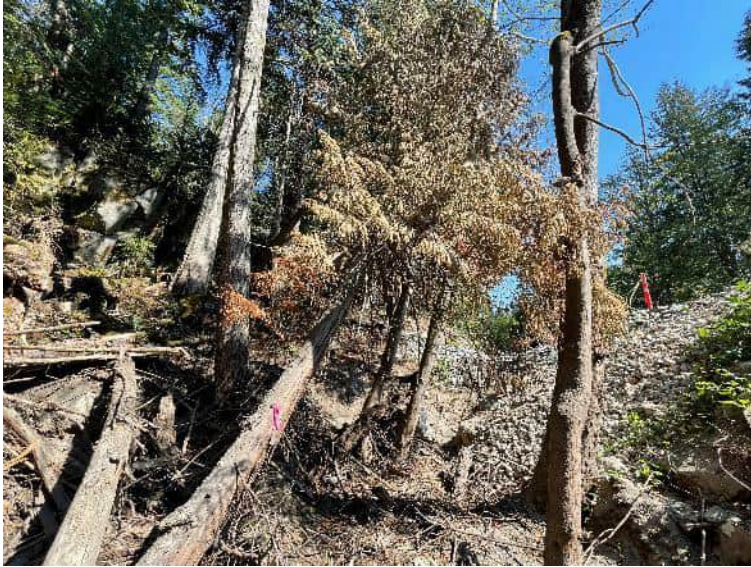
Photograph 12:

**Partially failed and recently
dead or in significant decline
Tree #233**

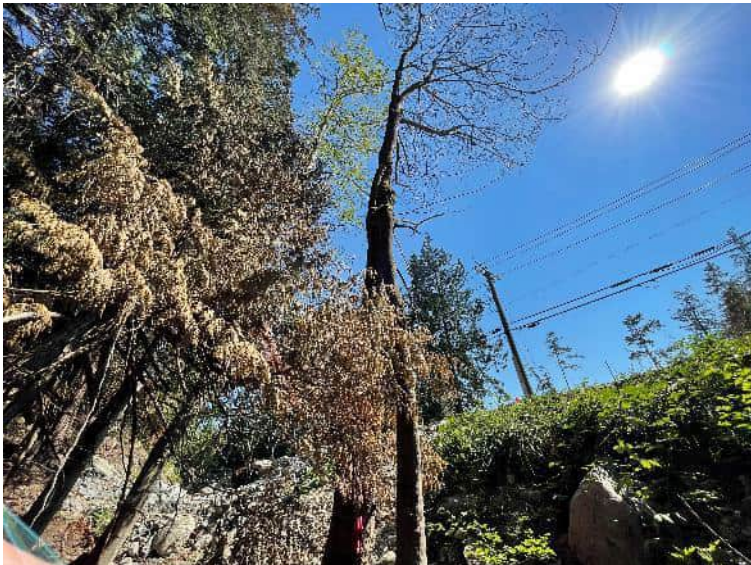
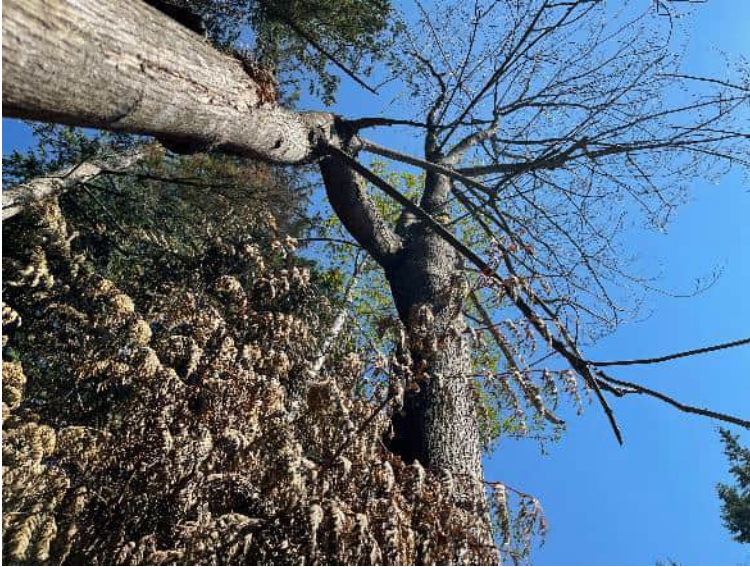
235	Mb	bigleaf maple	<i>Acer macrophyllum</i>	25	18	- Standing dead. - Erosion at base of tree with new material added. - Lean to southeast; towards road. - Photographs 13 and 14.	- Redroofs Road - Construction workers and equipment during remedial works	Probable	High	Likely	Severe	High	Convert to wildlife stem ~3-4m above grade to reduce risks	Prior to commencement of construction
236	Dr	red alder	<i>Alnus rubra</i>	24	18	- Some dieback in canopy; low vitality. - Lean towards road. - Some material and sediment accumulation at base of tree; buried root collar. - Tree #233 leaning into 236. - Photographs 15 and 16.	- Redroofs Road - Construction workers and equipment during remedial works	Possible	High	Somewhat Likely	Severe	Moderate	Convert to wildlife stem ~3-4m above grade to reduce risks	Prior to commencement of construction
237	Dr	red alder	<i>Alnus rubra</i>			- Some dieback in canopy; low vitality. - Lean towards road. - Some material and sediment accumulation at base of tree; buried root collar. - Tree #233 leaning into 237. - Photograph 16.	- Redroofs Road - Construction workers and equipment during remedial works	Possible	High	Somewhat Likely	Severe	Moderate	Convert to wildlife stem ~3-4m above grade to reduce risks	Prior to commencement of construction

**Topped and dead Tree #234
growing into standing dead
Tree #235**

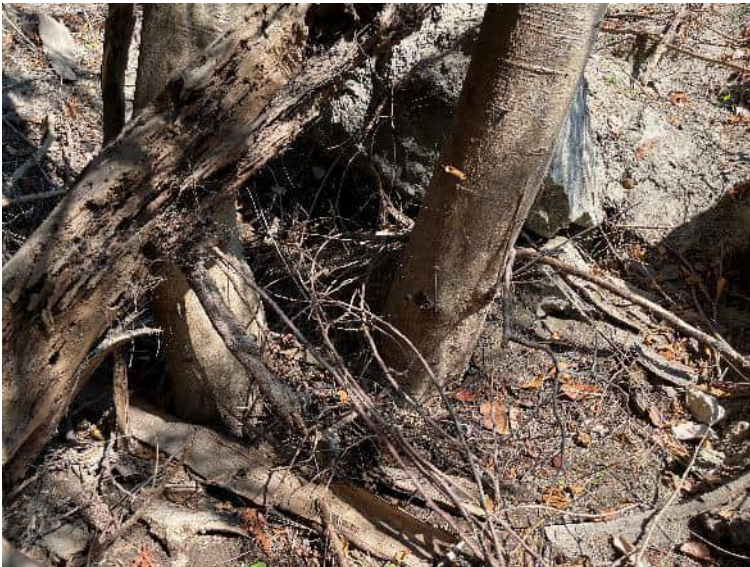
Photograph 15:

Buried base of Tree #236

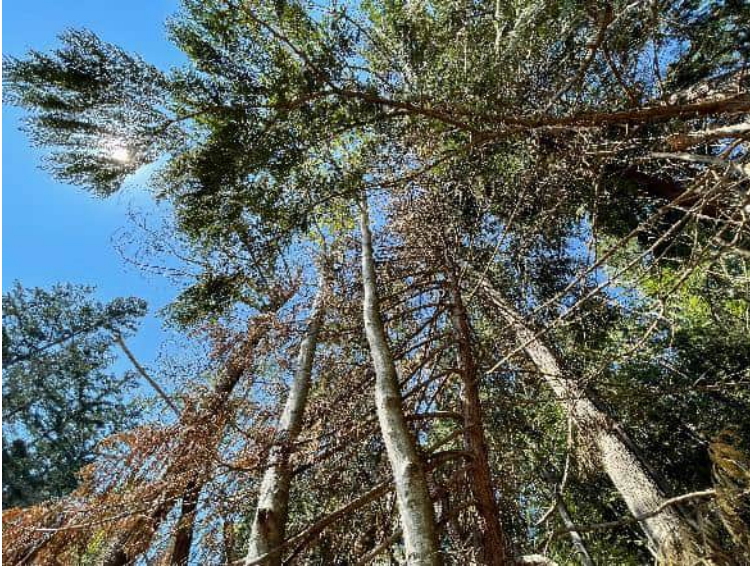
Photograph 16:

**Upper canopies of Trees #236
and #237 in decline**

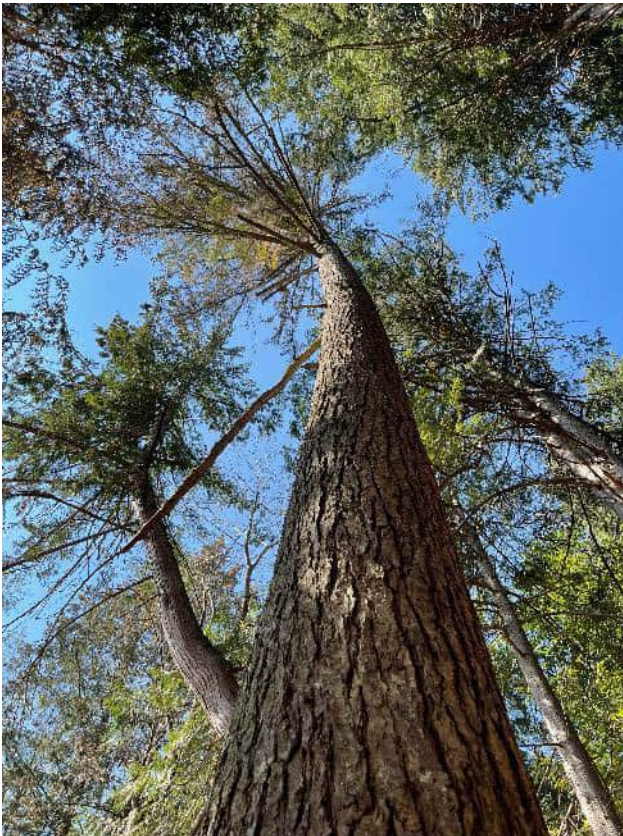
Photograph 17:

238	Hw	western hemlock	<i>Tsuga heterophylla</i>	56	28	- In significant decline with dieback evident throughout canopy. - Significant amount of material/sediment accumulation around base of tree potentially suffocating roots. - Very slight, eutrophic swoop in upper portion of main stem to south; towards road. - Photographs 17 and 18.	- Redroofs Road - Construction workers and equipment during remedial works	Possible	High	Somewhat Likely	Severe	Moderate	Convert to wildlife stem ~3-4m above grade to reduce risks	Prior to commencement of construction

**Significant dieback in
Tree #238**

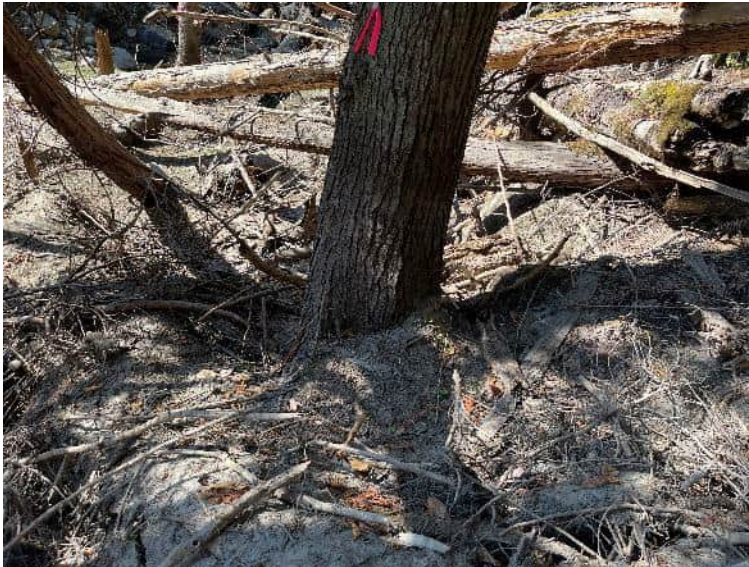
Photograph 18:

**Significant material
accumulation around the base
of Tree #238**

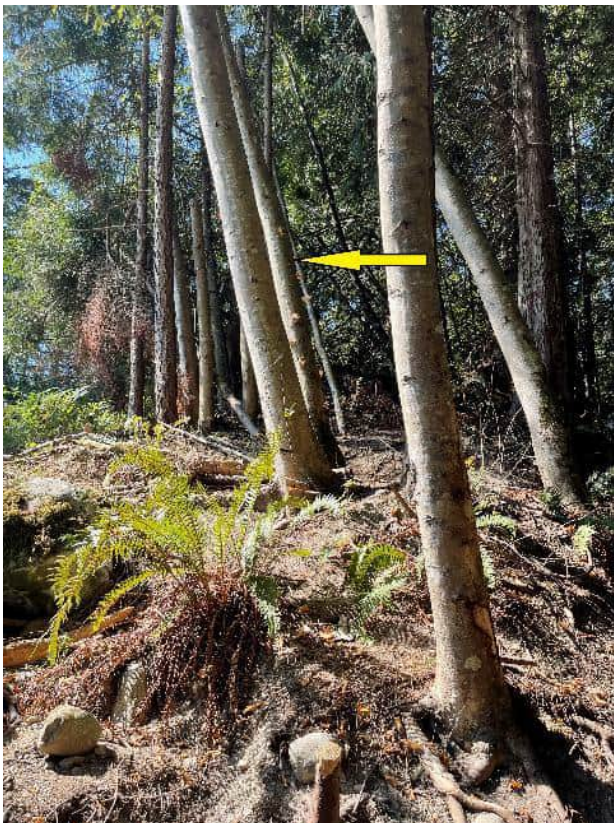
Photograph 19:

Upon further review of the photographic record collected during the field review, one additional tree that was not inventoried at the Kenyon Creek Site appeared to be of concern. The tree was located directly north of Tree #328 and can be seen in Photograph 19. The tree appeared to have fungal fruiting bodies throughout the main stem, suggesting internal rot. It is recommended that this tree be removed to grade, with the stump retained.

**Showing un-inventoried tree
north of Tree #328 with fungal
fruiting bodies requiring
removal**

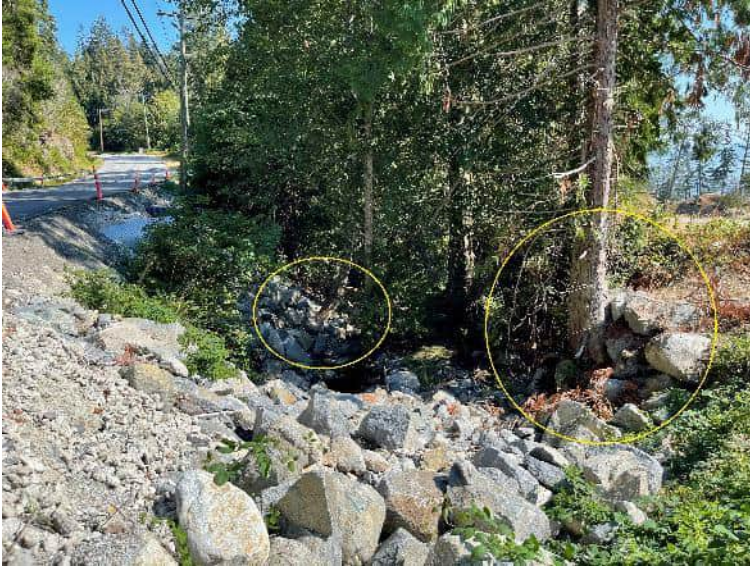
Photograph 20:

Impacts to trees on the downstream side of Redroofs Road appeared to be limited to an intermediate western redcedar on the west side of Kenyon Creek immediately adjacent to the culvert outfall, and a young red alder on the east side of the creek roughly 3–4m downstream of the redcedar tree (Photograph 20). Both trees have been partially buried at the base with what appears to be newly placed riprap. It is assumed that placement of the large rock also wounded the buried portion of the trees.

The western redcedar tree downstream of Redroofs Road appeared to be in moderate decline, which is likely more related to climatic changes (i.e., prolonged summer drought conditions with extreme heat) than the recent works completed along the banks of Kenyon Creek. The vitality of the red alder appeared to be normal with no visible dieback or stress. There is a chance that placement of the riprap around the base of these trees could have long-term effects (i.e., soil compaction, physical wounds creating point of entry for decay, etc.); however, no mitigation is recommended at this time. These two trees should be reviewed in two years to reassess vitality.

Tree resources downstream of Redroofs Road showing minor impacted trees

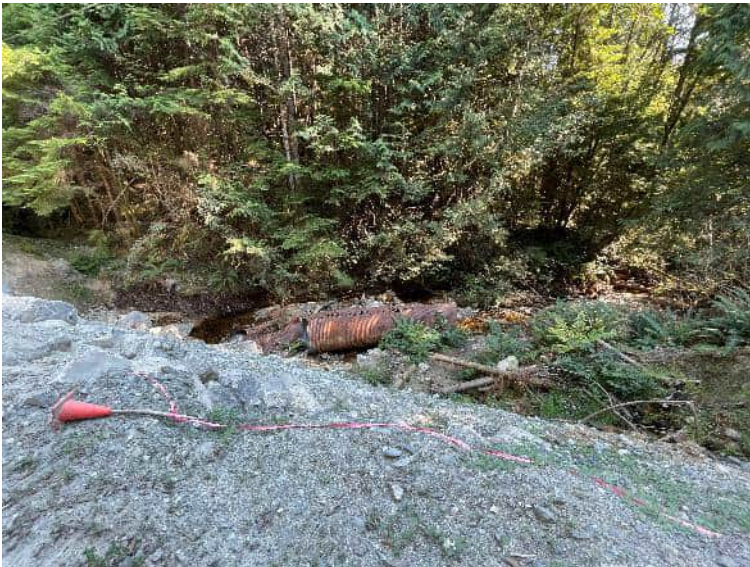
Photograph 21:

Trees outside of disturbance area on downstream side at Gough Creek Site

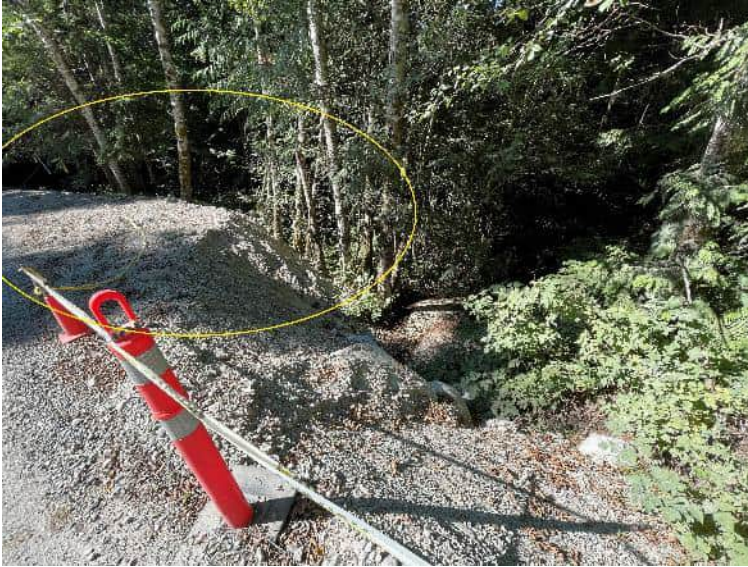
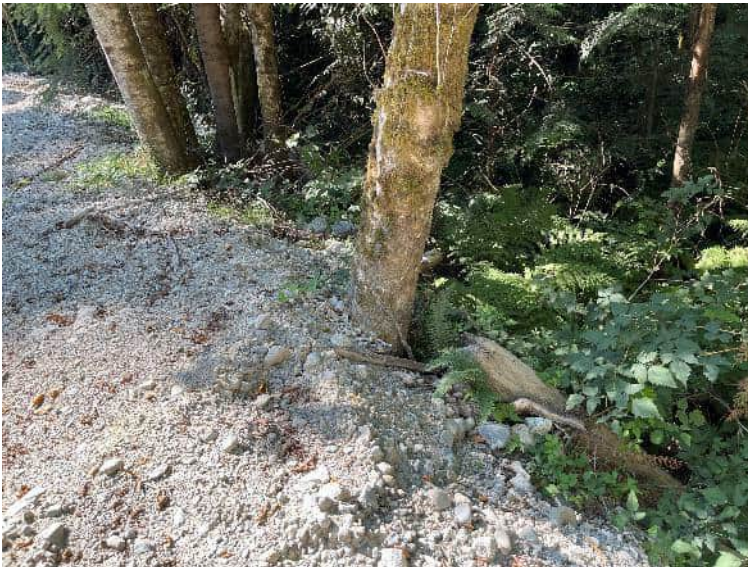
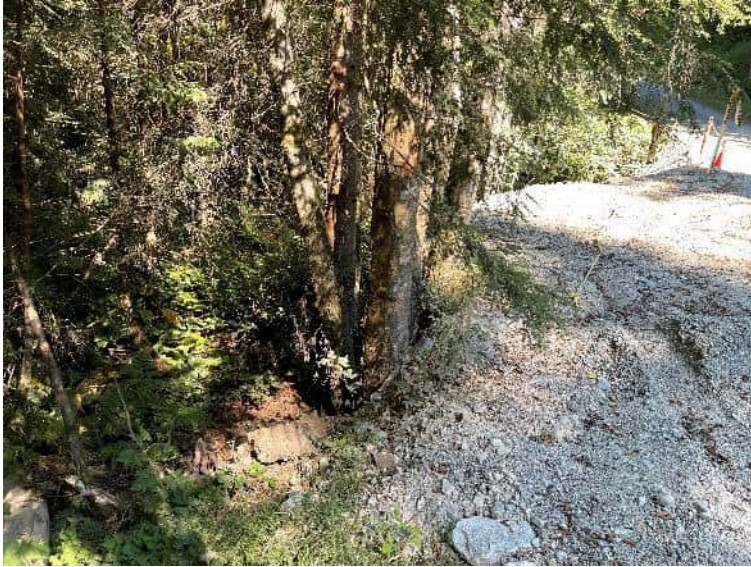
The most notable and prolonged impacts to trees on the upstream side of Day Road at the Gough Creek Site appeared to be partial burial of trees immediately adjacent to the road. The fill slope created from road repairs and/or widening extended down and around several red alder trees that occurred in this location (Photographs 22 through 25). The trees affected by the material placement appeared to be in good health at the time of review, although a few had some dieback in the upper portions of the canopy which was likely present prior to the flood event.

In the long-term, it is likely that the fill slope material will adversely affect the health of these trees. Soil compaction and burial could suffocate root systems, causing a gradual decline in tree vitality (i.e., over next few years). If the trees do decline, the likelihood of failure will increase. The likelihood of failed trees falling towards Day Road is high. Traffic frequency on Day Road is unknown, so the likelihood of a failure impacting a car and occupants is uncertain; however, it is very likely that a tree failure would result in disruption of traffic flow.

**Buried red alder trees on
upstream side of road at
Gough Creek Site**

At a minimum, the affected trees should be reviewed within the next two growing seasons to assess impacts, monitor potential decline, and prescribe mitigation measures, as needed. As a precautionary measure, the MOTI may consider removing the affected trees to roughly 1m above grade to mitigate expected future risks.

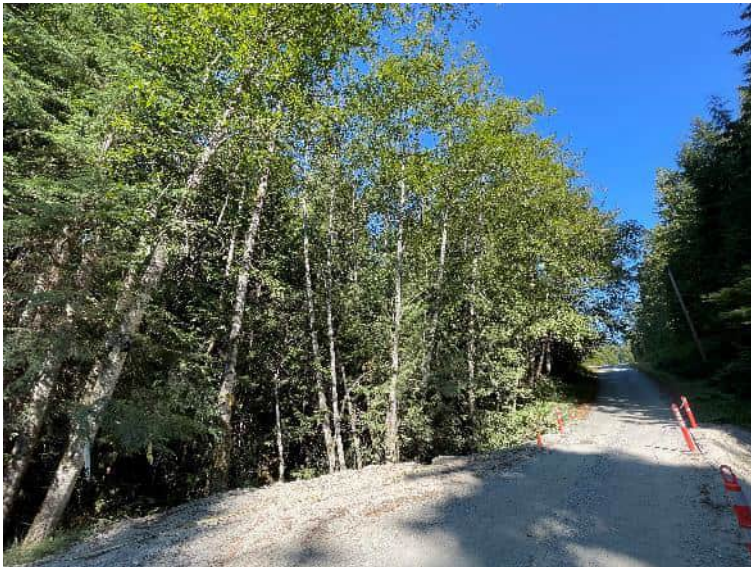
Photograph 25:

**Showing good vitality in buried
red alder trees on upstream
side of road at Gough Creek
Site**

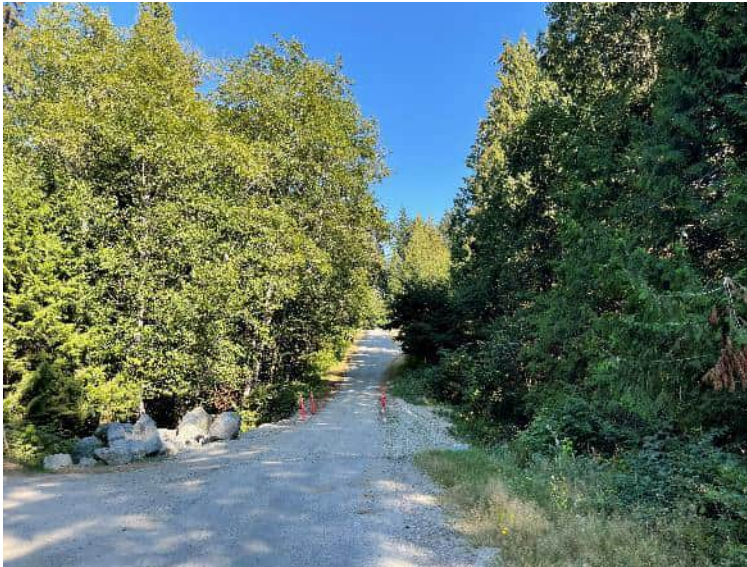
Photograph 26:

Showing young deciduous stand on upstream side of Day Road (left) at Clack Creek, and coniferous stand on downstream side (right)

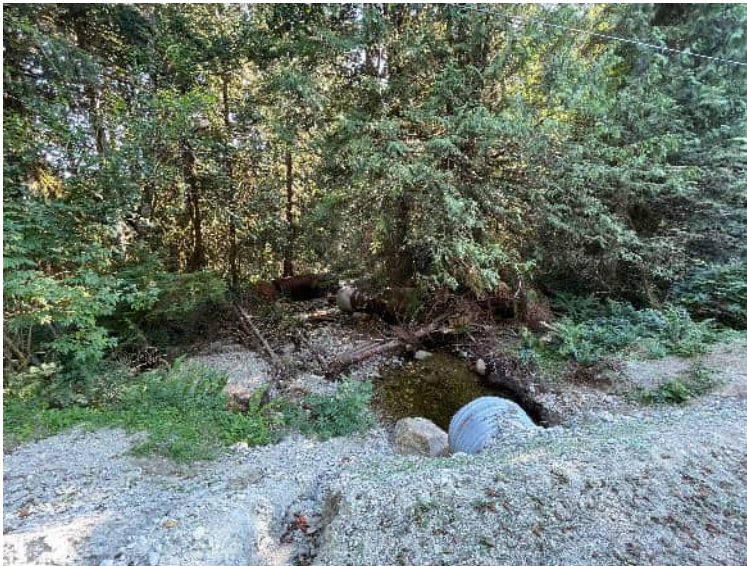
Photograph 27:

Disturbance was more evident on the downstream side of Day Road. Debris, including sections of the washed-out culvert were spread throughout the floodplain and into the forest (Photograph 27). A failed, young red alder tree was uprooted and extended across the stream, and other failed young western redcedar trees occurred on the floodplain paralleling the main channel. Geomorphological changes of the floodplain likely occurred; however, the scale is uncertain without a comparative baseline. It is possible that some root systems of remaining trees were disturbed, but stress in trees was not evident, nor did any trees appear to be in significant decline (Photograph 28).

Showing washed-out culvert and downed trees downstream of Day Road at the Clack Creek Site

No tree removals or modifications are recommended at this time for the forest stand downstream of Day Road at the Clack Creek Site. Tree health should be monitored over the next two growing seasons. If work is required to remove debris, we recommend retaining an arborist to provide guidance through construction and to assess retained trees once debris has been removed.

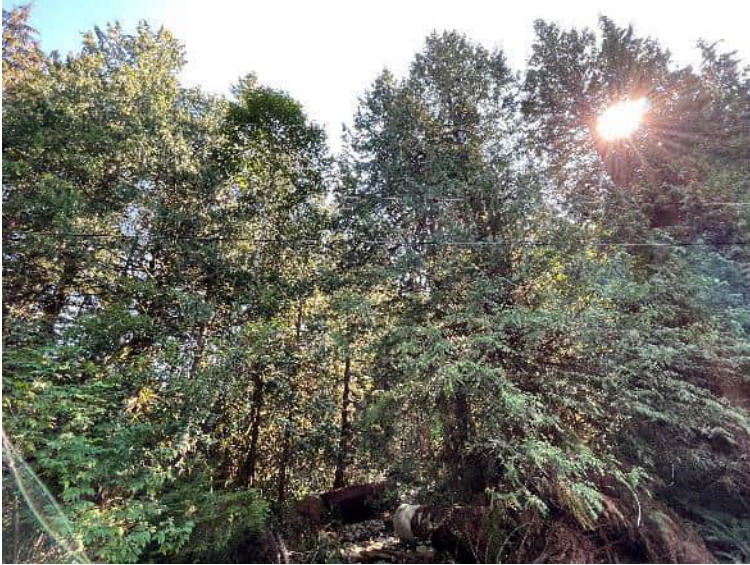
Photograph 28:

Stand canopy downstream of Day Road at Clack Creek showing good vitality

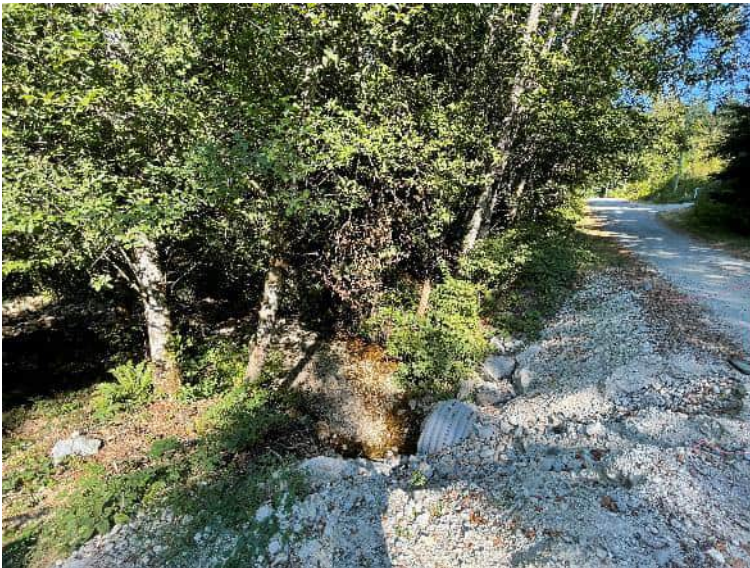
Photograph 29:

Showing minimal disturbance on upstream side of Day Road at the Clack Creek Site

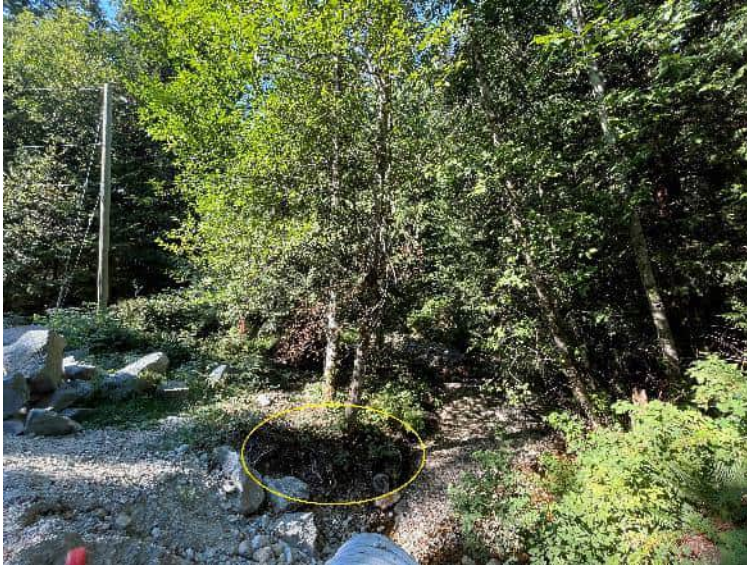
Photograph 30:

Showing minor erosion and root exposure on west side of Clack Creek upstream of Day Road

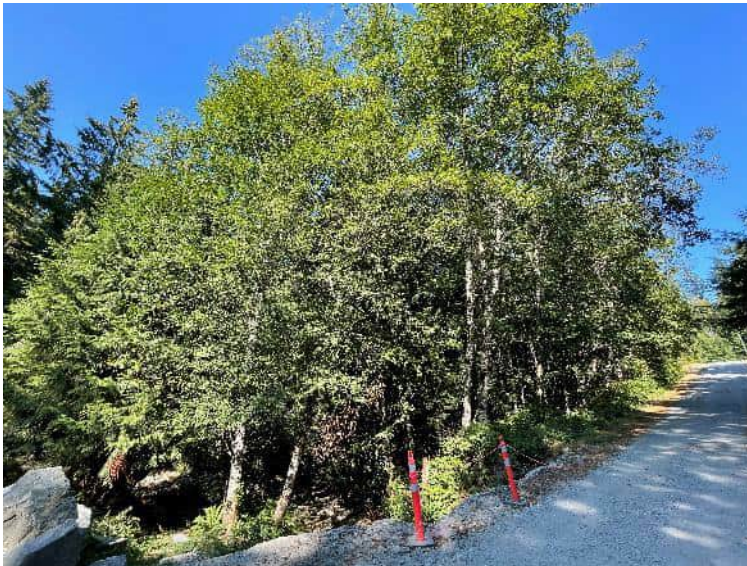
Photograph 31:

Showing good vitality in forest stand on upstream side of Day Road at the Clack Creek Site
