# GEOTECHNICAL REPORT

## ROCKWELL DRIVE FLOOD RECOVERY CULVERT REPLACEMENT SITES: DF1, DF2, DF3

PROJECT NO.: VG07795.300  
DATE: FEBRUARY 2023

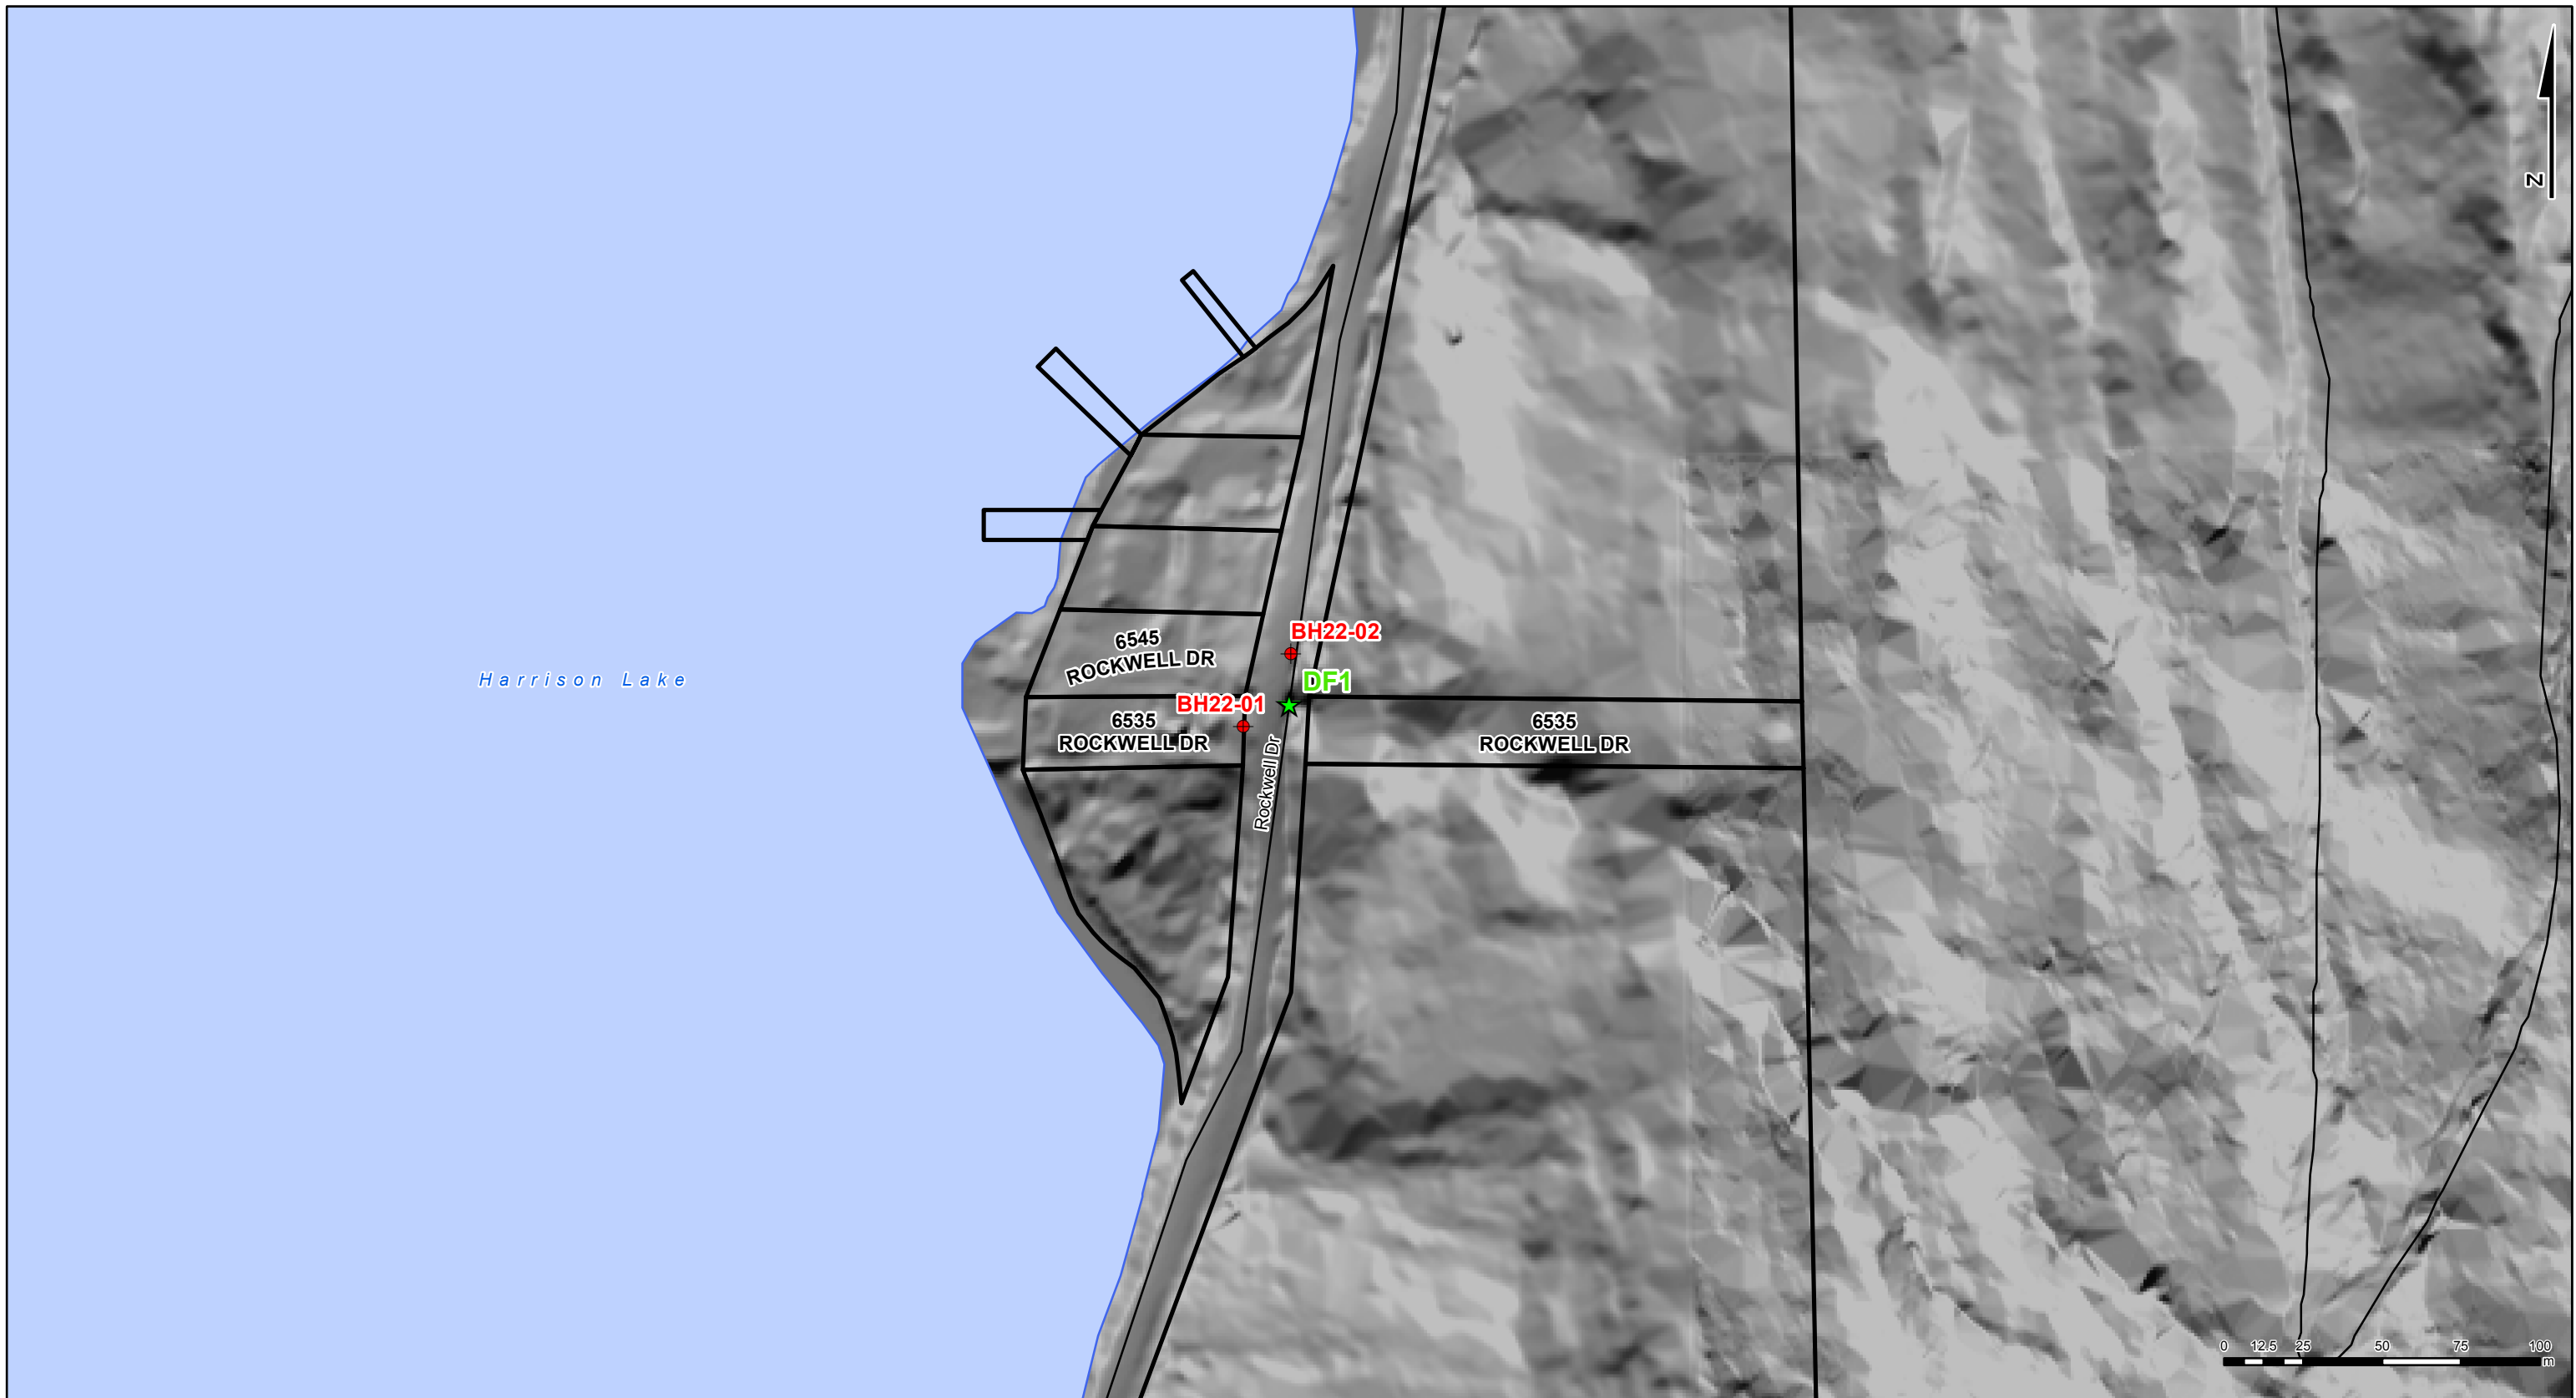
DATE: FEBRUARY 2023  
 PROJECT NO.: VG07795.300  
 REV NO.: A  
**FIGURE 2A**

Two boreholes, BH22-01 and -02, were drilled to a depth of 5.2 m on the southwest and northeast sides of the culvert crossing, respectfully. Locations are shown in Figure 2A. The subsurface conditions encountered by the boreholes are summarized below.

**Subgrade Fill:** Sand and gravel with trace fines, moist, loose to compact, with occasional cobbles, thickness between 0.9 and 1.4 m.

**Natural Gravelly Sand:** Gravelly sand with trace fines, occasional cobbles and boulders, moist, loose to compact, thickness between 0.9 and 1.5 m. In BH22-02, an organic rich layer approximately 0.2 m thick was observed on the top of this deposit, this organic layer is interpreted as a natural ground surface.

**Gravelly Silt:** Gravelly silt, moist, loose to compact. A boulder was found between the natural gravelly sand and gravelly silt in BH22-02. The thickness of the boulder as encountered by the drill was approximately 0.7 m.

**Groundwater:** Groundwater was not observed during drilling. Seasonal perched groundwater tables may be present on layers of lower permeable soils (e.g. gravelly silt).

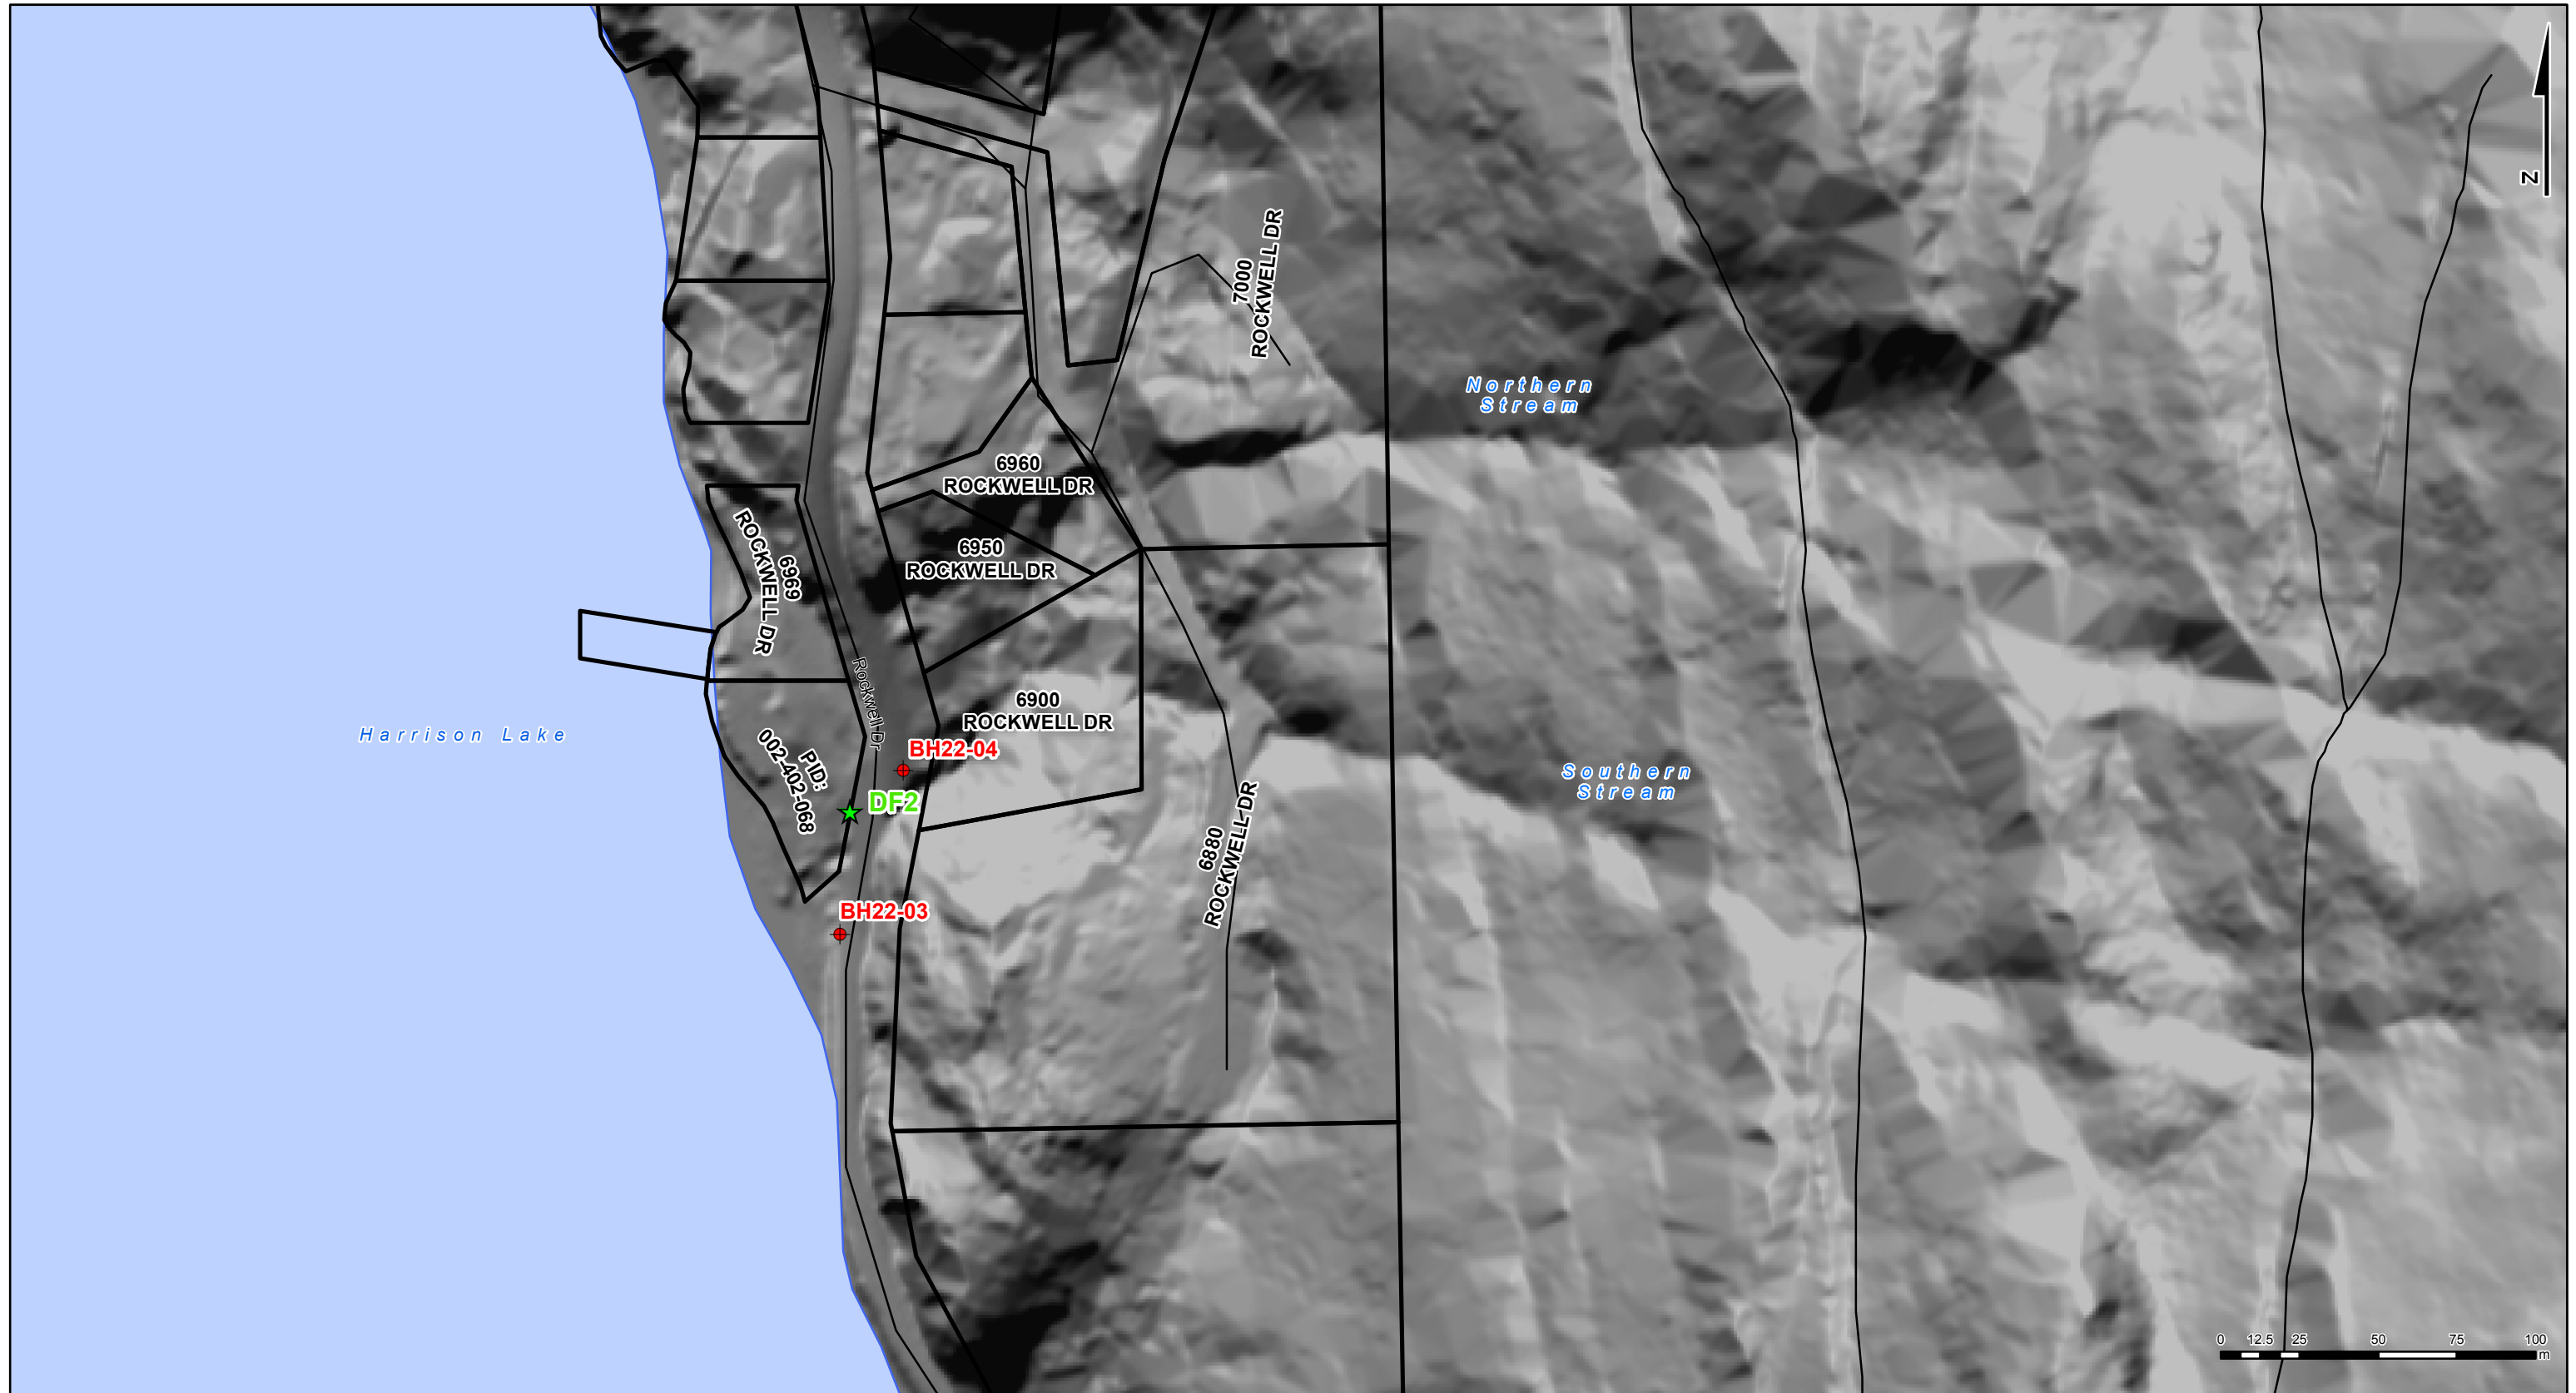
**FIGURE 2B**

Two boreholes, BH22-03 and -04, were drilled to depths of 3.9 to 4.3 m on the southeast and northwest sides of the culvert crossing, respectfully. Locations are shown in Figure 2B. The subsurface conditions encountered by the boreholes are summarized below.

**Subgrade Fill:** Gravelly sand or sand and gravel, with trace fines, moist, loose to dense, with occasional cobbles, thickness between 1.2 and 1.3 m.

**Natural Gravelly Sand:** Gravelly sand with trace fines, occasional cobbles, moist, loose to compact, encountered thickness between 1 and 1.7 m.

**Groundwater:** Groundwater was not observed during drilling.

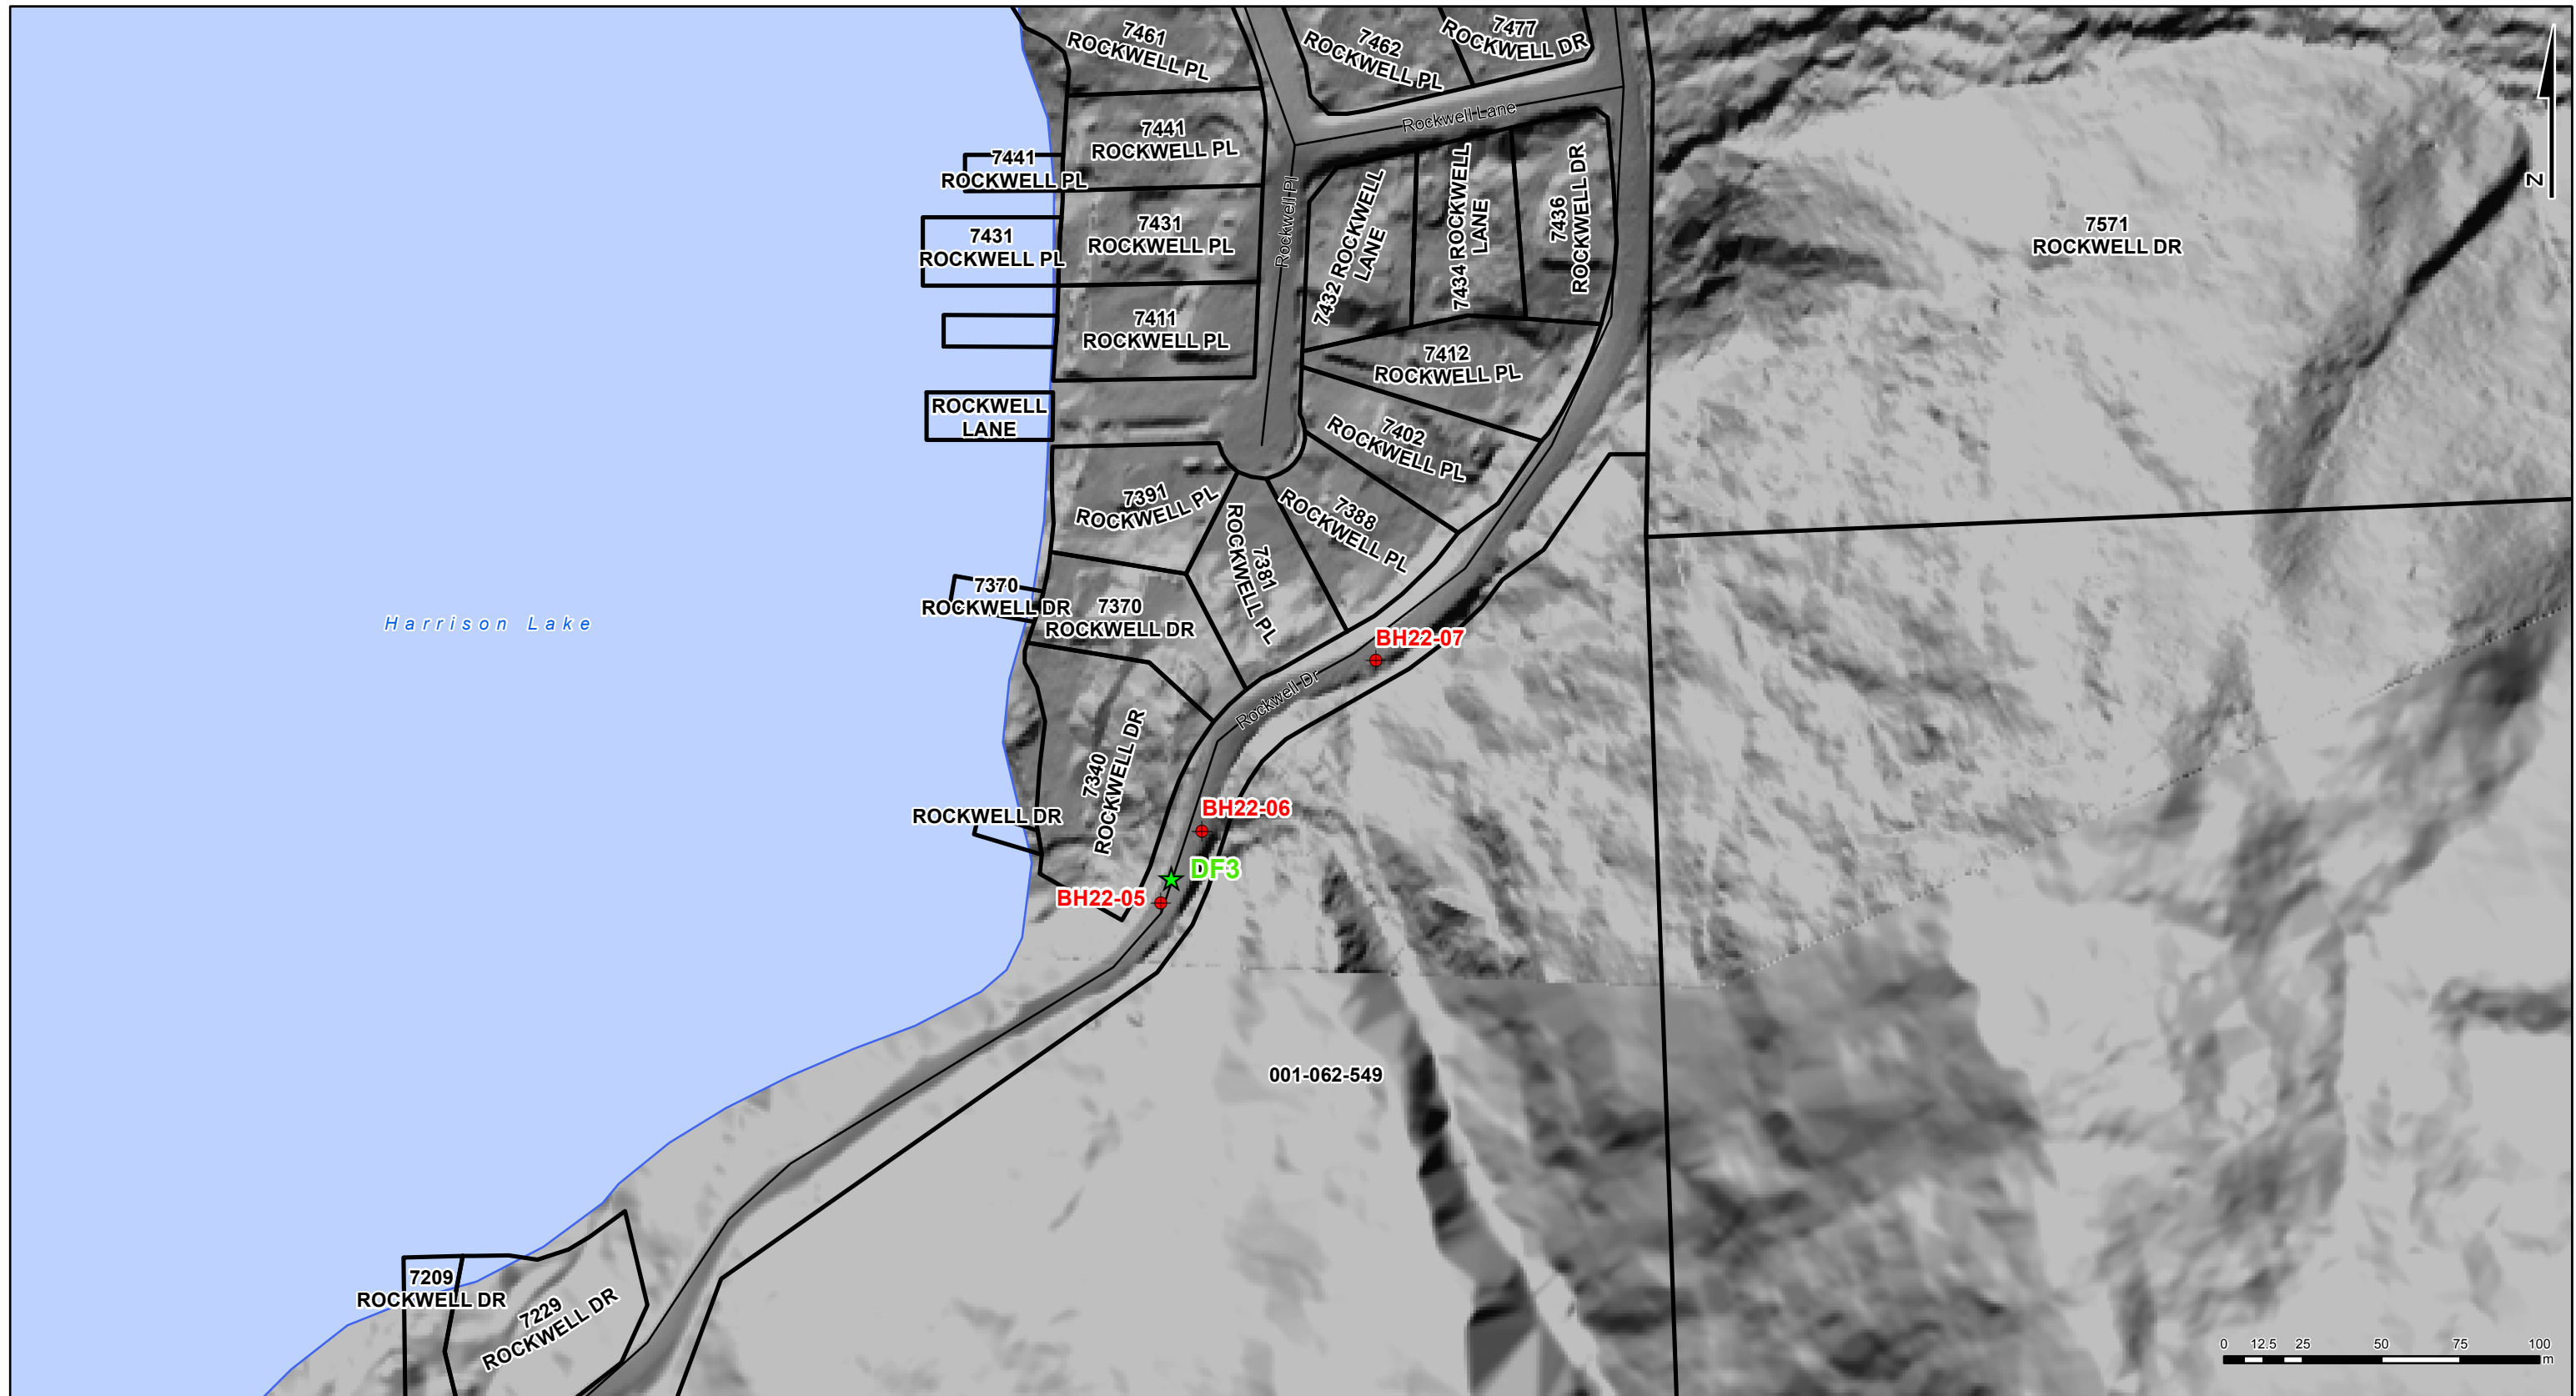
Two boreholes, BH22-05 and -06, were drilled to a depth of 3.7 m on the southwest and northeast sides of the culvert crossing, respectively. Locations are shown in Figure 2C. The subsurface conditions encountered by the boreholes are summarized below.

**Subgrade Fill:** Gravelly sand, trace silt, moist, loose to compact, with occasional cobbles, 1.3 m thick in BH22-05, subgrade fill was encountered to the bottom of BH22-06.

**Natural Gravelly Sand:** In BH22-05, natural gravelly sand with trace fines, moist, very loose to loose, 1.5 m encountered thickness.

**Groundwater:** Groundwater was not observed during drilling.
