**Timber Evaluation and Tree
Risk Assessment: Rockwell
Drive Flood Recovery
Project DF#4/ Agassiz,
Harrison Hot Springs, B.C.**

2023-07-28 | Original

Ministry of Transportation and Infrastructure

Prepared by: McElhanney Ltd.

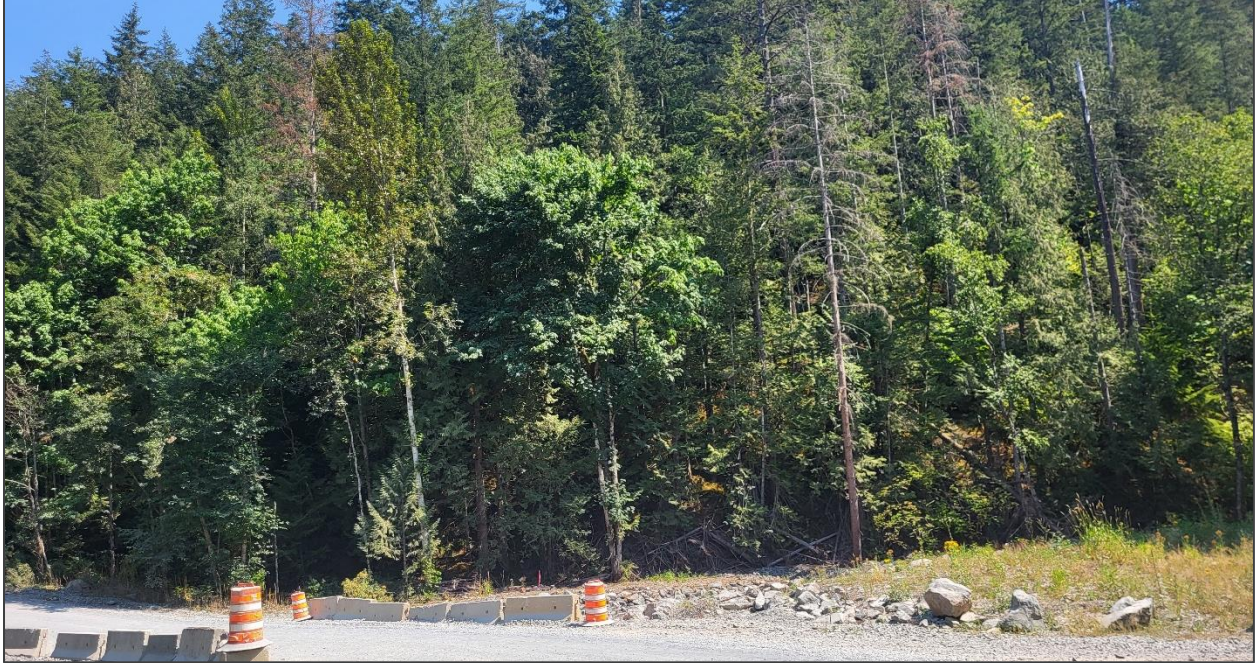
Figure 2. DF#4 - sample image of the soil erosion and steep terrain above the Hick's Lake Road (view from the West to the East).

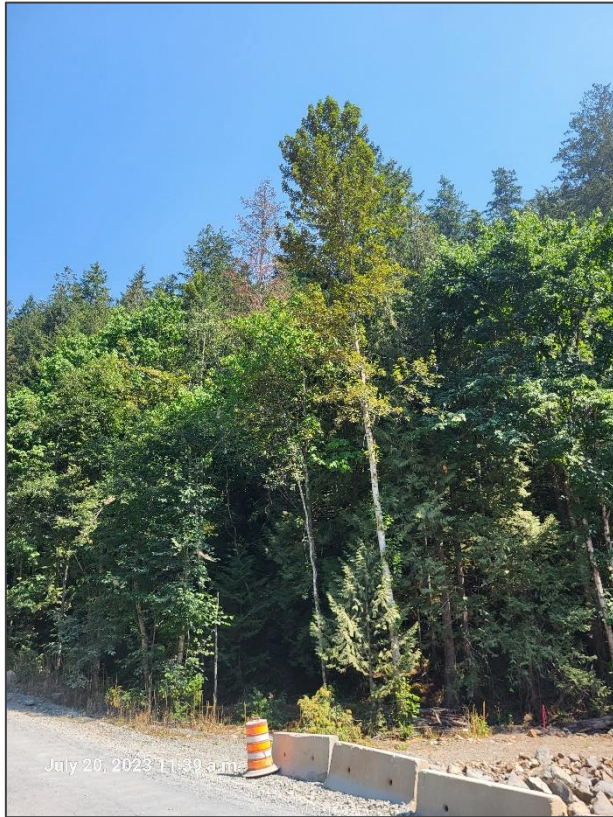
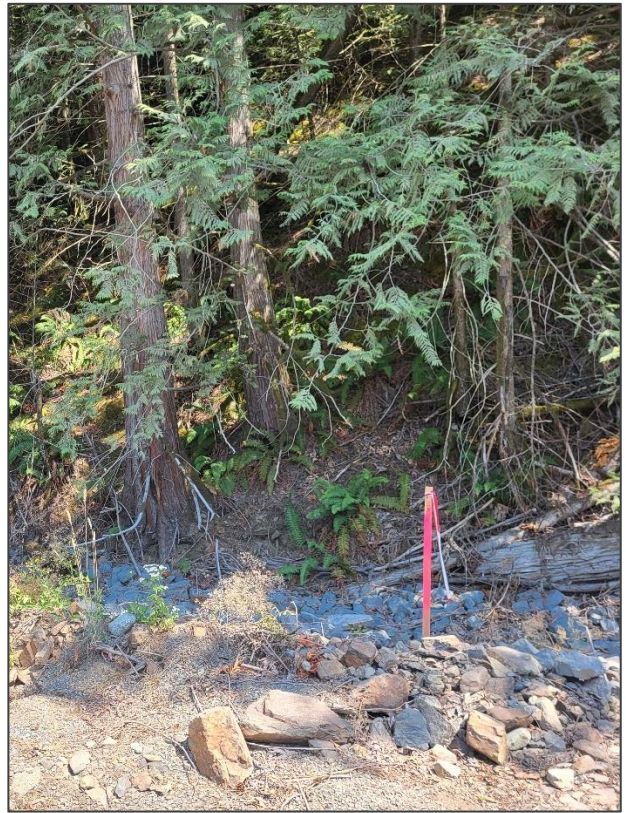
Photos 1 & 2. Sample images of DF#4 – above the road.

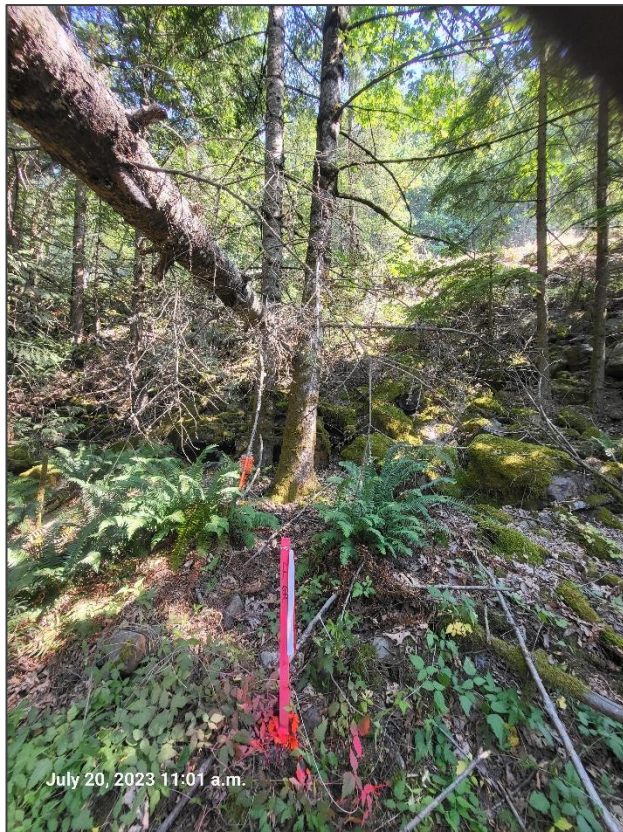
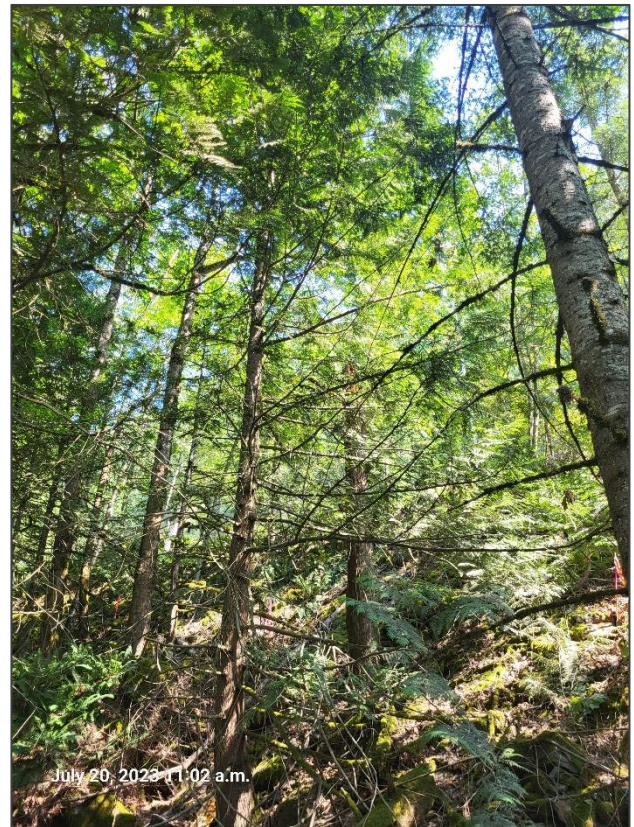
Photo 3 & 4. Sample images of DF#4 – below the road.

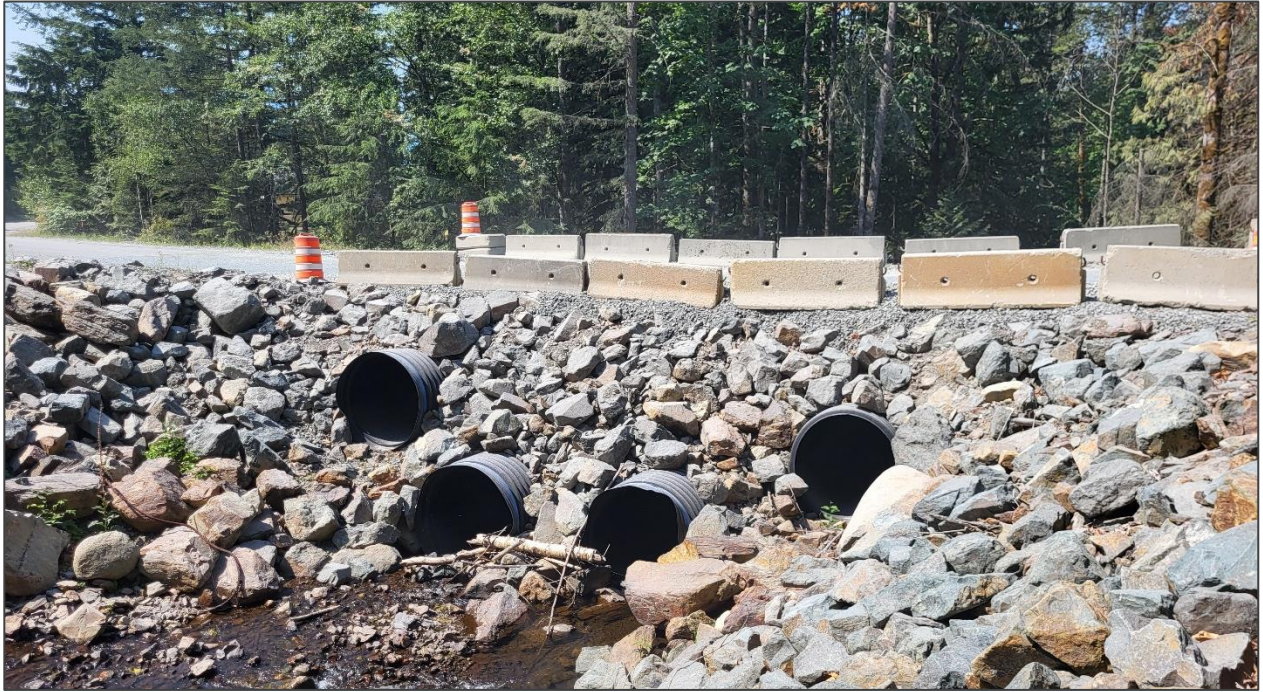
Photo 5. Sample image of the existing drainage DF#4 – above the road.

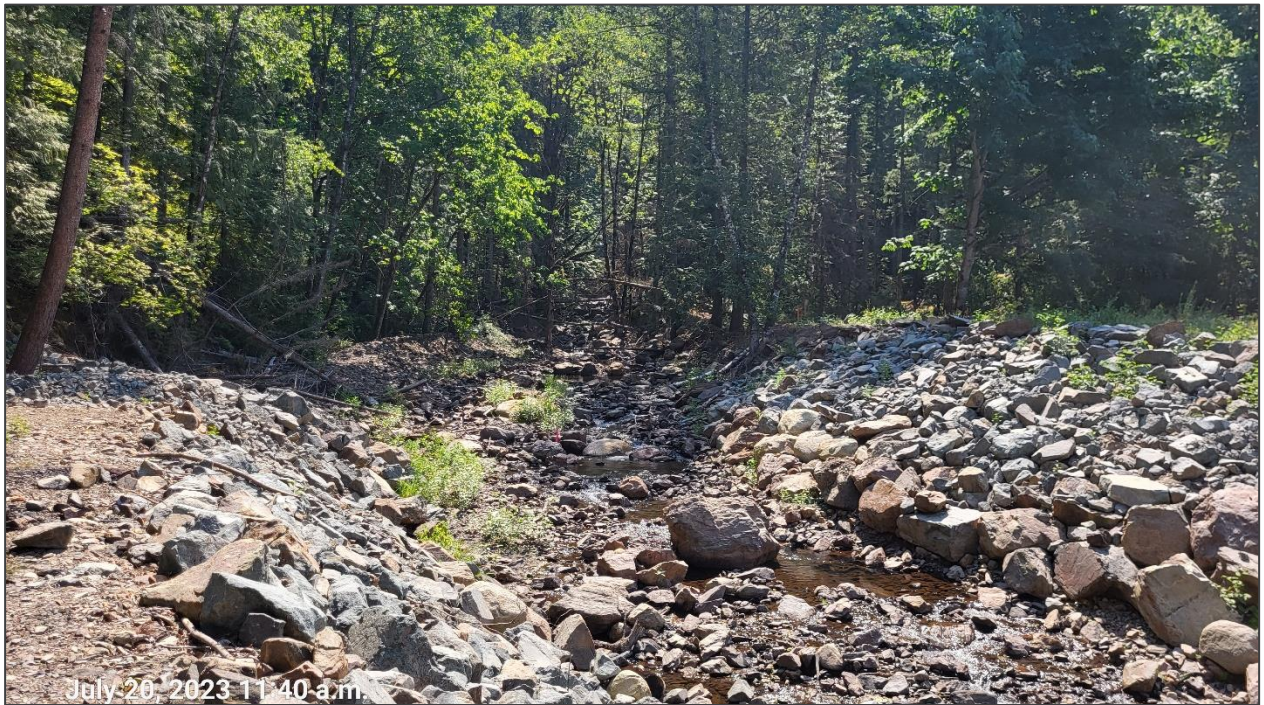
Photo 6. Sample Image of SF#4 – above the road.
