To: Dickson Chung
British Columbia Ministry of
Transportation

From: Catalina Tandara
Stantec

Project/File: Chilliwack Lake Road Flood Recovery (1158200850) Date: April 5, 2023

Reference: 14095-0002 Chilliwack Lake Road – Site D Box Culvert at Anderson Creek

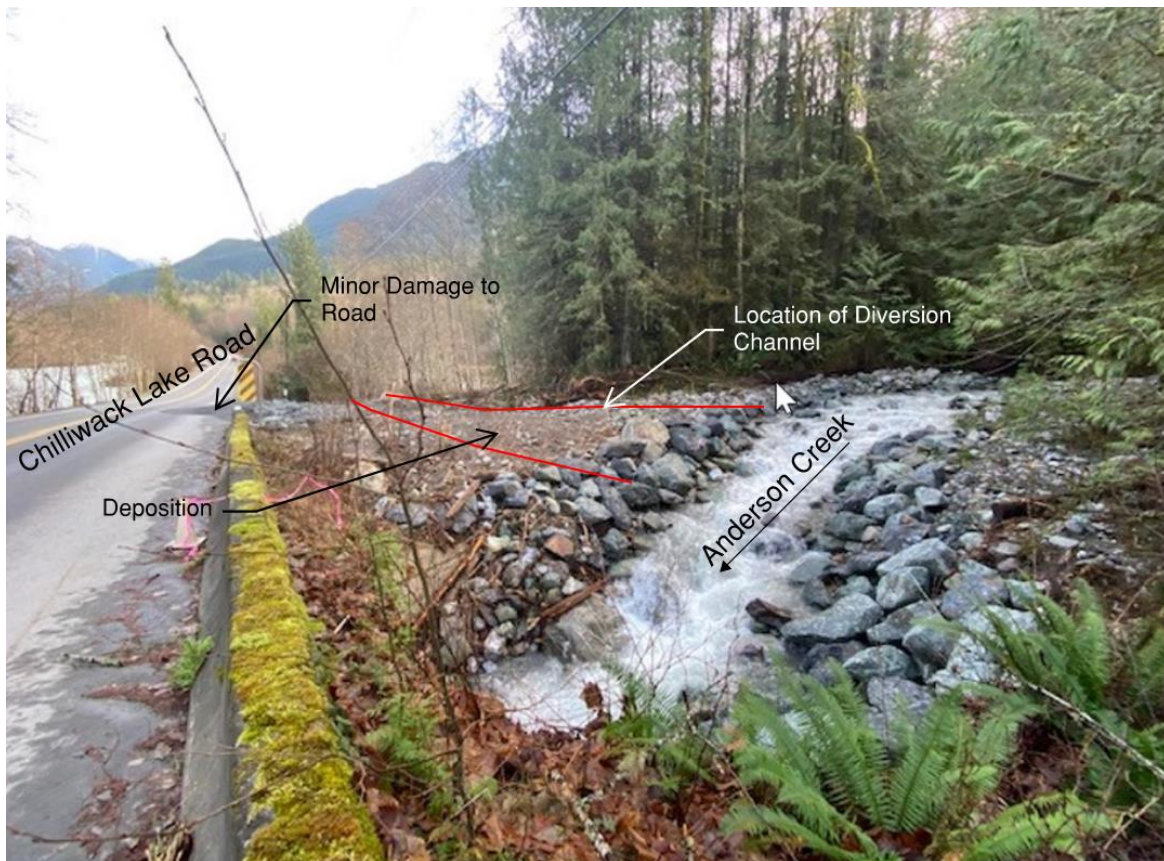
Figure 2 is of an image taken during Stantec's site visit in January 2022. Photo is taken prior to the clearing of the deposited rock material and repair to the asphalt surface of Chilliwack Lake Road.

Figure 2. Box Culvert Site after the November 2021 Heavy Precipitation Event

It is our understanding that the maintenance contractor re-established Anderson Creek and DFO re-established the diversion channel and the artificially raised boulder riffle to pre-flood conditions. In addition, an overflow gravel berm was installed above the diversion channel's left bank to reduce the flow length of future high flow events along the road embankment, it is unclear at this time if the gravel berm was constructed by the maintenance contractor or DFO. Site D in its re-established condition still poses a risk to Chilliwack Lake Road from breached larger flow events. Stantec recommends installing an armoured guide bank between the road and the diversion channel to mitigate erosion risk of the road embankment.

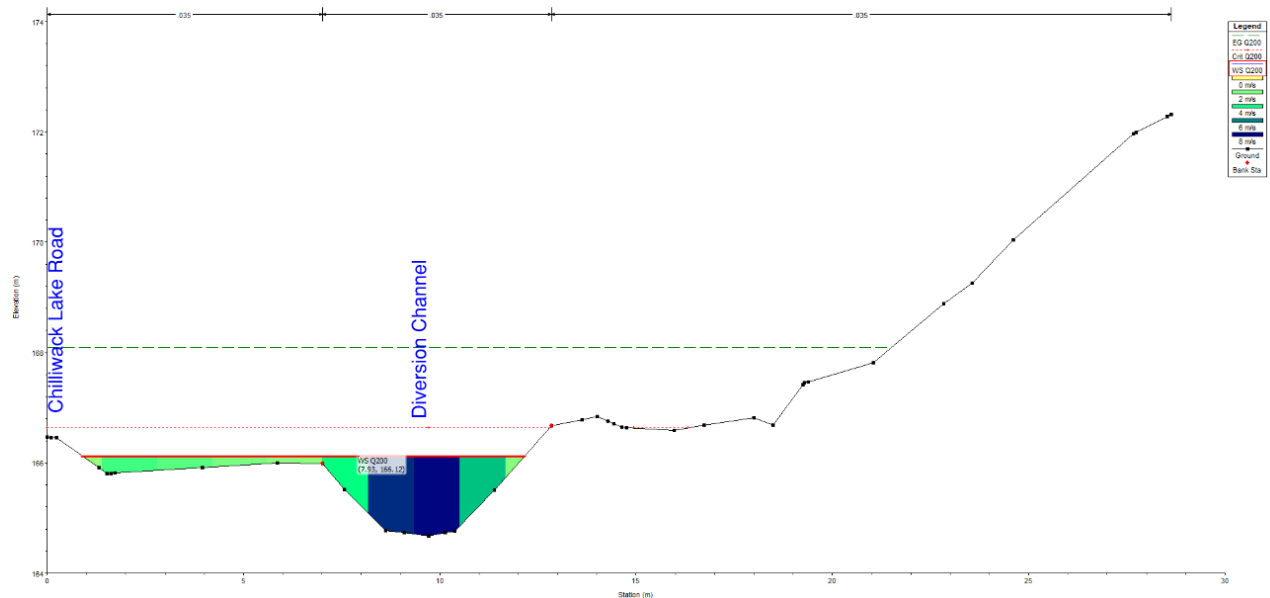
Figure 4. 1-D Model Hydraulic Section 4 - Design Flood Event – Existing Conditions

As shown in Figure 4 and 5, under re-established conditions Chilliwack Lake Road is not overtopped but the presence of water flow against the road embankment presents a risk of erosion. The modelled velocities along the road embankment exceed those that cobbles and pebbles can withstand according to TAC 2019 Table 4.3.

Due to the presence of fast flowing water at the toe of the road embankment, Stantec recommends the placement of a guide bank between the road embankment and the diversion channel.

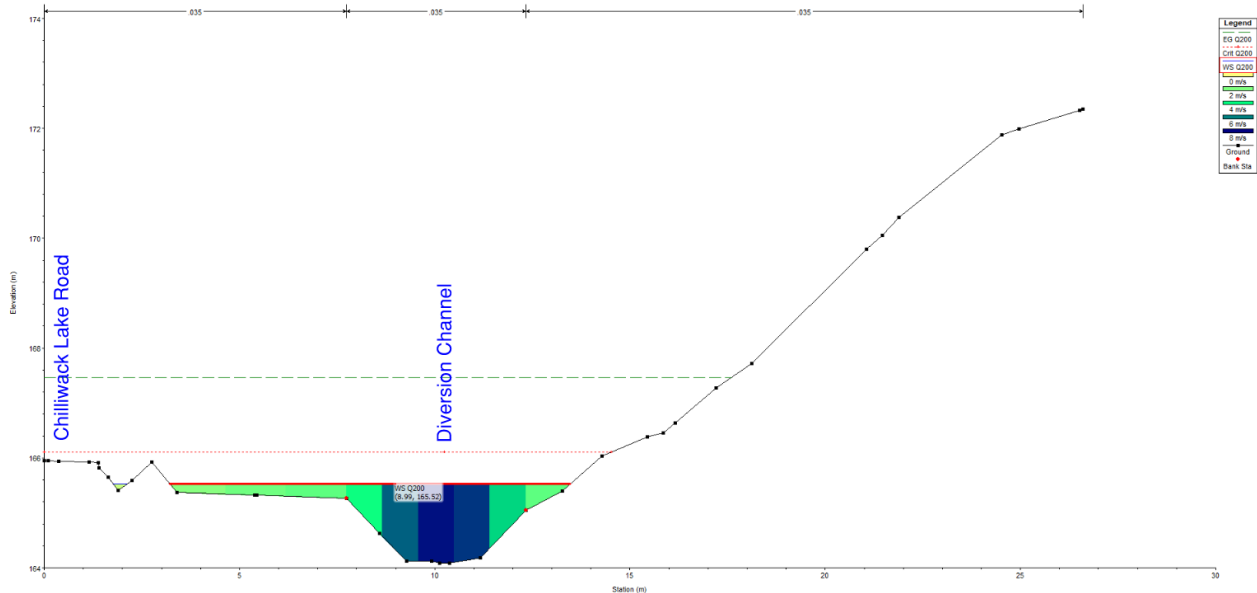
Figure 5. 1-D Model Hydraulic Section 3 - Design Flood Event – Existing Conditions

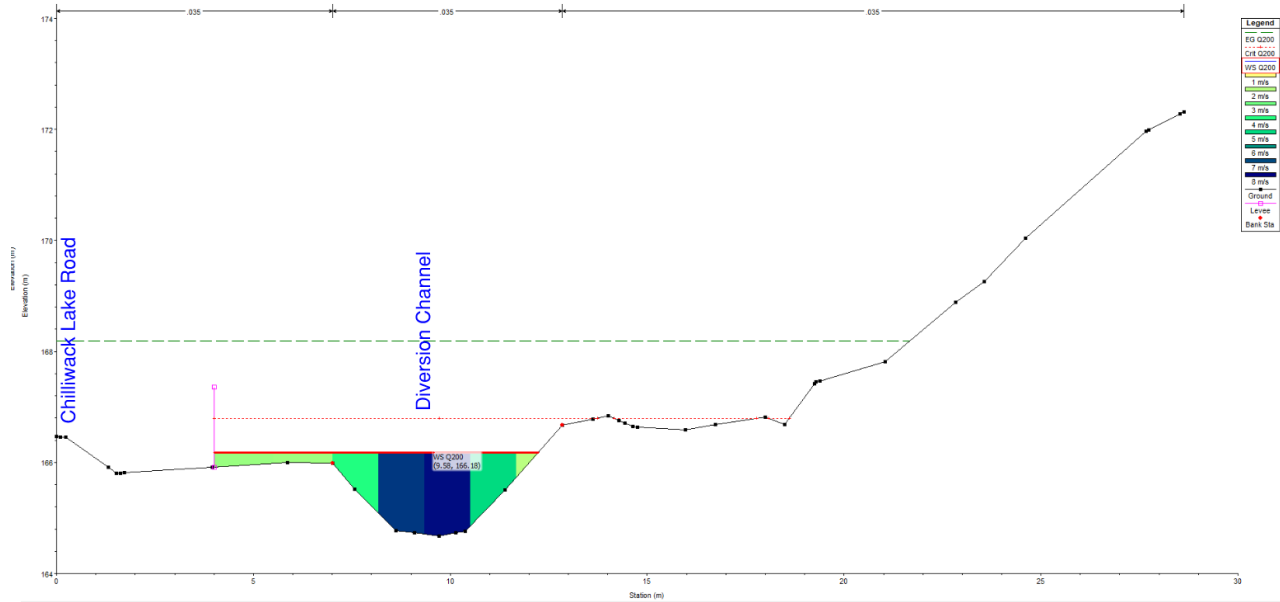
Figure 6. 1-D Model Hydraulic Section 4 - Design Flood Event – Proposed Conditions

The addition of the levee increased water surface elevations 0.06 m and 0.01 m at hydraulic section 4 and 3, respectively. The design of the recommended guidebank proceeded using the water surface elevations from the second model.

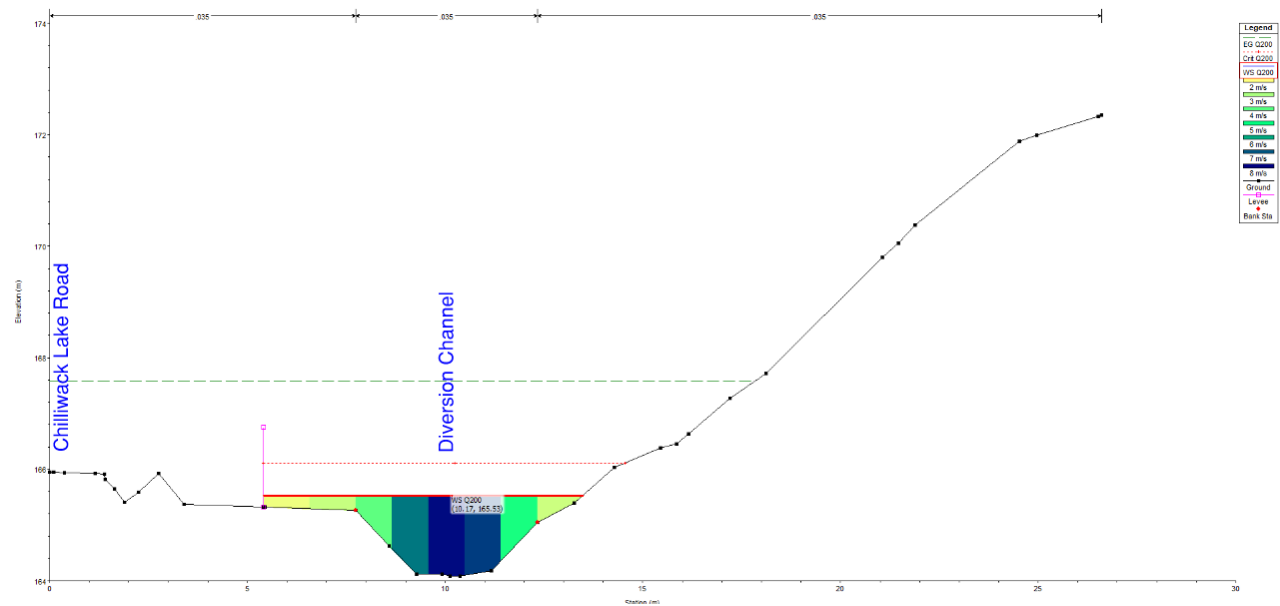
Figure 7. 1-D Model Hydraulic Section 3 - Design Flood Event – Proposed Conditions

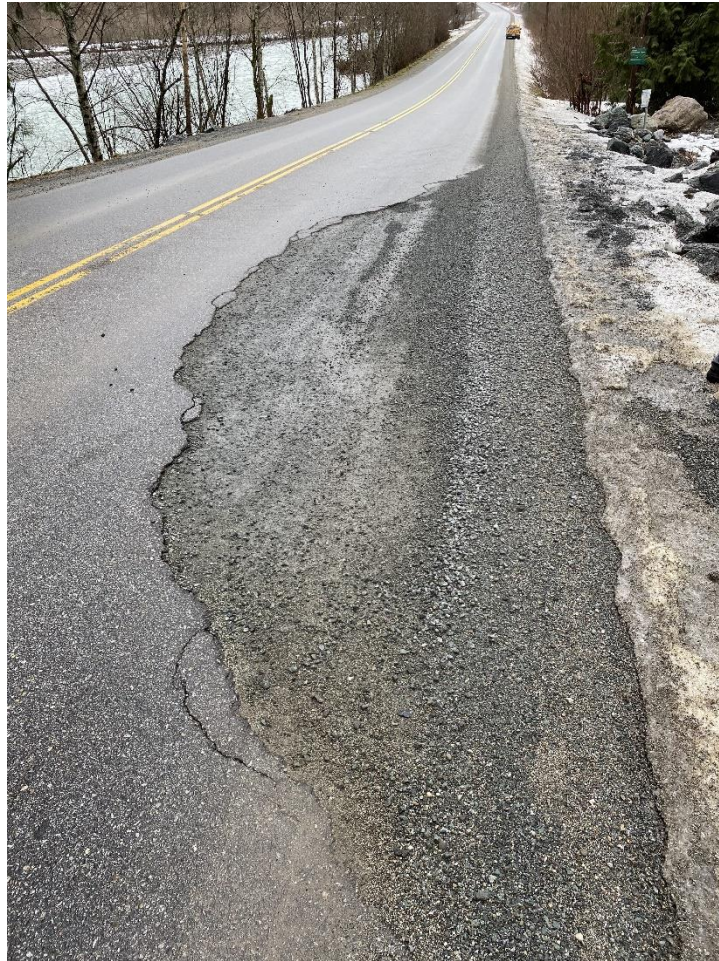
Breaching of the November 2021 water levels at the site and the diversion of water along its side to the spawning ponds caused damage to the road embankment and road base from erosion and washed away portions of pavement in the eastbound lane. Image 1.1 below shows the extent of the damage. The damage has been repaired by the Maintenance Contractor and is therefore no longer included in this scope of work.

Image 1.1 Asphalt Damage post November 2021 event. Repaired by the Maintenance Contractor.

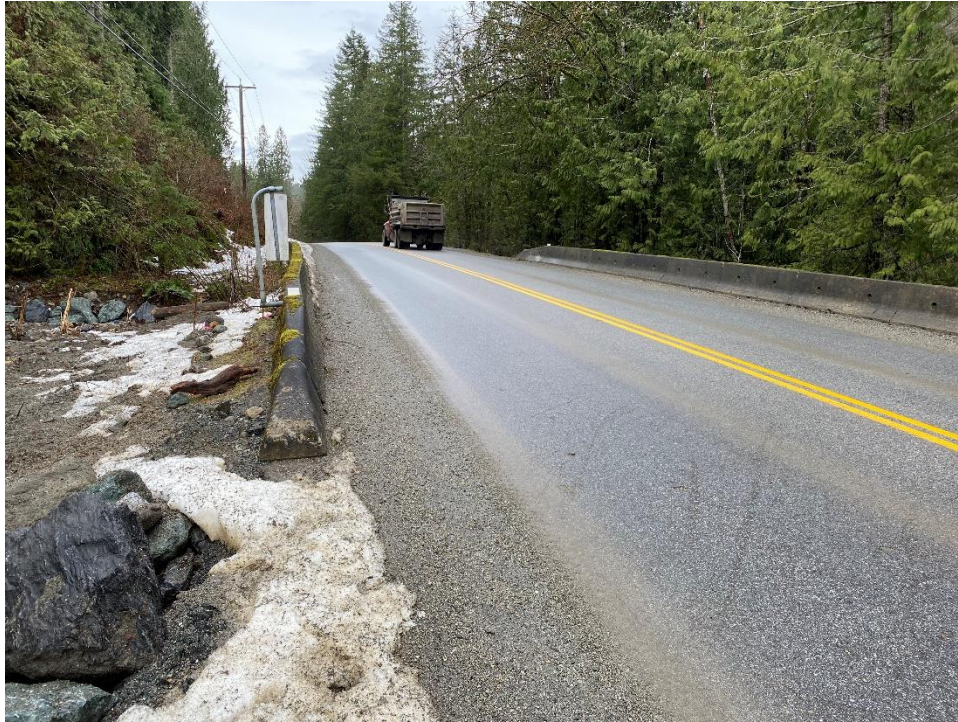
The November 2021 high water levels also caused damage to the opposing barrier flare parallel to the eastward bound travelled road lane. The initial repair of the site did not reinstate the asphalt apron for the barrier flare. The barrier was placed in a straight line, contrary to pre-event condition and BC MoTI standard. Image 1.2 below shows the temporary reinstalled barrier.

Image 1.2 Temporary Re-Installed Barrie. Non-Compliant to BC MoTI Standards

The work proposed in this memo will include reinstatement of the paved barrier flare and installation of the necessary barrier to meet BC MoTI standards.

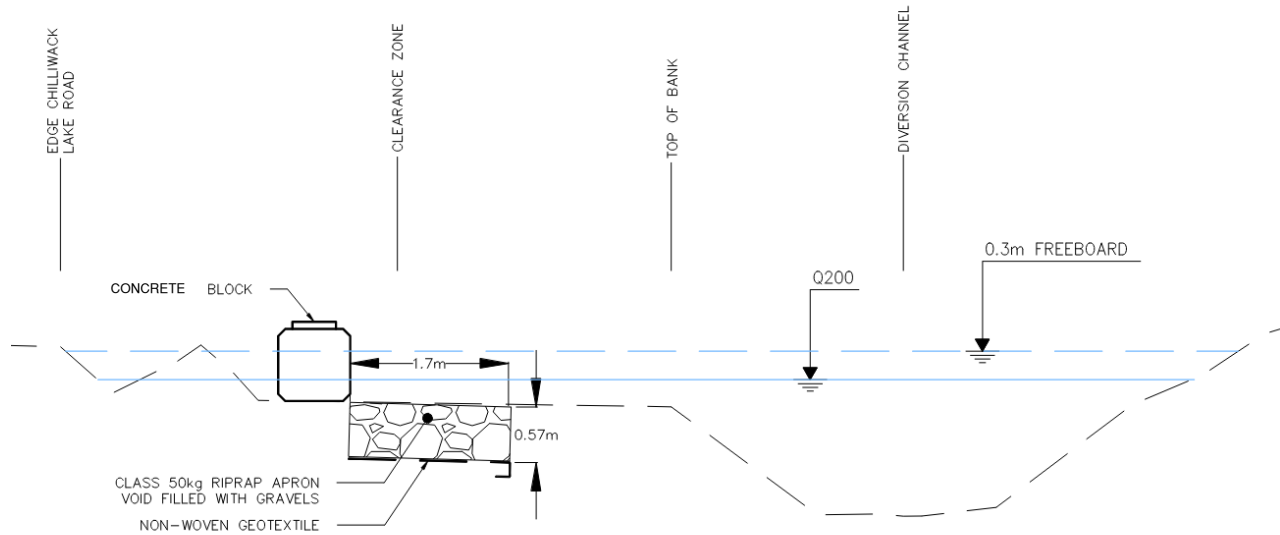
Figure 9. Proposed Cross Section of the Design at the Box Culvert Site

To meet the design parameters, Stantec recommends a linear placement of concrete blocks as the guidebank between the road embankment and the diversion channel. Concrete blocks that extend beyond the road barrier are to be placed along the Clearance Zone. Behind the road barrier the concrete barriers are to be placed 3.0 m away from the top of bank.

Class 50kg Riprap is to be keyed into the existing grade of the riverside of the concrete blocks at the concrete block's toe in an area that is approximately 1.7 m wide and 0.57 m thick. The hydraulic model suggests velocities up to 2.4 m/s along the toe of the concrete blocks. The 50kg Riprap mitigates avulsion risk from the design flow event. Non-woven geotextile will be keyed-in and placed underneath the Class 50kg Riprap.

The concrete block's height of 0.76 m is sufficient in providing an impediment to the design flow event along the entirety of its length. But as stipulated in TAC 2019 a 0.3 m freeboard is to be incorporated above the water surface elevations. In order to achieve the requirements of the freeboard, minor fill of 0.1 m is required below the concrete blocks at the upstream end.
