MEMO

TO: Scott Cosman. P ENG.
COMPANY: BC MOTI
FROM: Bob Forsyth
DATE: 17 November 2022
CC: Wayne Byczek, P Eng, Johnathan Tillie, Michael Carreira, P Eng.
PROJECT NO.: VG07794.312
SUBJECT: Silver Skagit Road, South of Hope, BC
Road and Culvert Repair at km 36.7
Project Number: 14122, Site ID: SA07-150-24

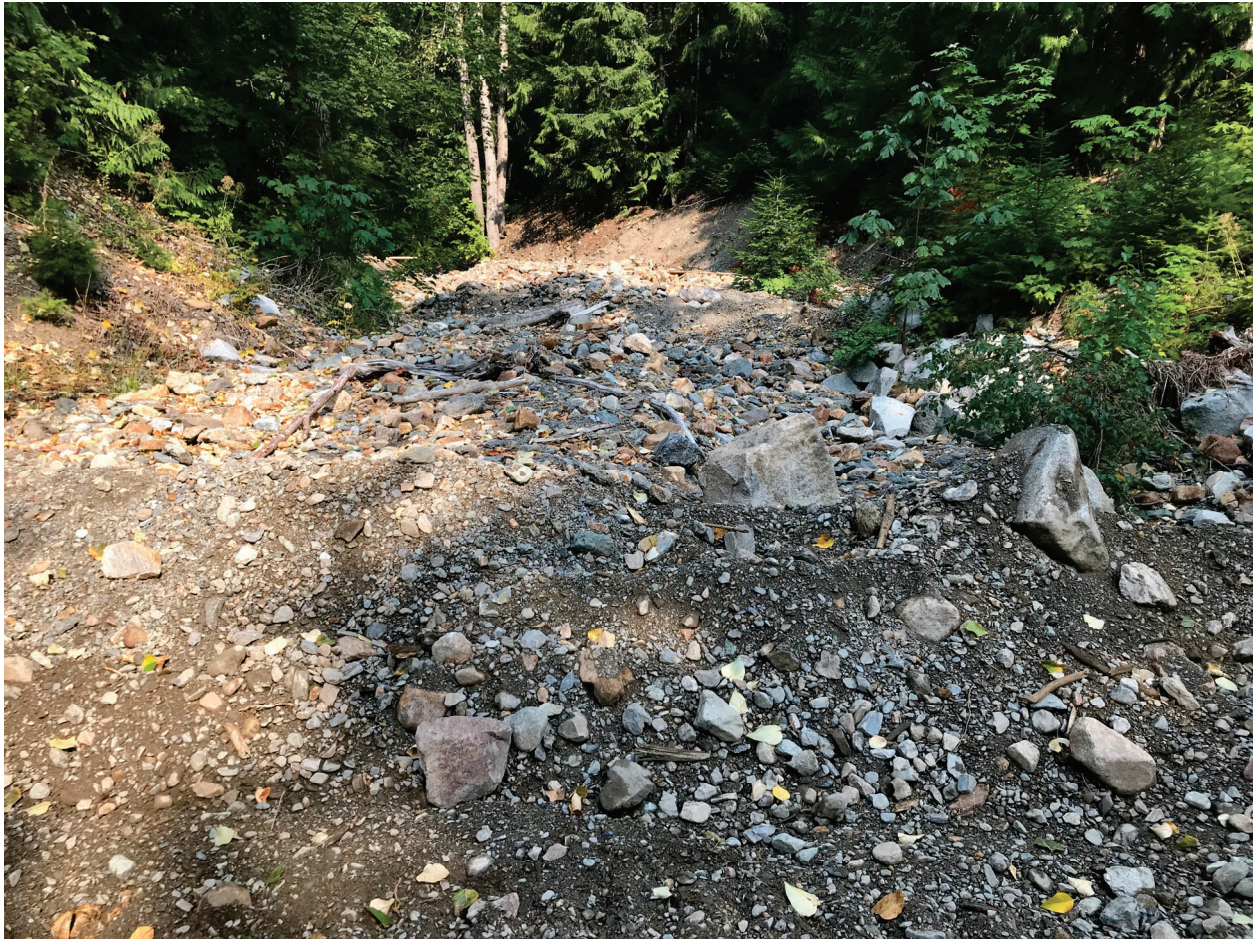
Photo 1: September 14, 2022. Looking upstream from the road.

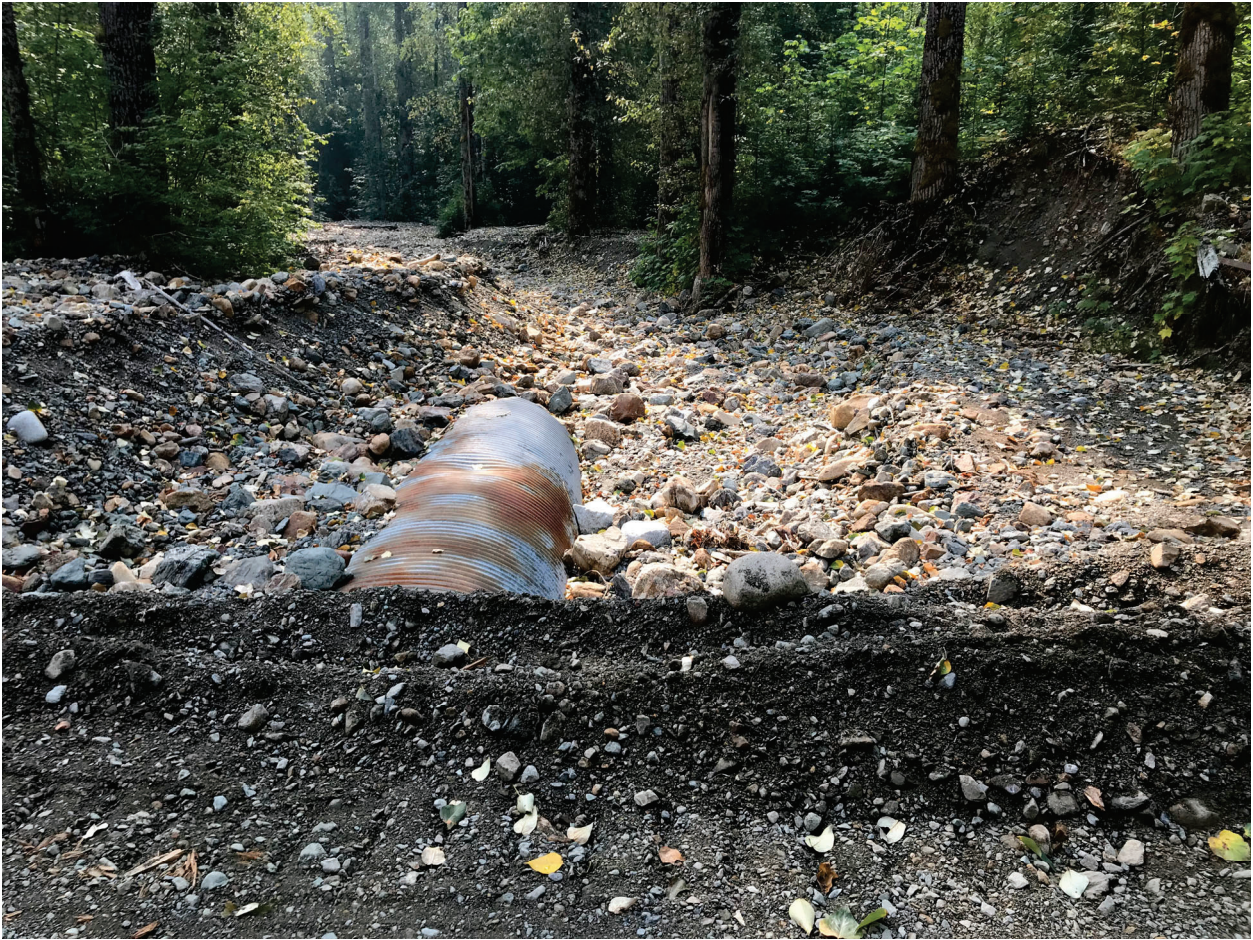
Photo 2: September 14, 2022. Looking downstream from the road.

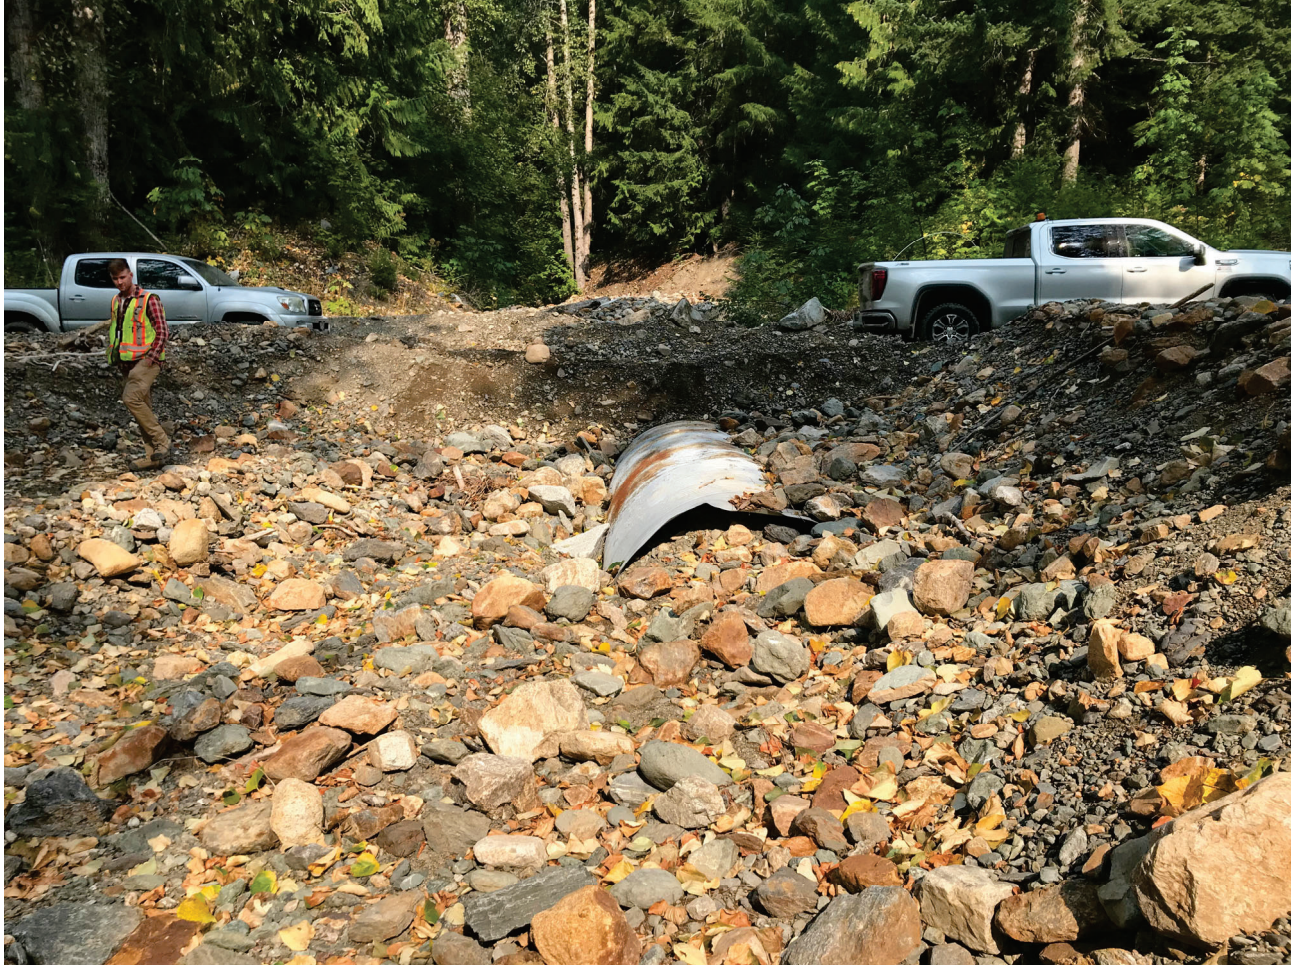
Photo 3: September 14, 2022. Looking upstream at the existing culvert outlet.

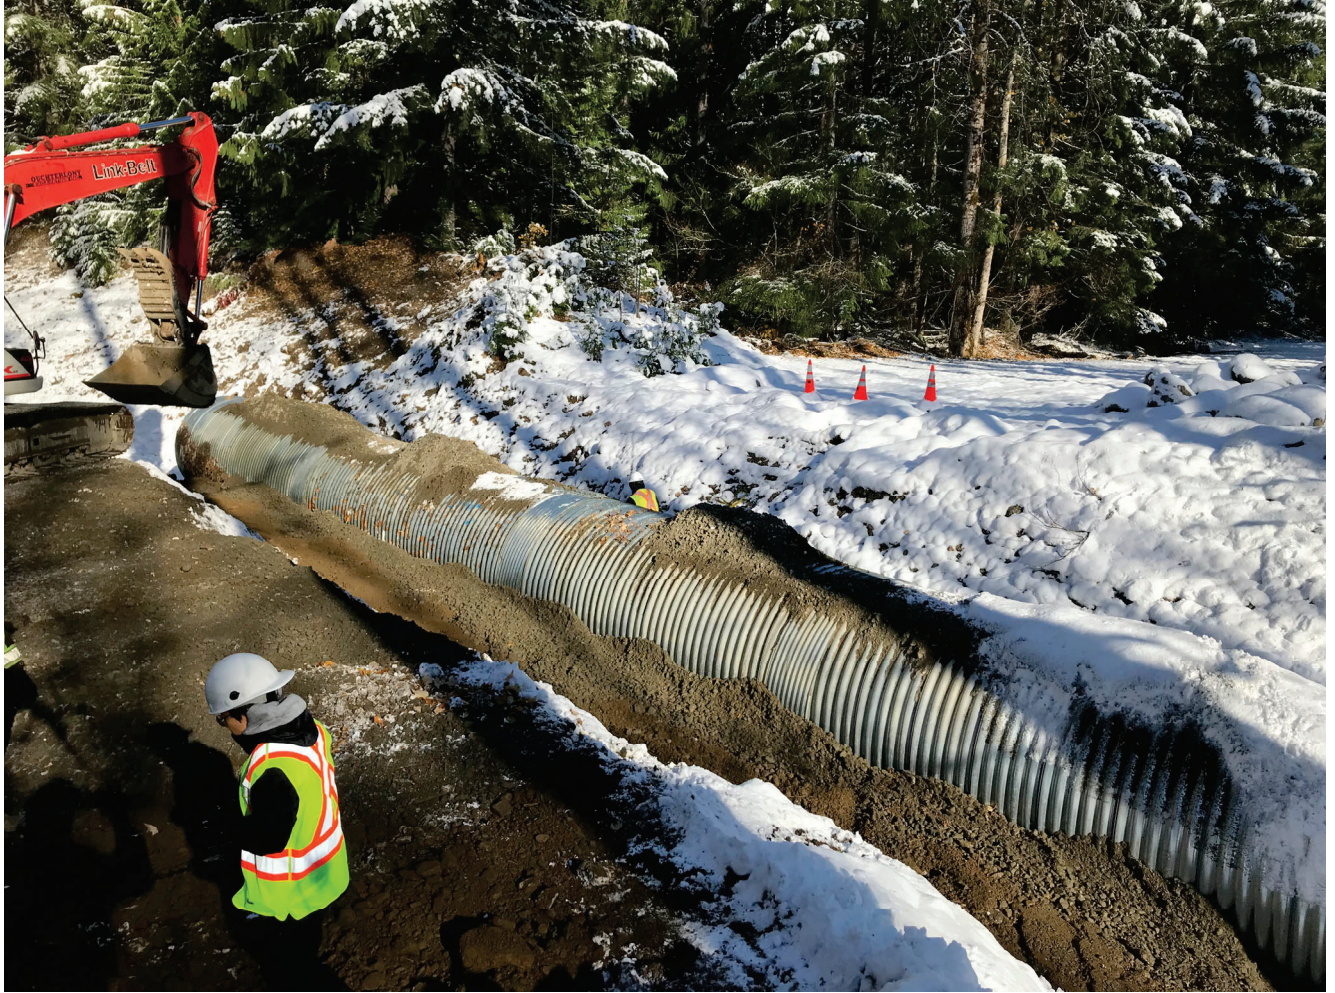
On November 9, 2022, we visited the site and observed the status of construction. The channel had been cleaned both upstream and downstream of the road and the culvert was in place and being backfilled.

Photo 4: November 9, 2022; Culvert installation is in progress

The new culvert should be bedded and backfilled with WGB material.

Fill materials should be compacted in lifts, of maximum 300 mm loose thickness, using vibratory equipment. Water should be added as required so that the fill is close to optimum moisture content during compaction. We understand that compaction of fills will be witnessed by the project civil inspector.
