**TO:** Scott Cosman, P Eng.  
**COMPANY:** BC MOTI  
**FROM:** Bob Forsyth  
**DATE:** 4 November 2022  
**CC:** Wayne Byczek, P Eng, Johnathan Tillie, Michael Carreira, P Eng.  
**PROJECT NO.:** VG07794.306  
**SUBJECT:** Silver Skagit Road, South of Hope, BC  
Road and Culvert Repair at Km 34.5  
Project Number: 14121, Site ID: SA07-150-17

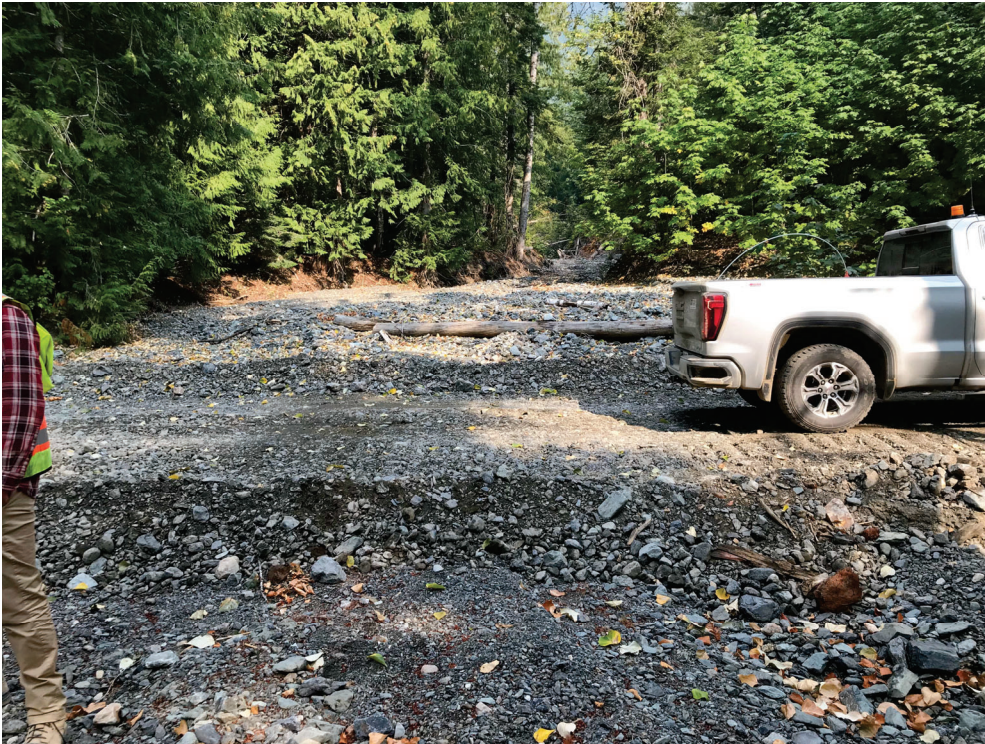
**Photo 1:** September 14, 2022. Looking upstream at the creek channel from the road.

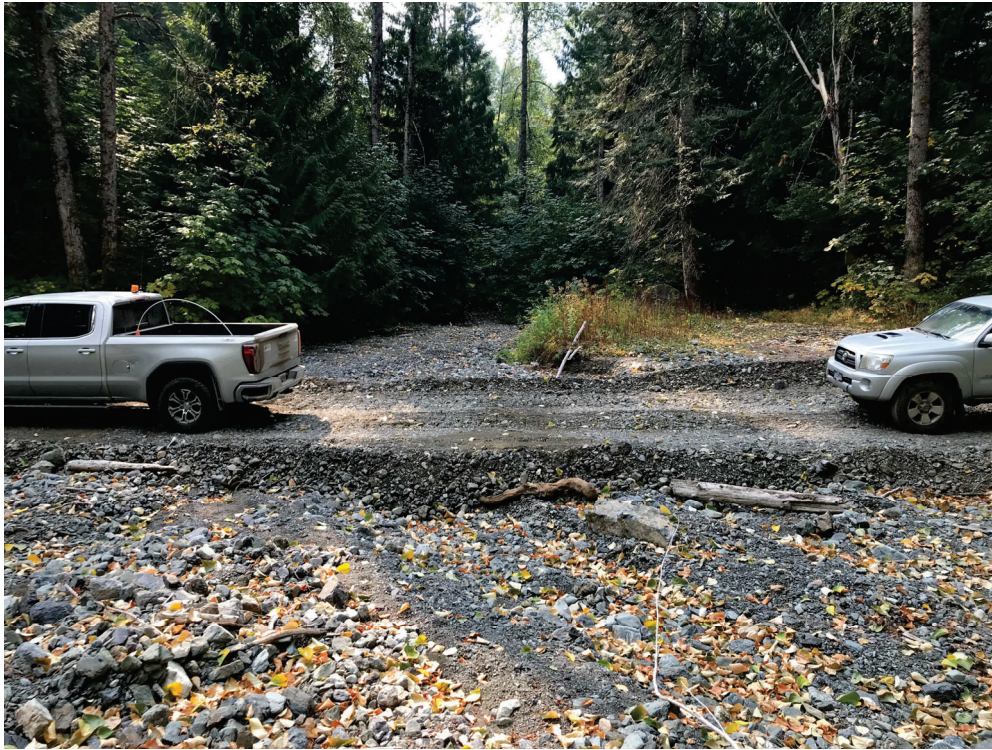
**Photo 2:** September 14, 2022. Looking downstream at the creek channel from the road.

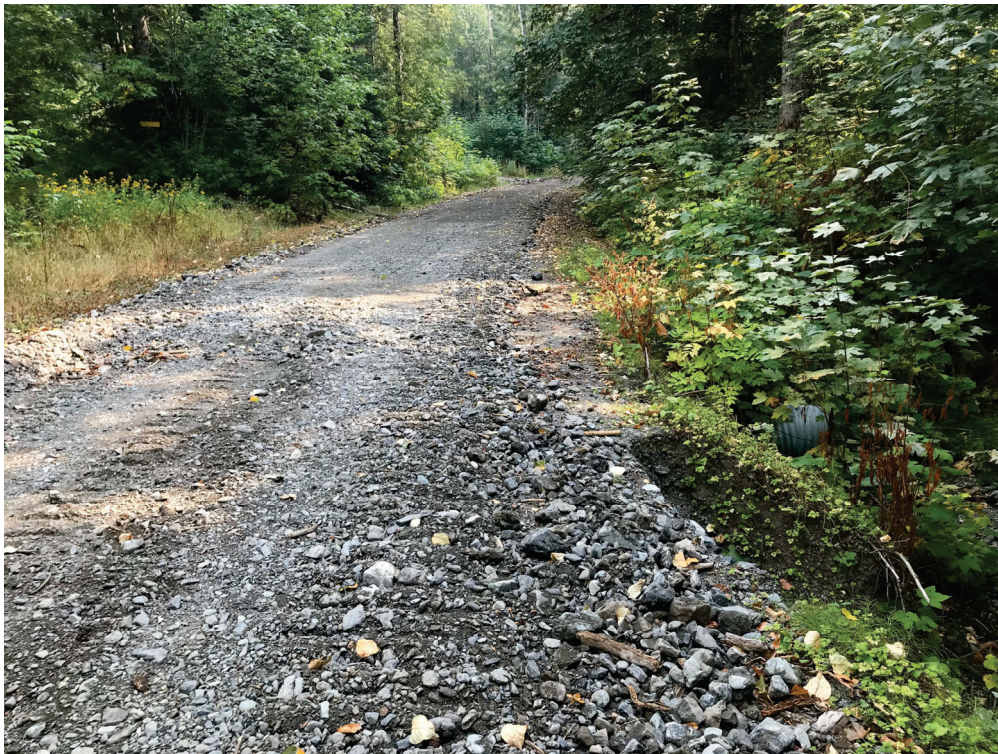
About 40m to the east of the main channel there are two more culverts crossing beneath the road. The inlets to the eastern culverts are buried and the outlets are exposed on the south (downstream) side of the road.

**Photo 3:** Looking east at culvert undercrossing of the road about 40\_m east of the main creek channel

Cleaning of the two eastern culverts should be carried out as part of the repair work. The inlet area should be cleared of vegetation and debris removed from culvert interiors.
