MEMO

TO: Scott Cosman. P Eng.
COMPANY: BC MOTI
FROM: Bob Forsyth
DATE: 4 May 2023
CC: Wayne Byczek, P Eng, Johnathan Tillie, Michael Carreira, P Eng.
PROJECT NO.: VG07794.303 Rev.1
SUBJECT: Silver Skagit Road, South of Hope, BC
Road and Culvert Repairs at Several Locations, Geotechnical Review of 100% Design Drawings (Rev 1)

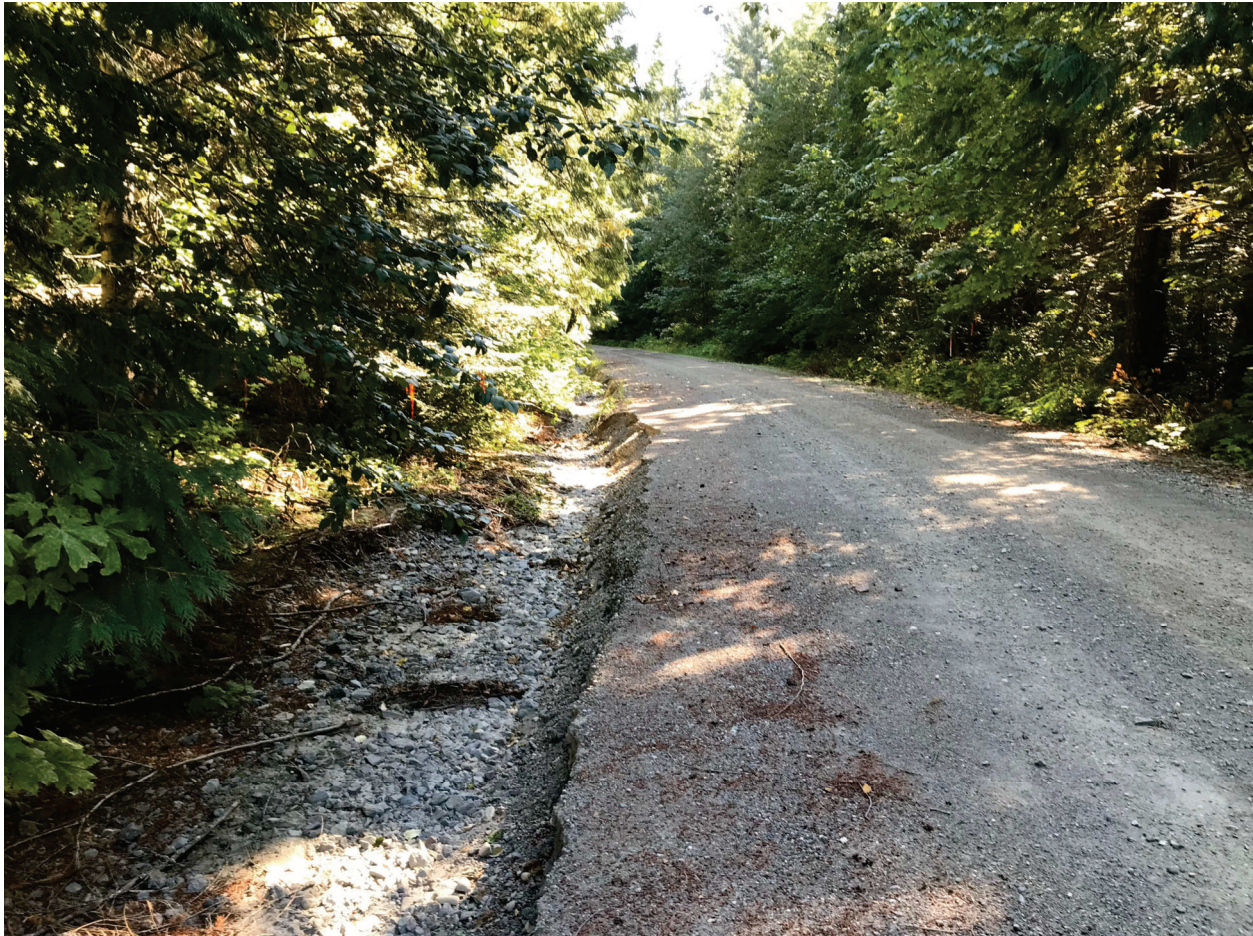
At this location, shown in Photo 1 below, a seasonal creek crossed beneath the Silver Skagit Road in a CSP culvert. The inlet became blocked and during the 2021 flood event, a concentrated stream of water flowed for about 300 m down the east roadside ditch, causing erosion of the ditch and east shoulder of the road. As well there were erosional rivulets on the road at about km 33.0 where the flow crossed the road.

Photo 1: Looking south from km 32.7 of the Silver Skagit Road, on September 21, 2022. Note the erosion damage to the east ditch and shoulder of the road.

The proposed design specifies replacement of the existing metal culvert with a concrete box culvert and improvement of the channel at the culvert inlet and outlet. The shoulder and ditch on the east side of the road will be reconstructed and the road will be regraded and resurfaced as required. From a geotechnical perspective we are in general agreement with the plan and have no further comment.

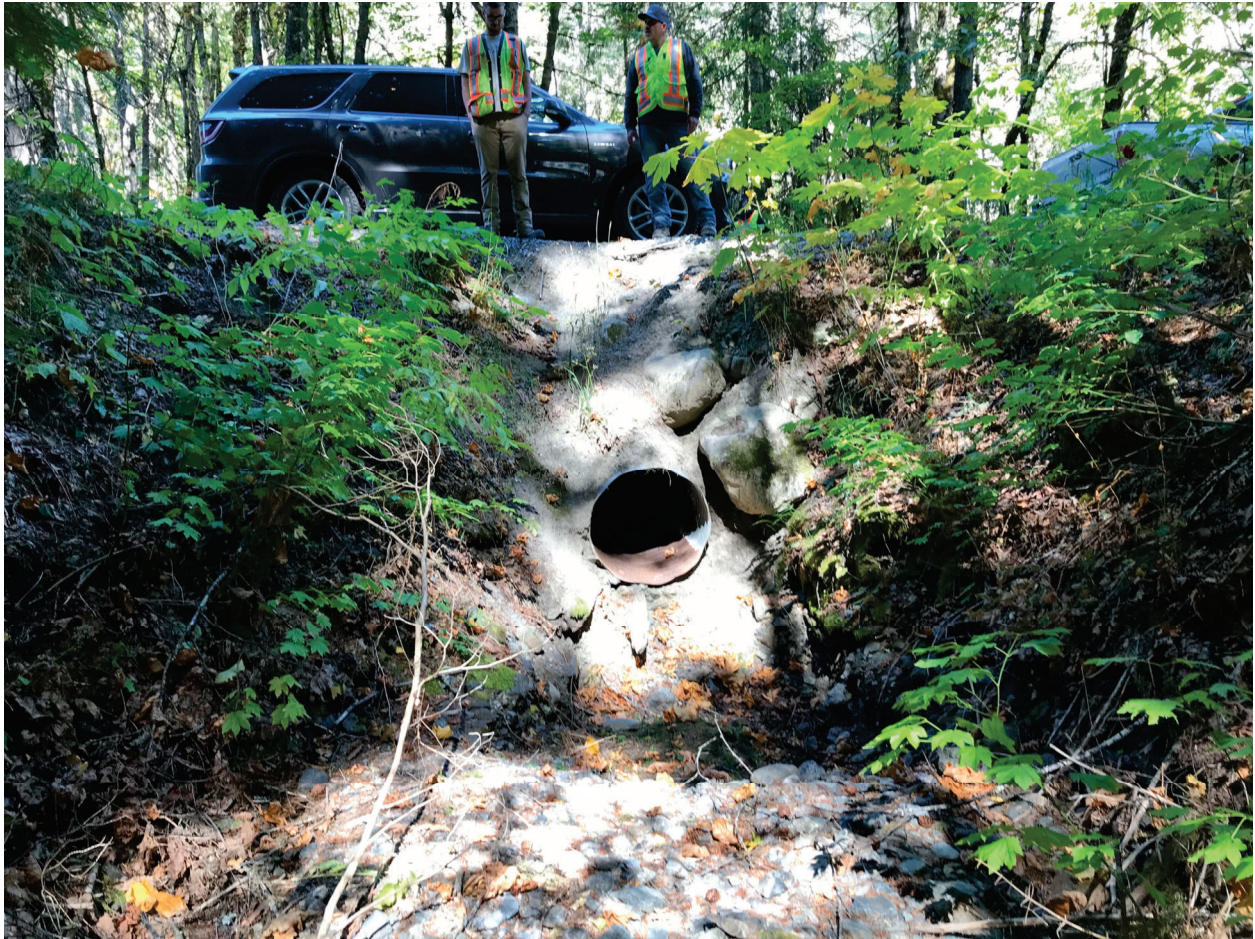
the east roadside ditch, causing erosion of the ditch and east shoulder of the road. As well, there was some erosion in the vicinity of the culvert outlet.

Photo 2: Looking east at the culvert outlet at km 38.4, on September 21, 2022. The culvert inlet was buried.

The proposed design specifies replacement of the existing metal culvert with two concrete box culverts and improvement of the channel at the culvert inlet and outlet. The shoulder and ditch on the east side of the road will be reconstructed and the road will be regraded and resurfaced as required. From a geotechnical perspective we are in general agreement with the plan and have no further comment.

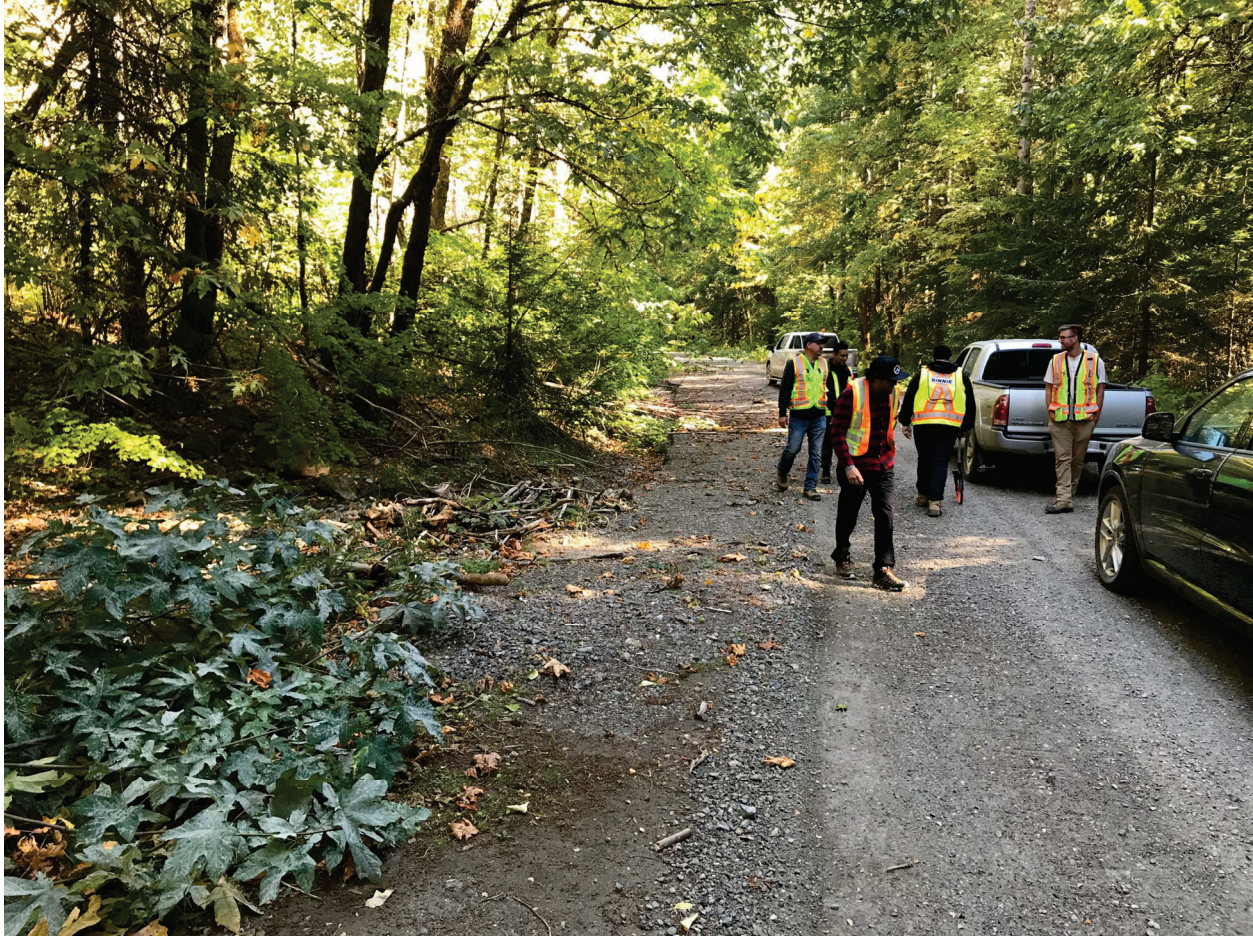
Similarly at km 38.4, another seasonal creek crossed beneath the Silver Skagit Road in a CSP culvert. The inlet became blocked and during the 2021 flood event, a concentrated stream of water flowed for about 220 m down

Photo 3: Looking south from km 38.4 on September 21, 2022. Note the erosion on the east side of the road.

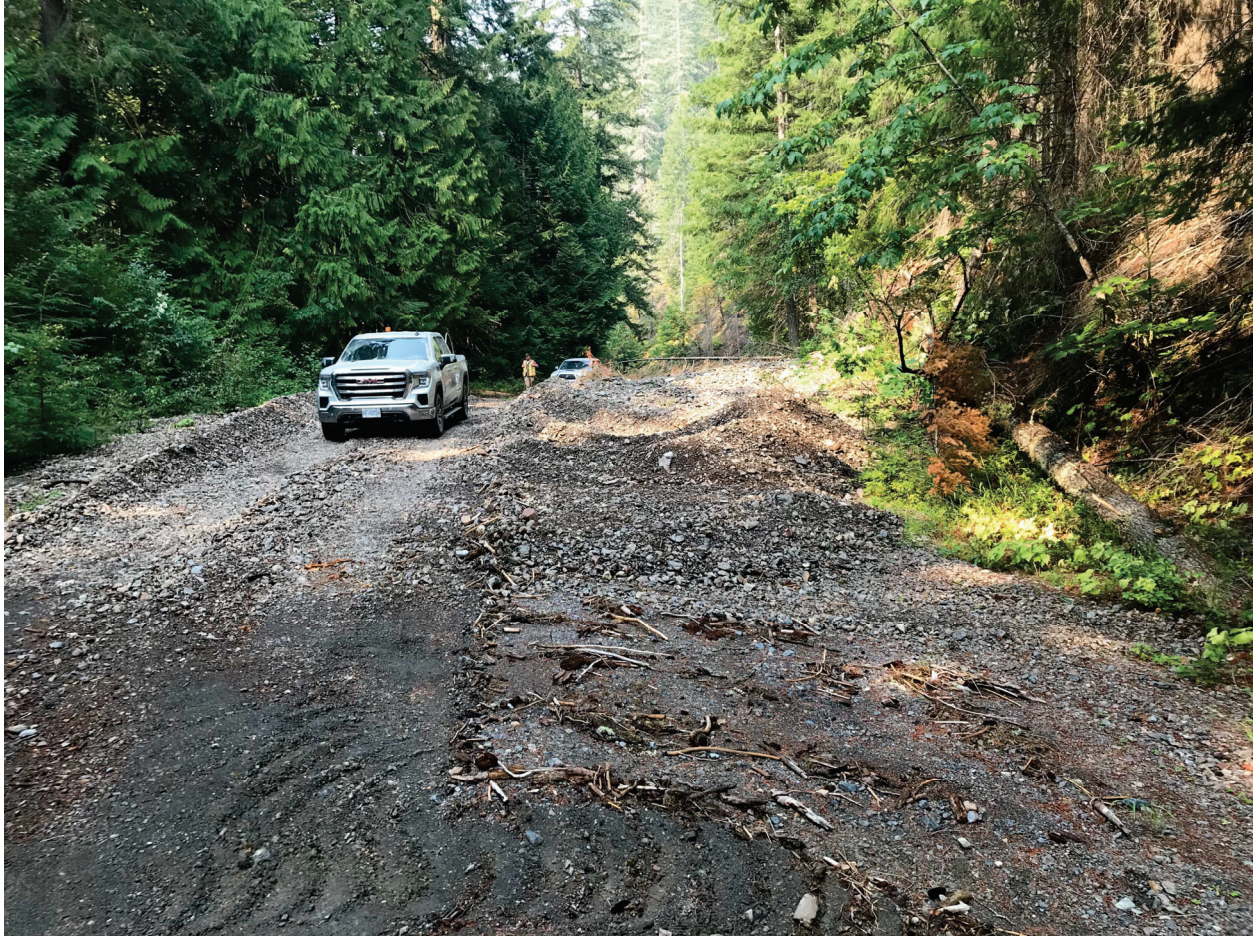
At this location, up to about 0.8 m of granular material was deposited on the roadway during the 2021 flood event. This drainage course may not have been identified previously as no existing culvert has been located at the site. The site is photographed below.

Photo 4: Looking north at the deposit of granular material on the road at km 39.2.

The proposed design specifies the installation of a concrete box culvert at the creek location and improvement of the channel at the culvert inlet and outlet. The road will be graded and surfaced as required. From a geotechnical perspective we are in general agreement with the plan and have no further comment.

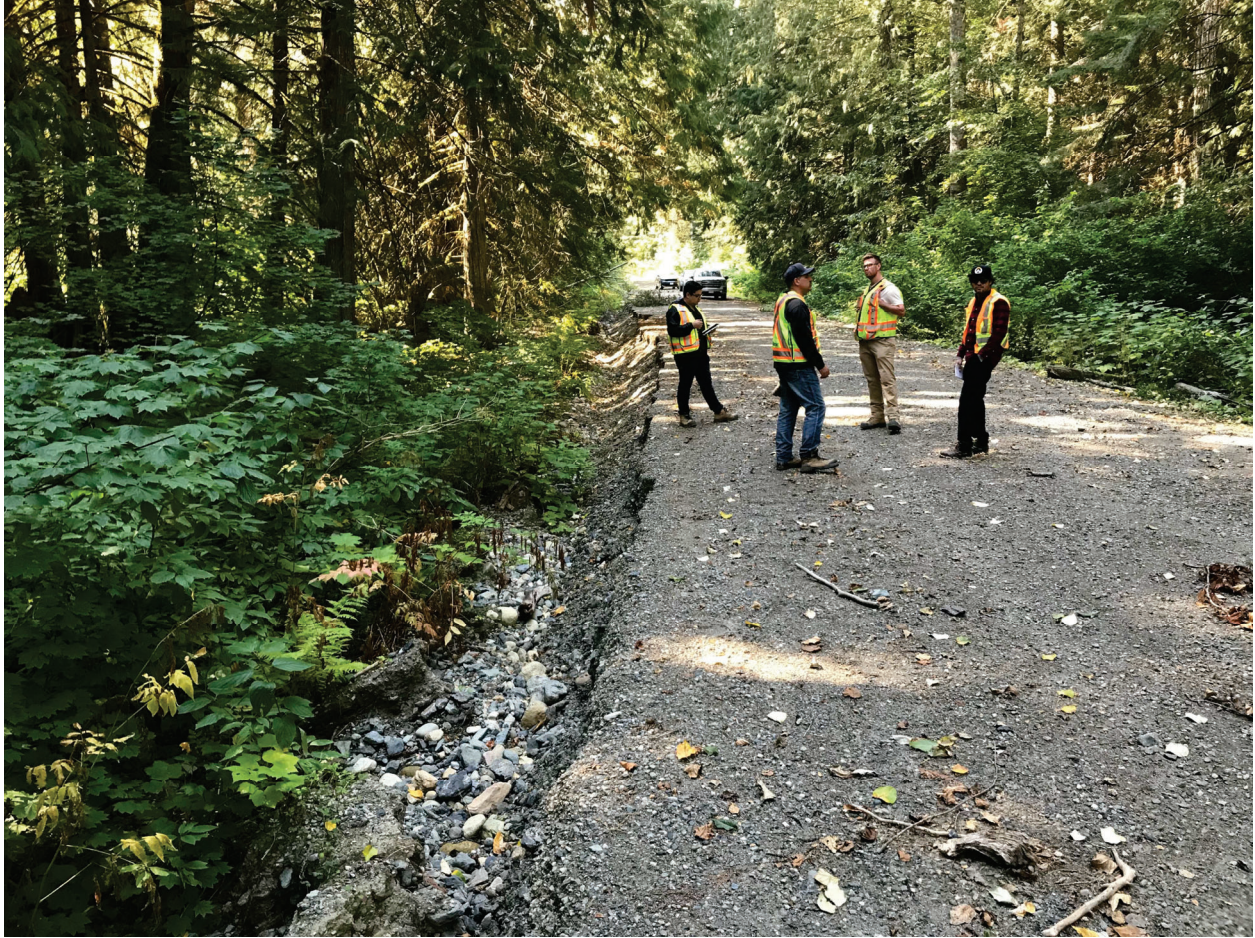
In the vicinity of km 43.1, the Silver Skagit Road crosses a relatively flat forested area. Drainage is poor in that the area will tend to collect surface water during wet weather. For a distance of about 100 m, erosion occurred along the west shoulder of the road. A metal culvert with a damaged outlet was noted near the south end of the road section.

Photo 5: Looking north at the road at km 43.1, September 21, 2022. Note the erosion of the west shoulder.

We are in general agreement with the design of the proposed repair which includes re-construction of the shoulder on the west side of the road and grading and surfacing of the road as required.

The base of the embankment will be toed into the native soil. The depth of stripping / thickness of organics at this location could be more than 300 mm.

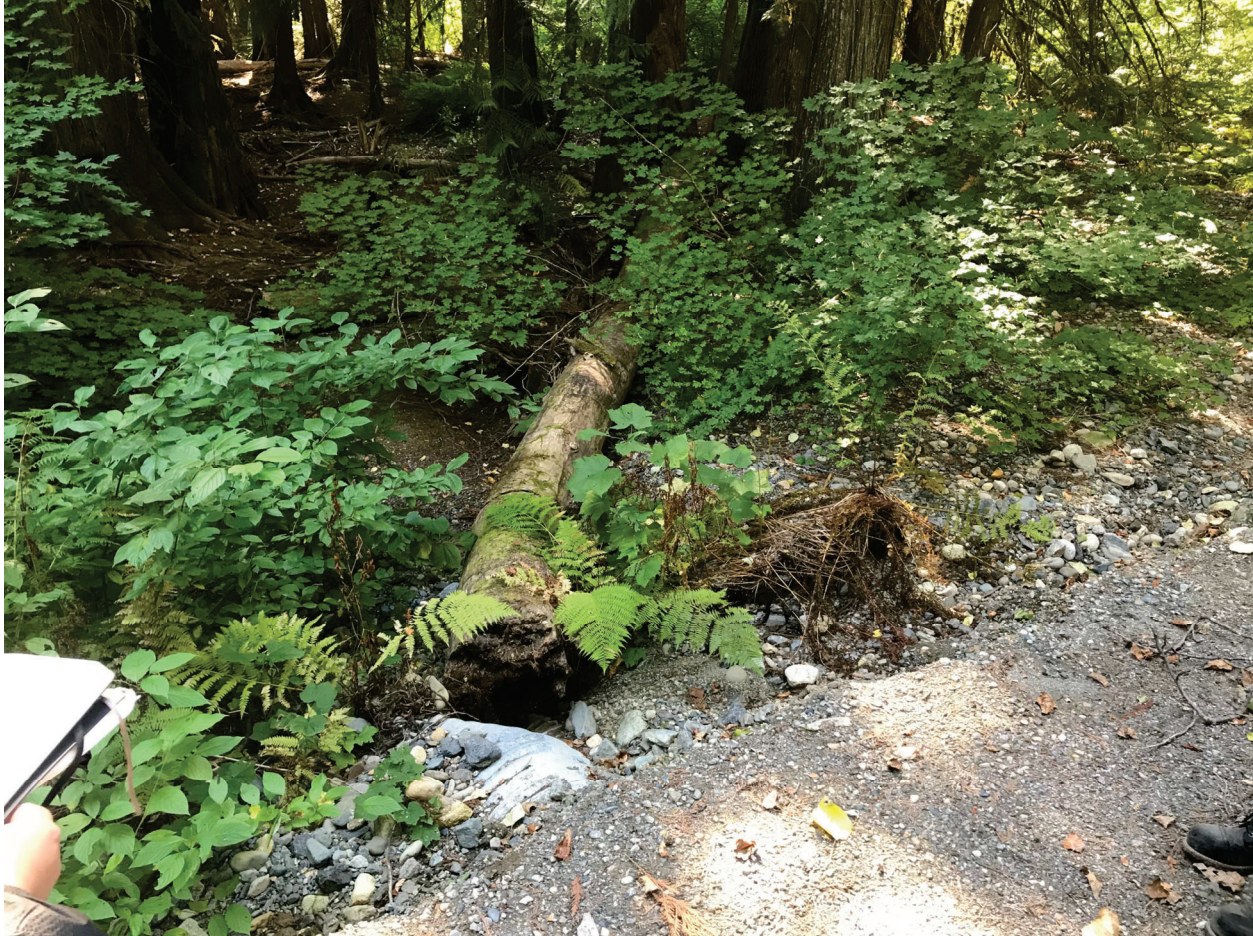
Photo 6: Culvert outlet near km 43.1, September 21, 2022

As well the culvert should be repaired and maintained going forward (maintenance should include removal of the log in front of the culvert outlet).

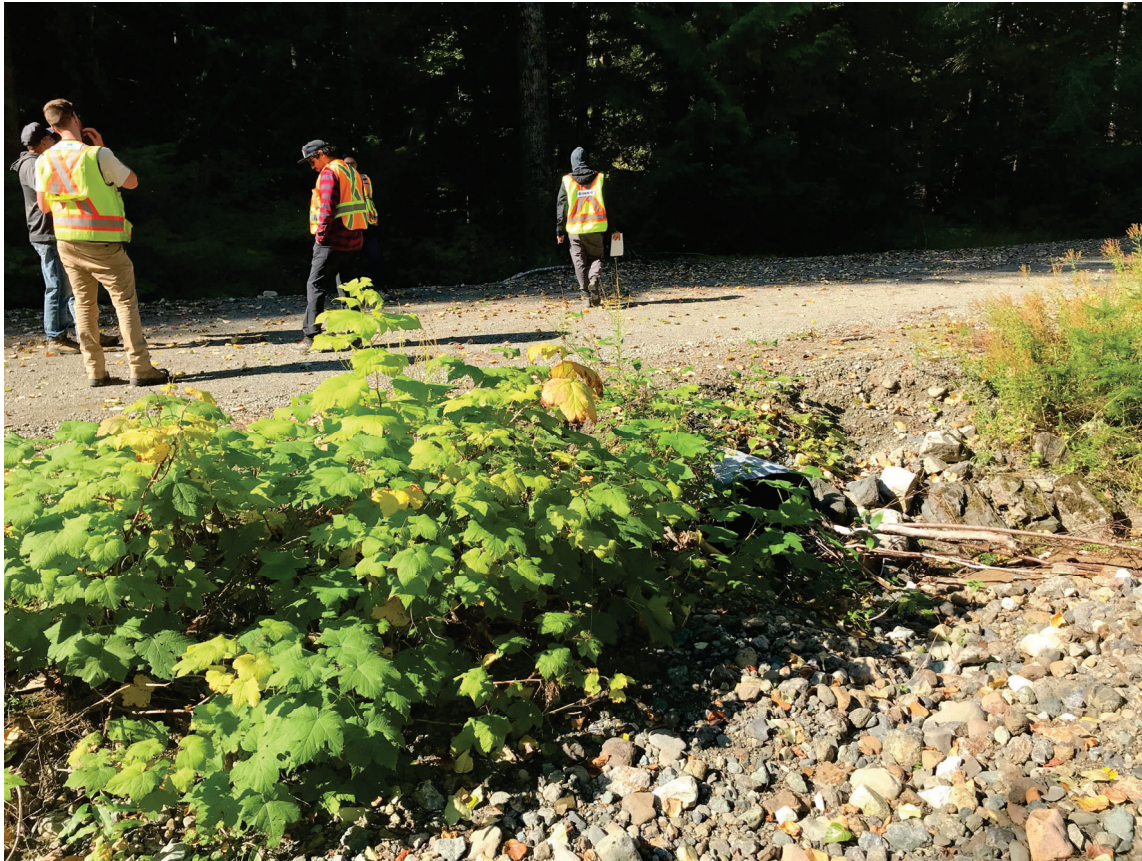
At this location a culvert was partially blocked. In November 2021, flood waters eroded the ditch on the east side of the Silver Skagit Road for a distance of about 50 m then flowed across the road resulting in erosional rivulets on the road surface. Deposition of less than 300 mm of sand occurred on the surface of a nearby trailhead clearing/parking area on the east side of the road.

Photo 7: Culvert inlet at km 55.0 partially blocked with gravel, September 21, 2022.

The proposed design includes replacement of the existing corrugated metal culvert with two concrete box culverts, reconstruction of the damaged portion of the embankment on the east side of the road and regrading / resurfacing of the road and trailhead area. From a geotechnical perspective we are in general agreement with the design and have no additional comments.

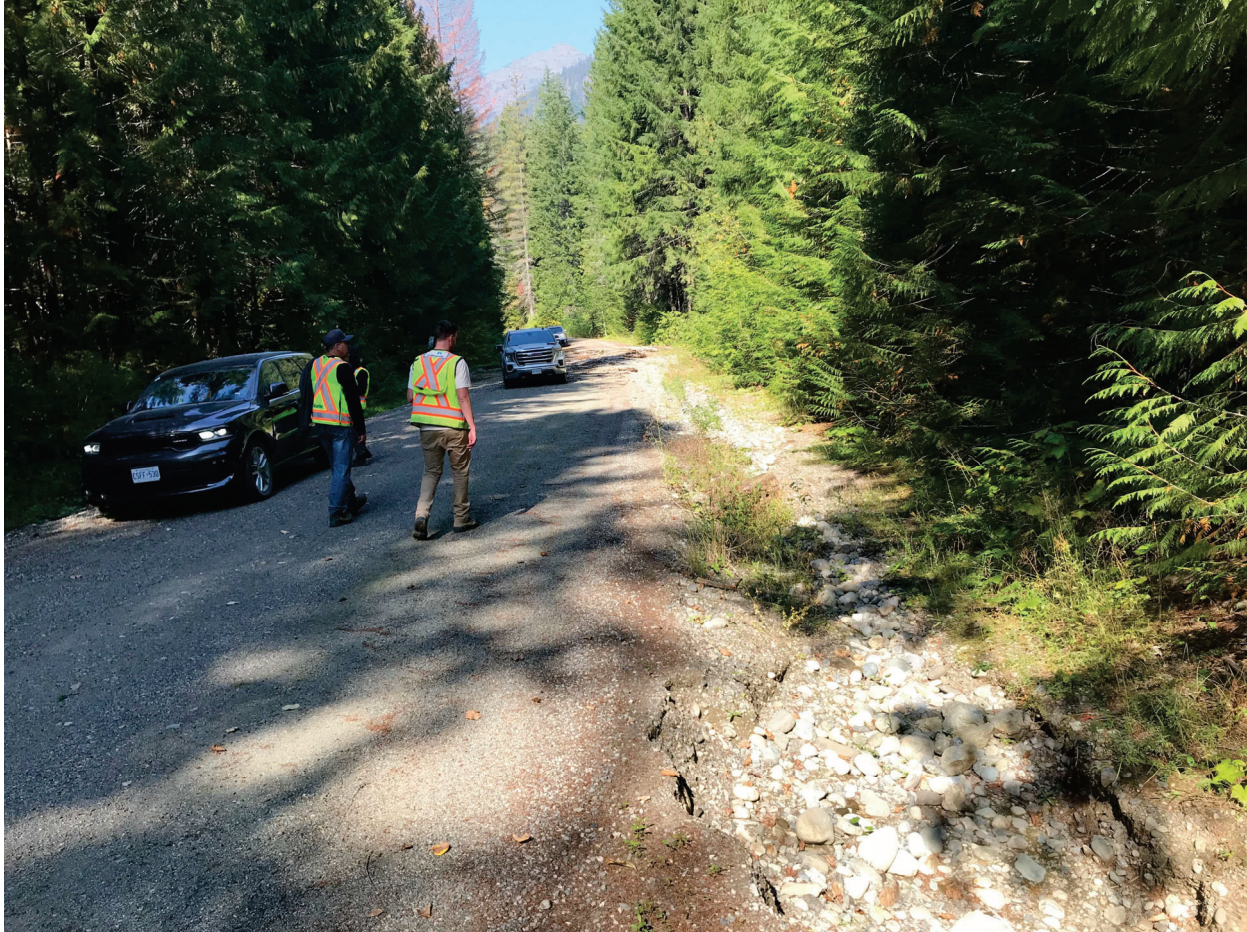
Photo 8: September 21, 2022. Looking north at erosion of the ditch and shoulder on the east side of the road, km 55.0.

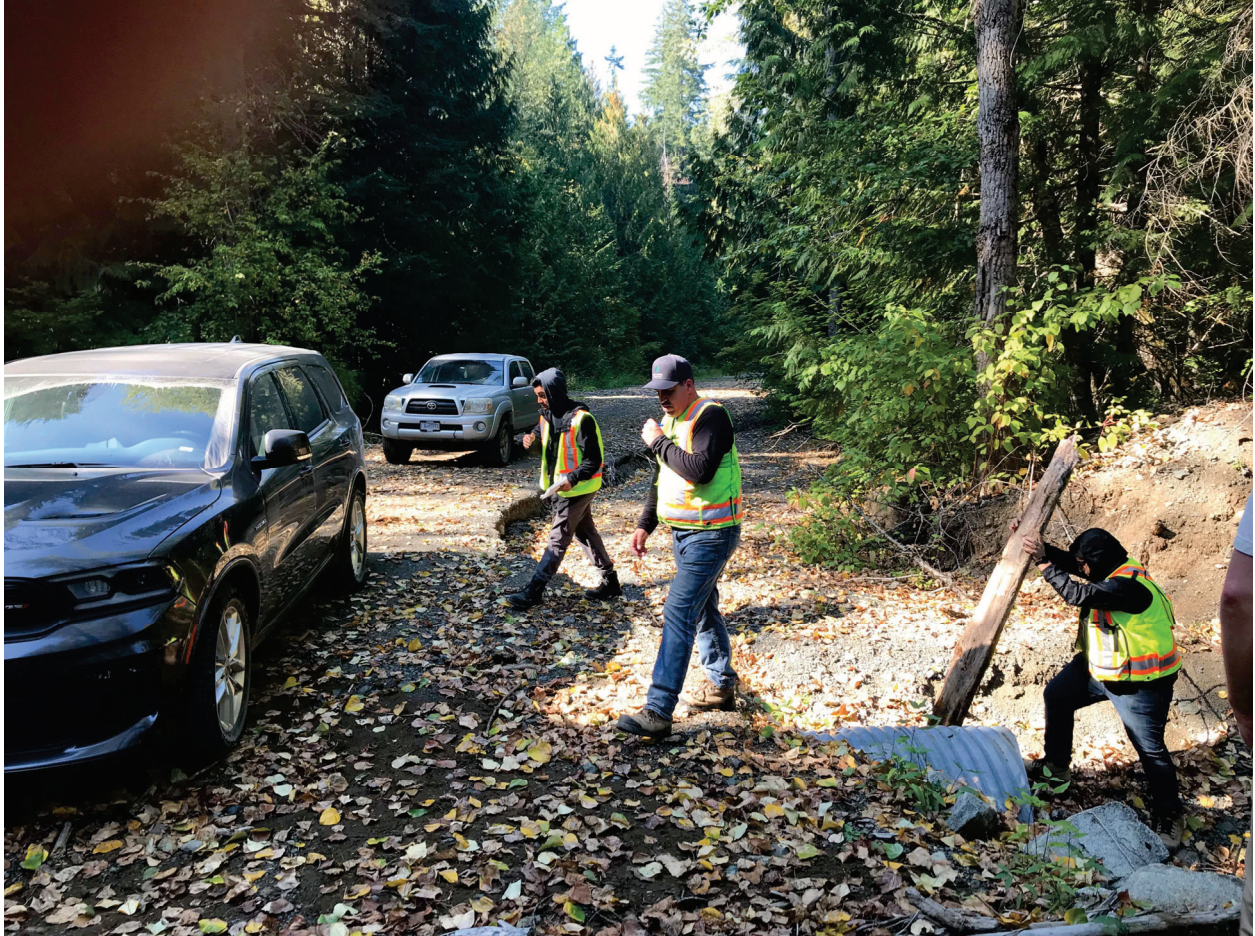
At this location, a seasonal creek crosses beneath the Silver Skagit Road in two metal culverts. These culverts were partially blocked and in 2021, flood waters eroded the ditch and shoulder on the east side of the road for a distance of about 25 m.

Photo 9: September 21, 2022. Looking north at culvert inlets at km 56.7. Note erosion along the east side of the road north of the creek channel.

The proposed design includes replacement of the existing corrugated metal culverts with three concrete box culverts, reconstruction of the damaged portion of the embankment on the east side of the road and regrading / resurfacing of the road. From a geotechnical perspective we are in general agreement with the design and have no additional comments.

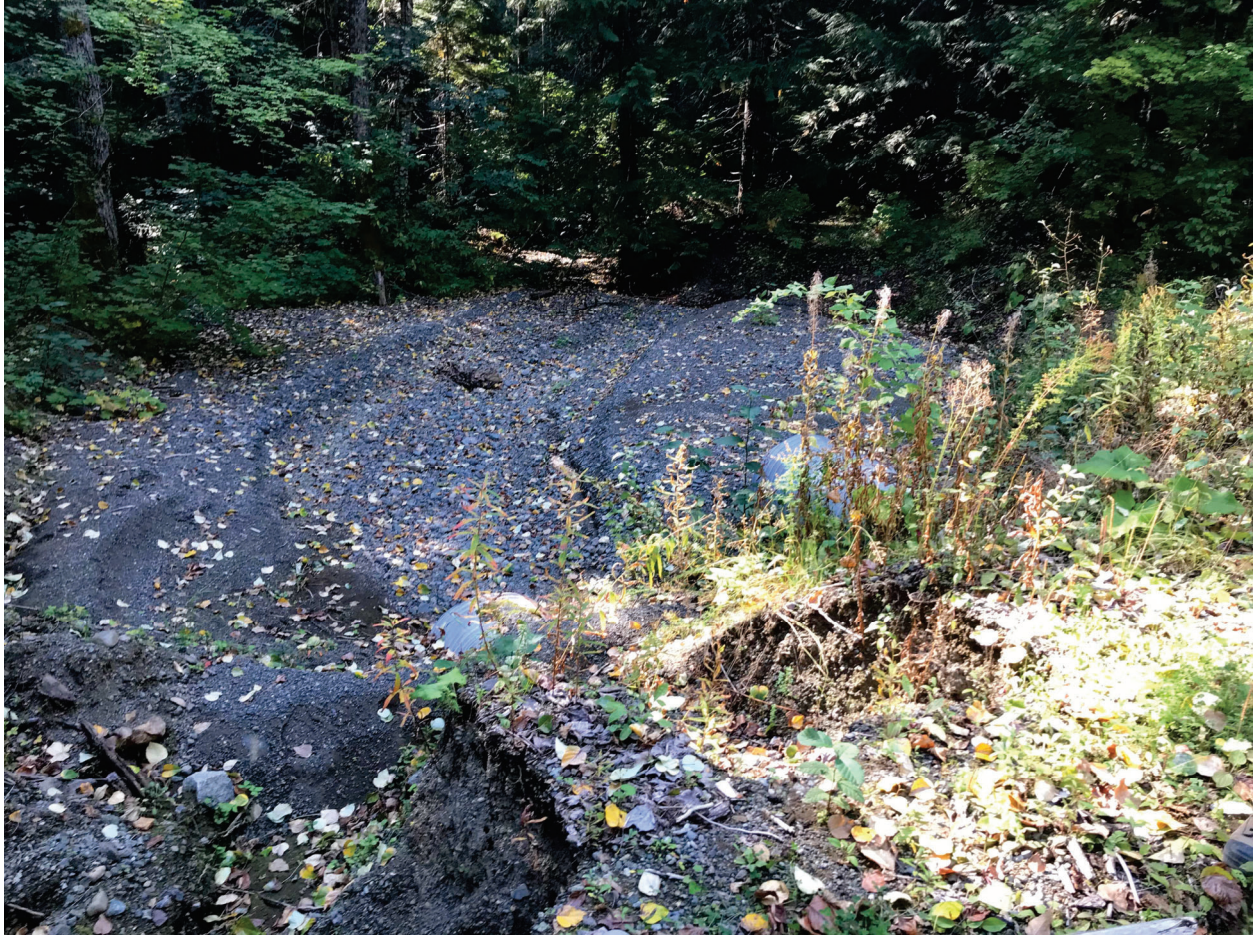
Photo 10: km 56.7, Spetemebr 21, 2022. Looking west at the culvert outlets and creek channel downstream of the road.
