BRIARWOOD DRIVE, MILL BAY, BC

Geotechnical Report – Temporary Repair Condition

WSP File No.: 20M-01141-06

**Subject: Geotechnical Site Characterization of Road Failure at
Briarwood Drive, Mill Bay, BC**

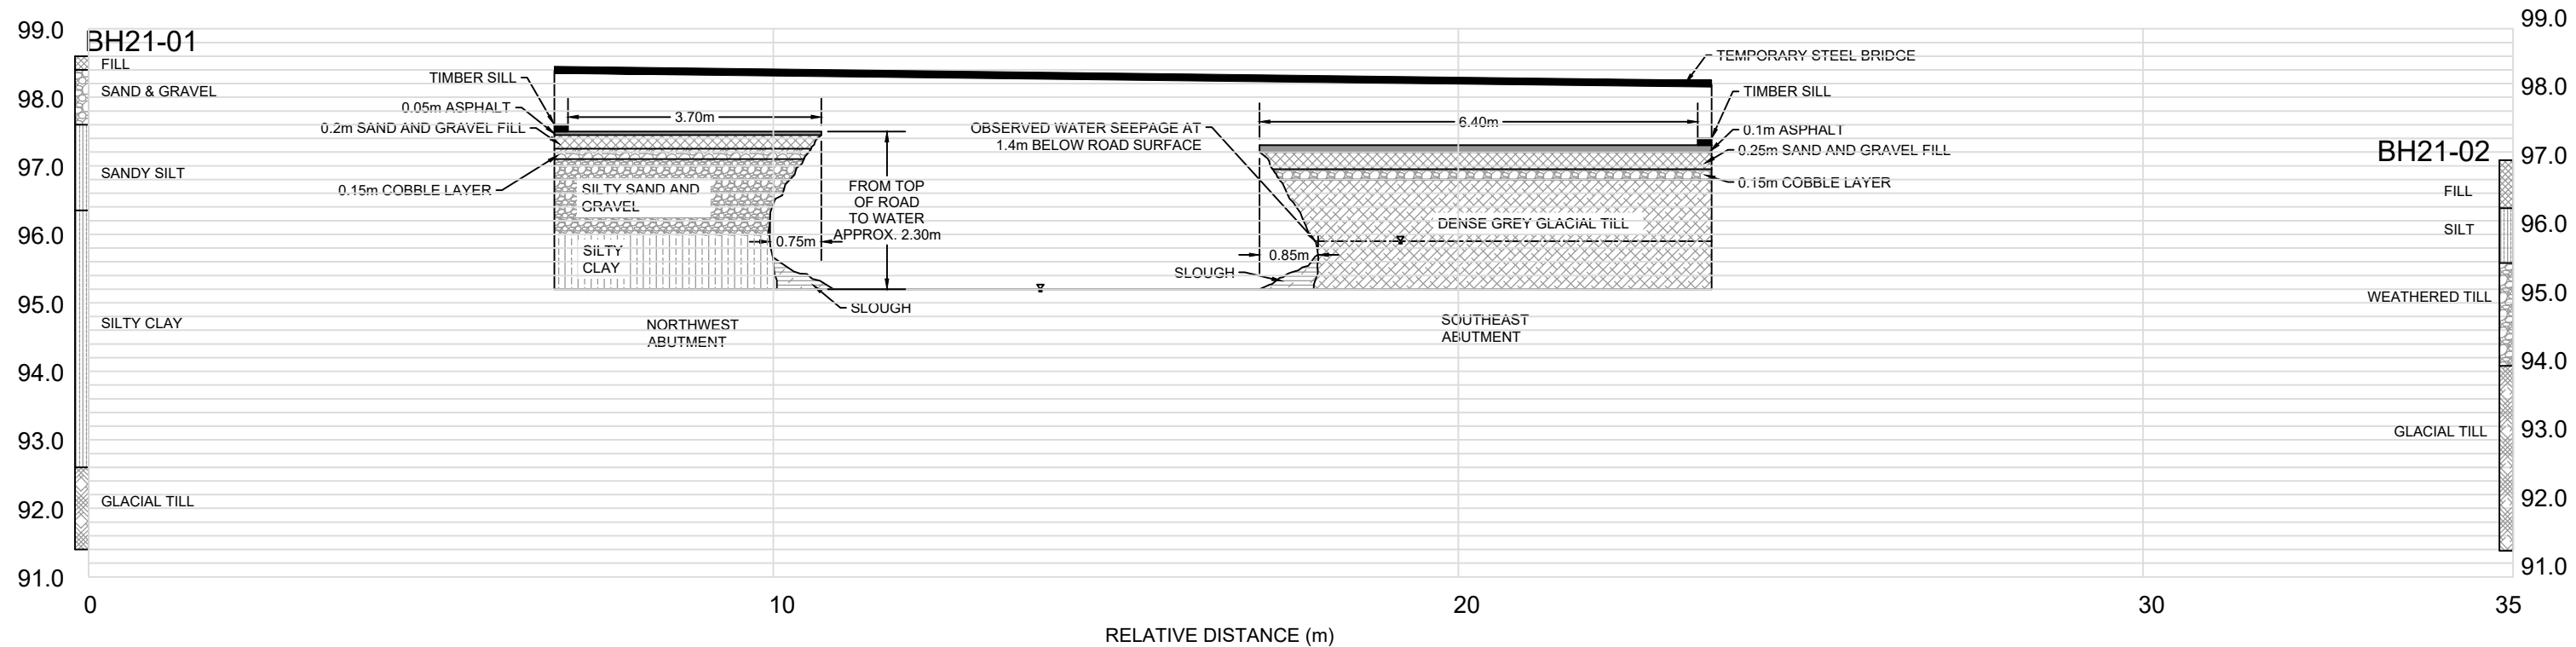
PROJECT:		BRIARWOOD DRIVE	
CLIENT:		MINISTRY OF TRANSPORTATION AND INFRASTRUCTURE	
TITLE:		FAILED SLOPE CONDITIONS	DRAWING: 02

A cross-section showing the borehole logs and the observed exposed soil conditions is shown on Figure 2. Note that the elevations shown on Figure 2 are relative only and are based on an assumed Temporary Benchmark (TMB) elevation of 100.00m. The TMB was a nail placed at the base of a Hydro pole located on the north side of the road, east of the temporary bridge crossing.

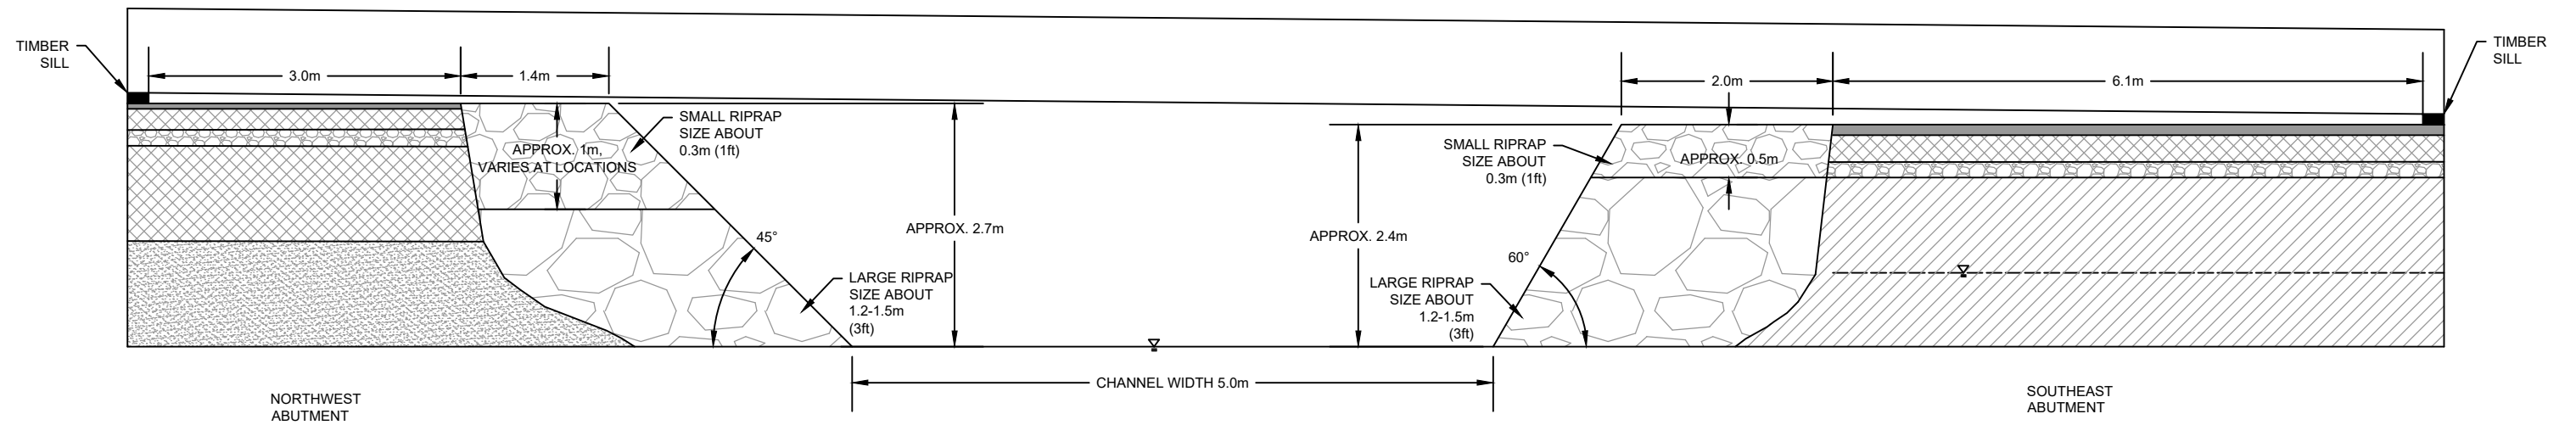
PROJECT:		BRIARWOOD DRIVE	
CLIENT:		MINISTRY OF TRANSPORTATION AND INFRASTRUCTURE	
TITLE:	RIPRAP ARMORED SLOPE	DRAWING:	03

The temporary slope protection measures were carried out by Emcon Services Inc. between 10 January 2022 and 14 January 2022. WSP was on site periodically during that timeframe to observe the conditions and take measurements of the final configuration. In summary, a non-woven geotextile was placed over both exposed soil slopes and at the toe of the slopes. Larger rock armouring (up to 1.5m in diameter) was placed at the toe of the slopes up to about 0.5m below the crest. Smaller 0.3m diameter rock armouring was placed towards the crest. The overall face angle of the armoured slopes ranged from about 45° to 60° as measured from the horizontal. Field review reports taken at the time are included in Appendix E. A cross section of the repair is shown in Figure 3.

In addition, the riprap facing that has been temporarily placed is over-steepened and locally the factor of safety of this riprap slope is less than 1.5. To restabilize the slopes in a temporary condition that meets the minimum factors of safety for the riprap facing, the riprap would need to have a slope not steeper than 1.5H:1V and be keyed into the toe of the slope. In addition, it is important that the sloughed soils be removed, and a non-woven geotextile placed under the riprap and be in close contact with the underlying fill and natural soil. To achieve this, the soil slope cuts should be in a smooth and even condition before placing the non-woven geotextile. WSP's recommended revised temporary condition is presented in Figure 4. As noted, we understand that this revised temporary condition be implemented this summer when creek water levels are low. WSP should be present to review the conditions before and during placement of geotextile and rock armouring for the revised condition.

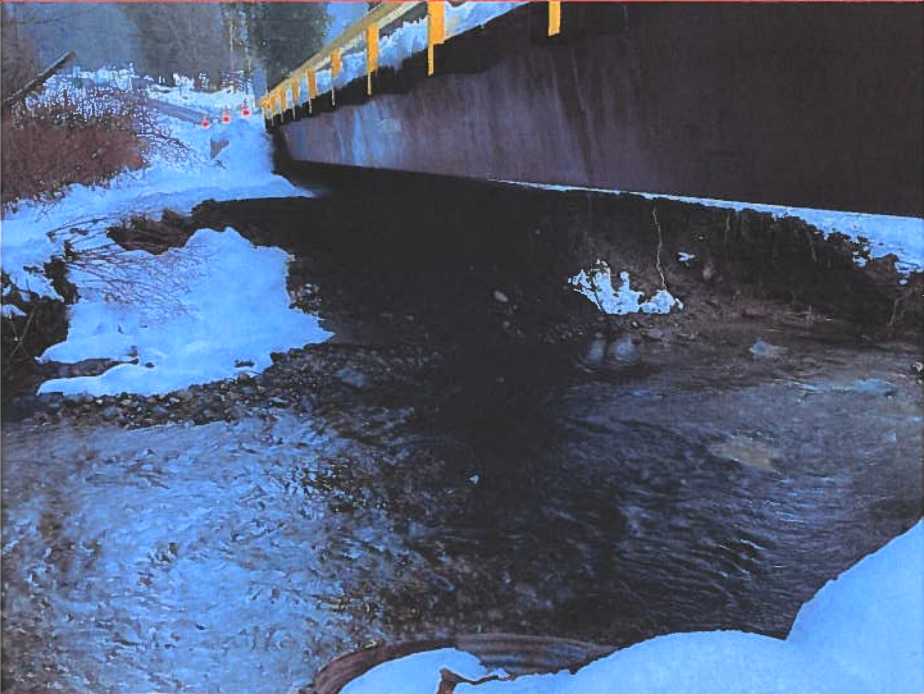
4. WSP observed fragments of the 1.5m-diameter steel culverts, asphalt pavement and concrete under the bridge, in the middle of the creek, and along the toes of both the NW and SE slopes.

<p>Photo 1: Jan 10, 2022</p> <p>Overview of the SE slope.</p> <p>Observed asphalt and concrete fragments under the bridge.</p> <p>Photo looking southeast.</p>

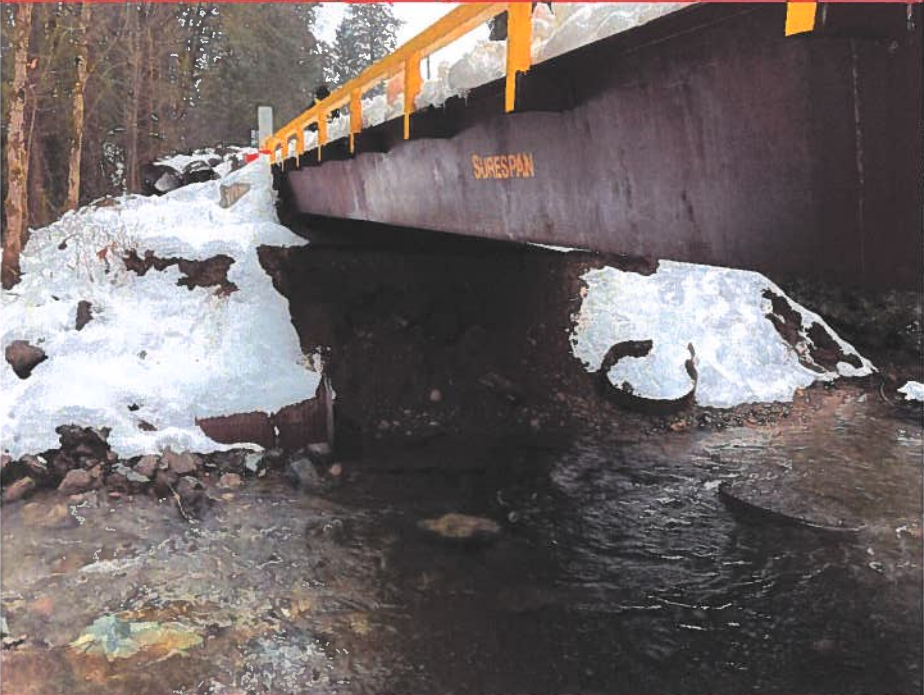
<p>Photo 2: Jan 10, 2022</p> <p>Overview of the NW slope.</p> <p>Observed steel drainpipe fragments under the bridge.</p> <p>Photo looking northwest.</p>

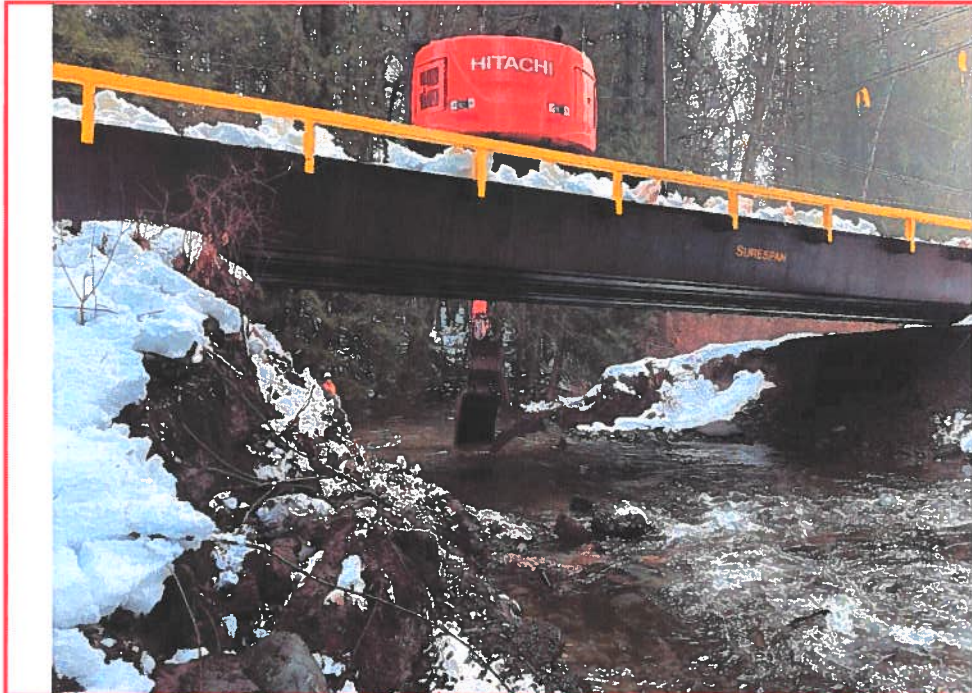
Photo 3:
Jan 11, 2022
Observed removal of road failure fragments in process.
Photo looking east.

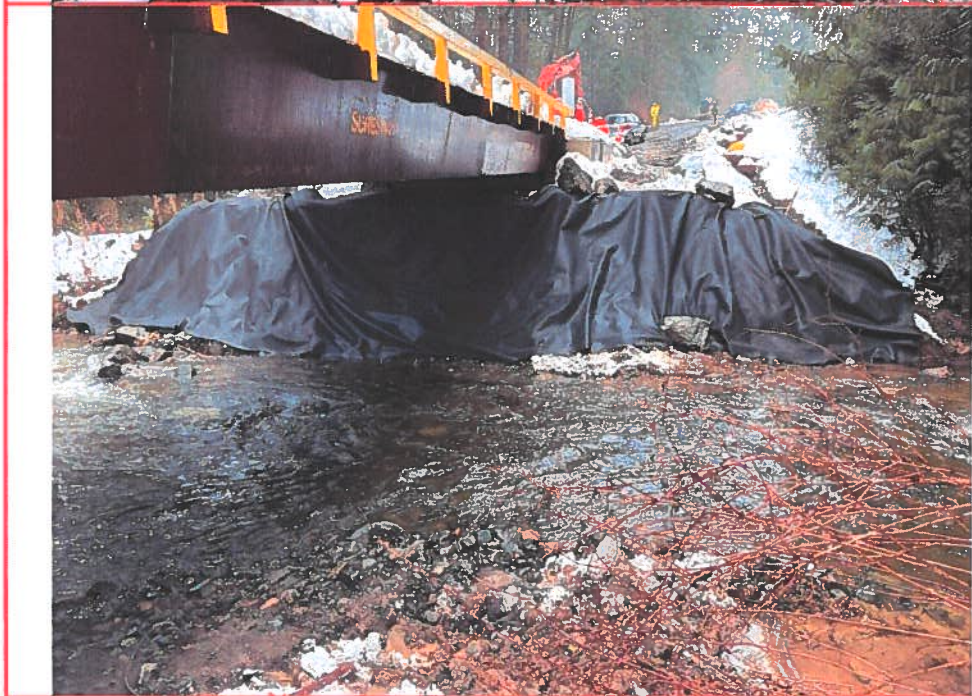
Photo 4:
Jan 11, 2022
The entire NW slope was covered by geotextile.
Photo looking northwest.

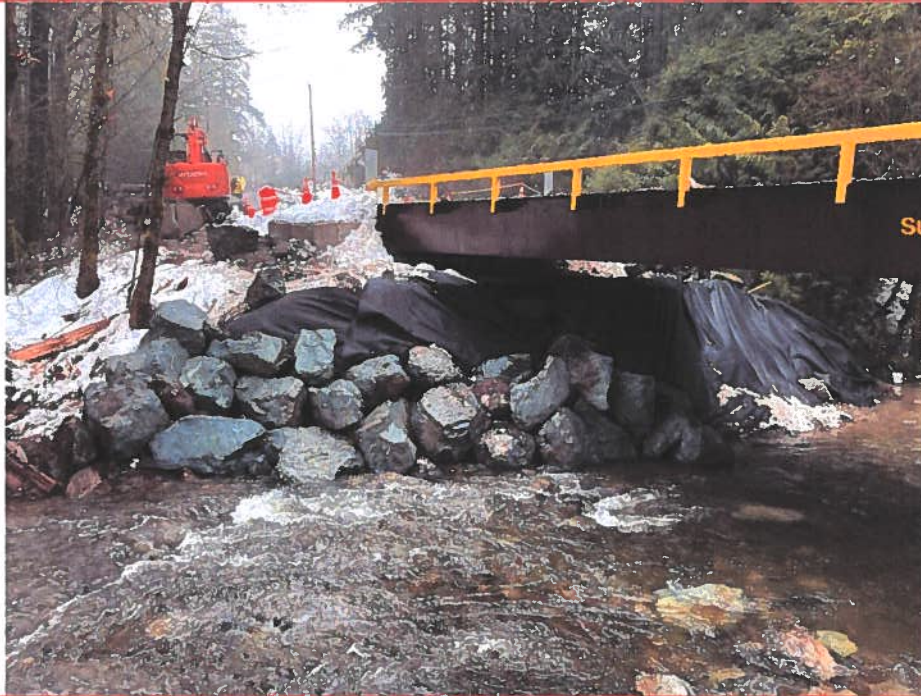
Photo 5:

Large ripraps armoured the bottom half of the NW slope on its southwest side.

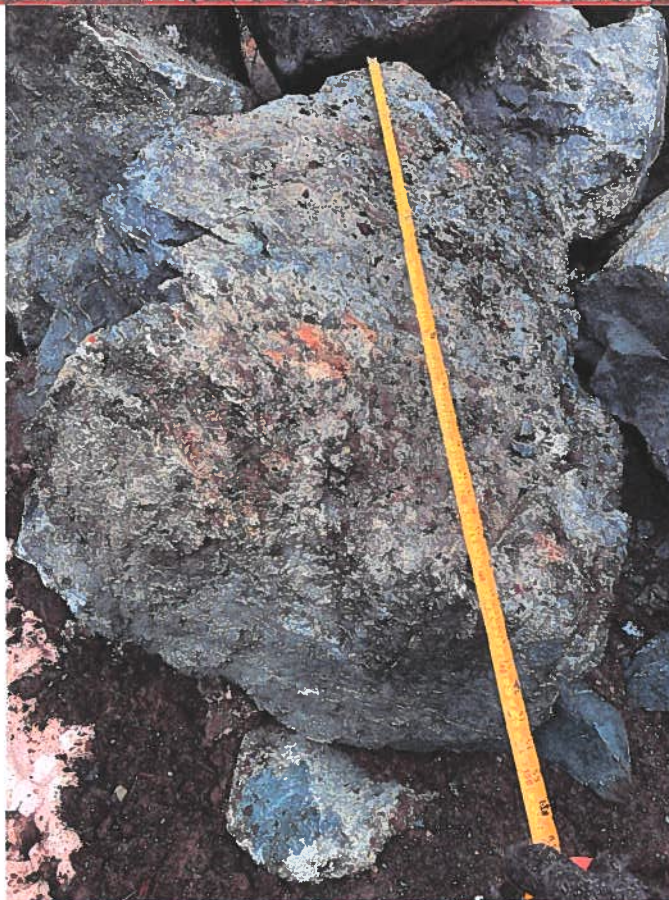
Photo 6:

The large riprap with dimension up to 1.5m.

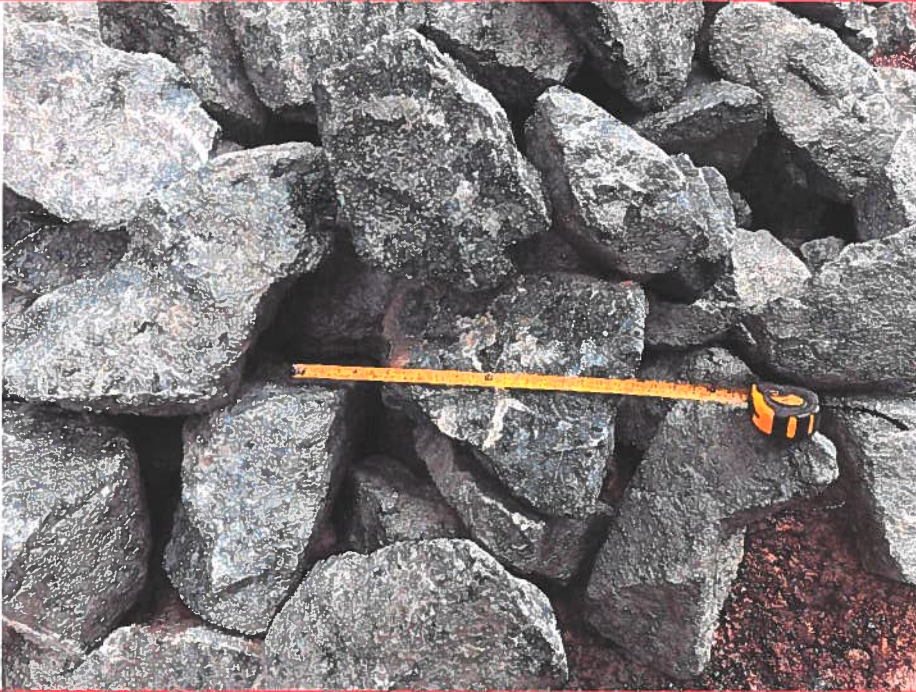
Photo 7:
Jan 11, 2022
The small riprap with dimension of about 0.3m (1ft riprap).

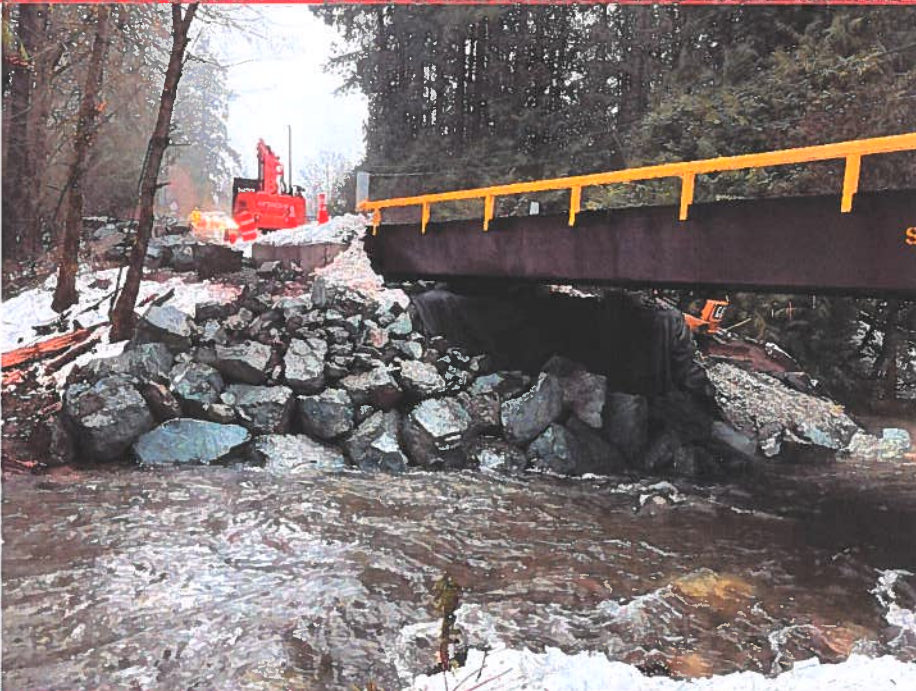
Photo 8:
Jan 12, 2022
Upper half of the southwest side of the NW slope was armoured with small ripraps.
Photo looking northwest.

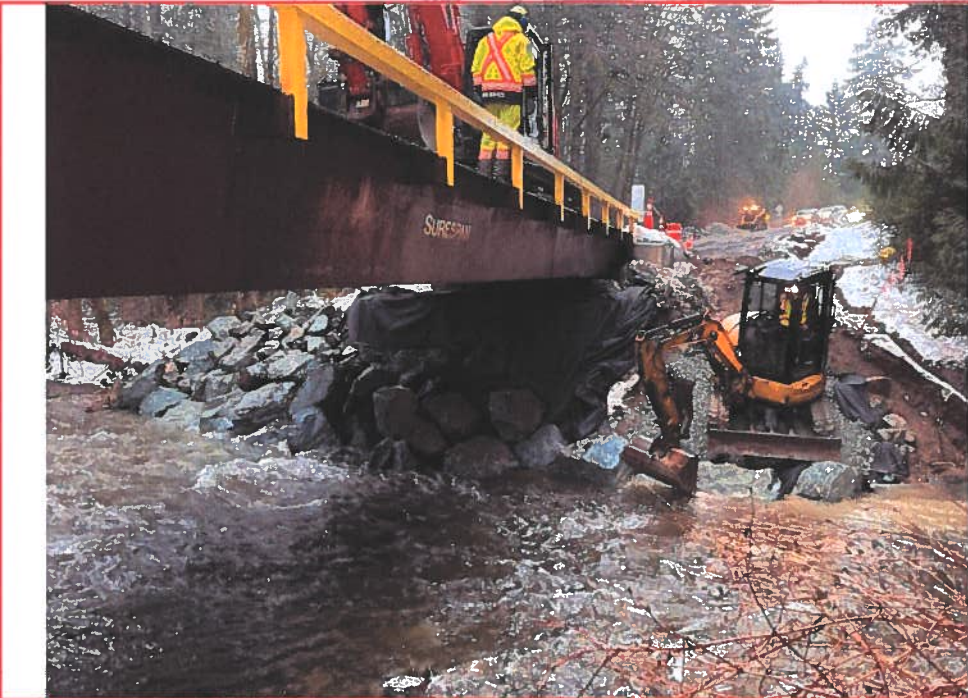
Photo 9:

Access ramp with 75 mm crushed gravel was placed to allow excavator to place riprap under the bridge.

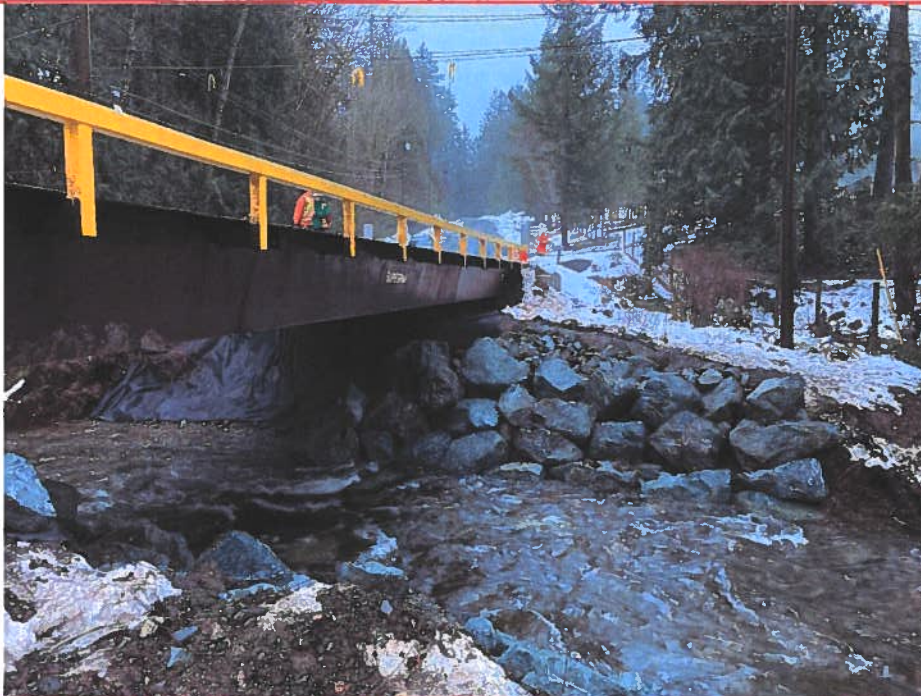
Photo 3:

Overview of the SE slope.

The southwest side of the SE slope had been armoured.

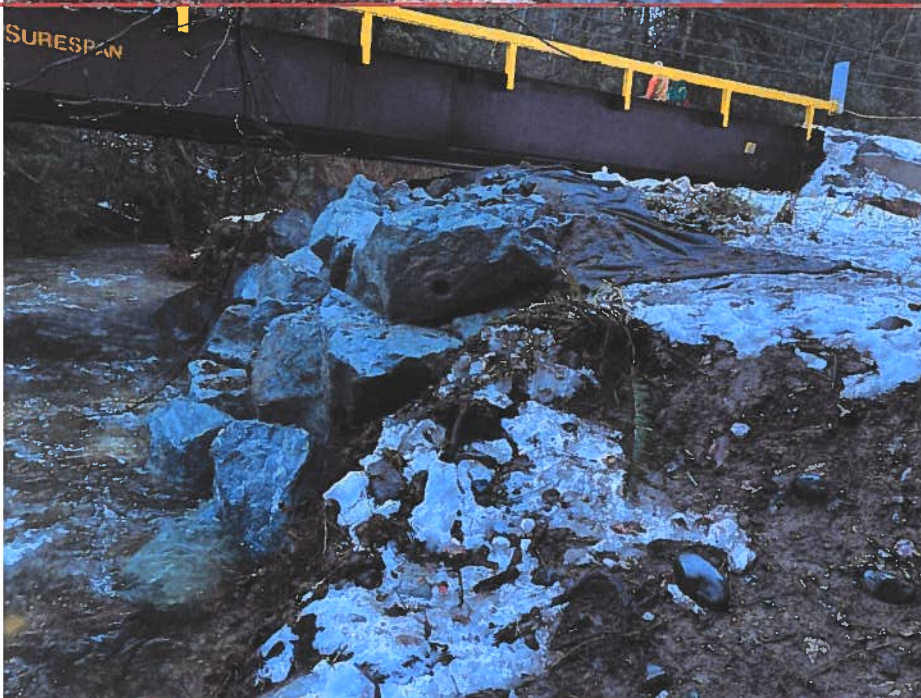
Photo 4:

Geotextile was extended beyond the crest for about 0.8-1.0m.

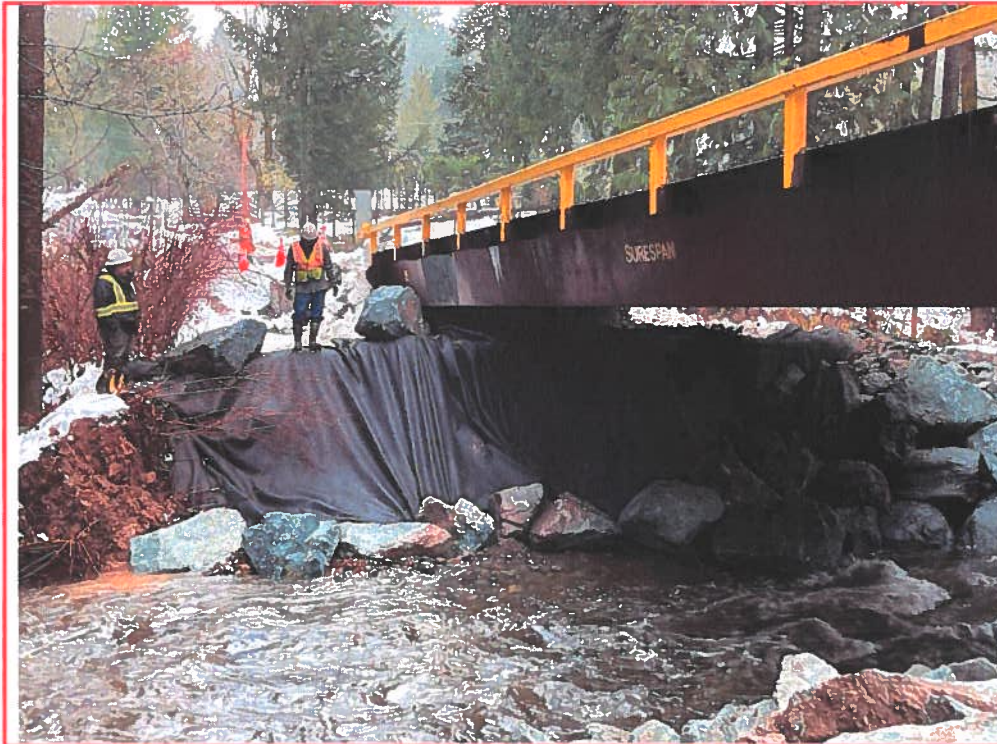
Photo 5:

5. WSP observed two large boulders (from the large riprap) were placed on the crest on the northeast side of the SE slope to hold the geotextile in place. WSP noted to the Contractor that it could be a potential hazard as the slope was not considered totally stable. The Contractor advised that the two boulders were only placed on the crest temporarily and would be removed before finishing the riprap placement.

Observed two large boulders placed to hold geotextile in place on the northeast side of the SE slope.
