BC MINISTRY OF TRANSPORTATION AND INFRASTRUCTURE

BRIARWOOD BRIDGE GEOTECHNICAL SITE CHARACTERIZATION

MARCH 2023

Subject: Briarwood Bridge No. 10427 - Geotechnical Site Characterization
Client ref.: 18003-2023

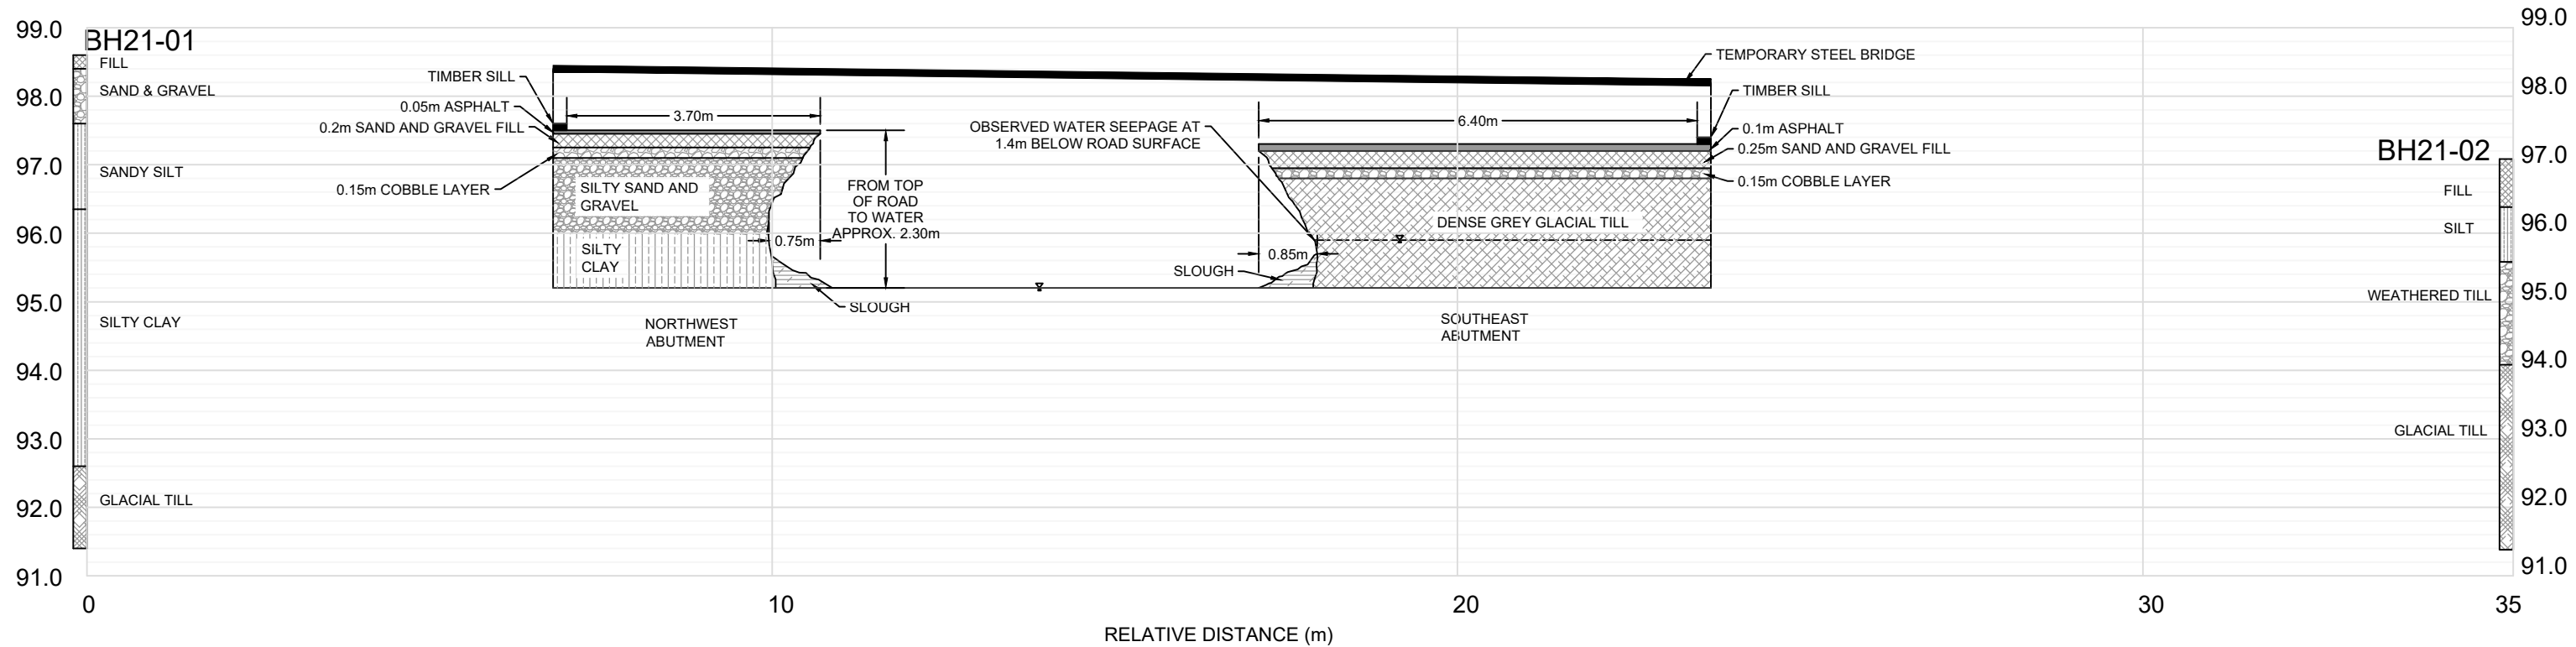
PROJECT:		BRIARWOOD DRIVE
CLIENT:		MINISTRY OF TRANSPORTATION AND INFRASTRUCTURE
TITLE:	SLOPE CONDITIONS WITH BOREHOLES	
DRAWING:	02

A cross-section showing the borehole logs and the observed exposed soil conditions is shown on Figure 2. Note that the elevations shown on Figure 2 are relative only and are based on an assumed Temporary Benchmark (TMB) elevation of 100.00m. The TMB was a nail placed at the base of a Hydro pole located on the north side of the road, east of the temporary bridge crossing.

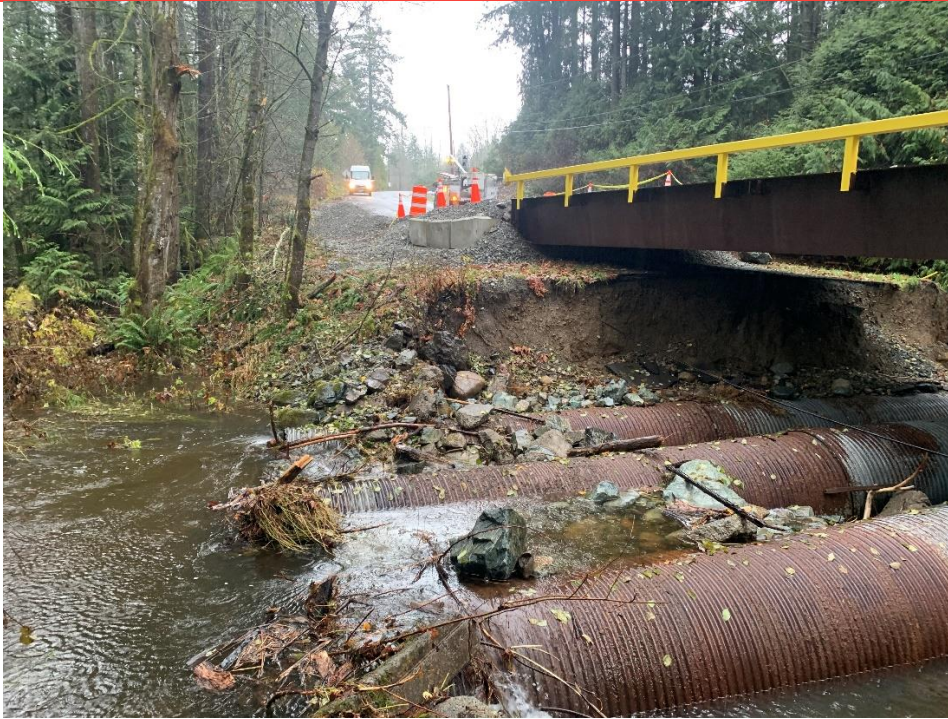
The width of the stream between the banks of Hollings Creek was about 12.5m at the road crossing after the failure. The observed exposed soils within the west bank consisted of sand and gravel fill over sand bedding and culvert backfill. The exposed soils observed within the east bank consisted of sand and gravel fill over glacial till. The stream bed was observed to consist of rounded gravel, cobbles, and small boulders.

Photo 3:
West creek
bank
following
washout
Nov 2021

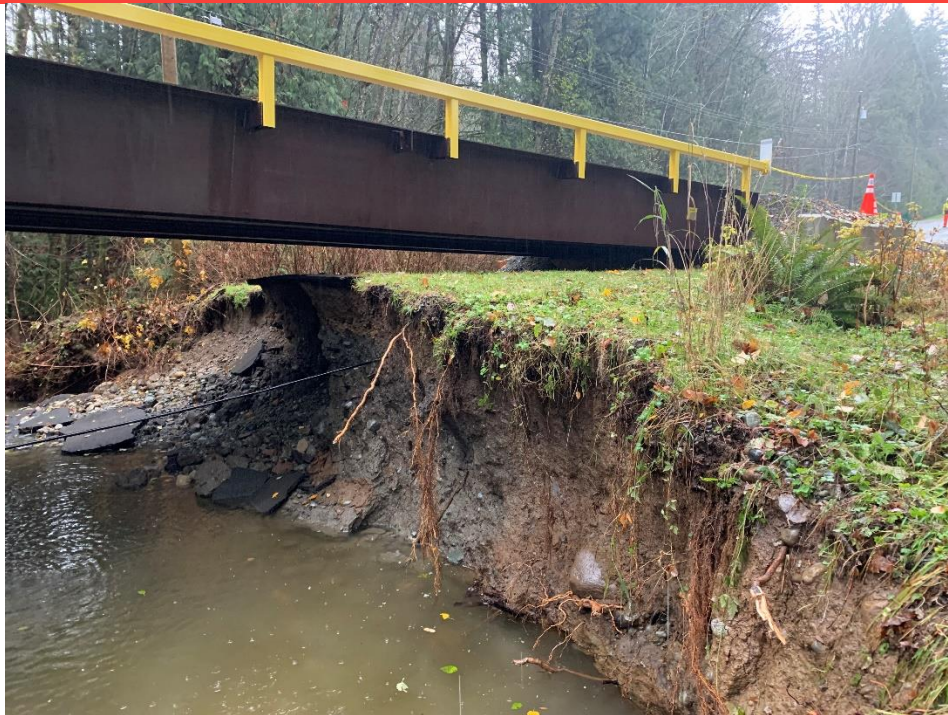
Photo 4:
East creek
bank
following
washout
Nov 2021

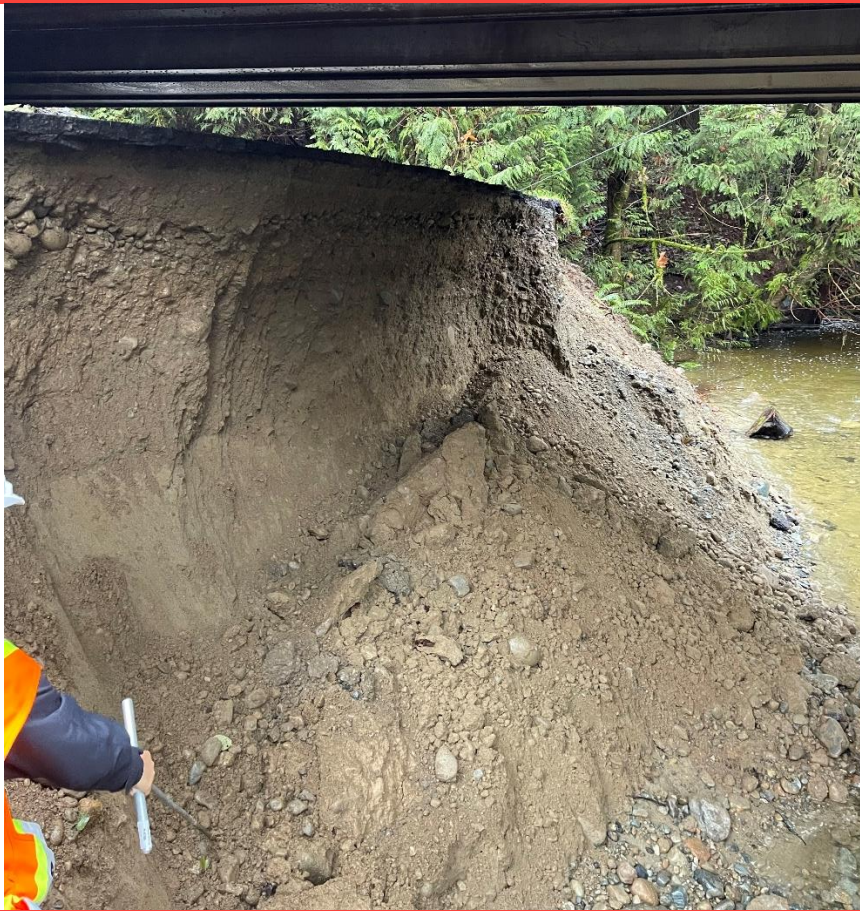
Loose sand was observed in the NW bank slope on an earlier site visit. However, upon further review it was determined to be isolated and likely backfill that was part of the former culvert installation.

Photo 5:
Sloughed
soils at
west creek
bank
(30 Nov
2021)

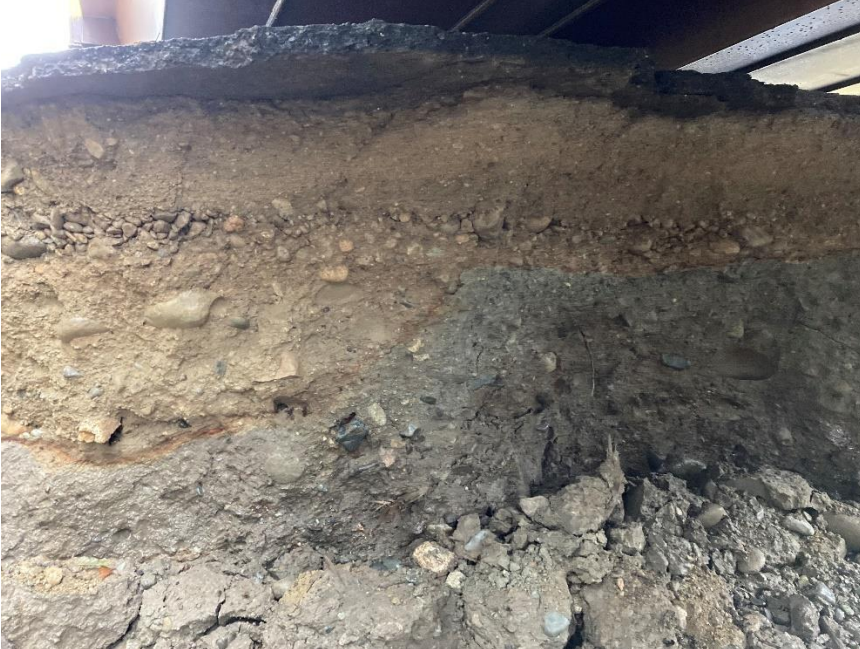
Photo 6:
Fill and
glaciated
soils at east
creek bank
(30 Nov
2021)

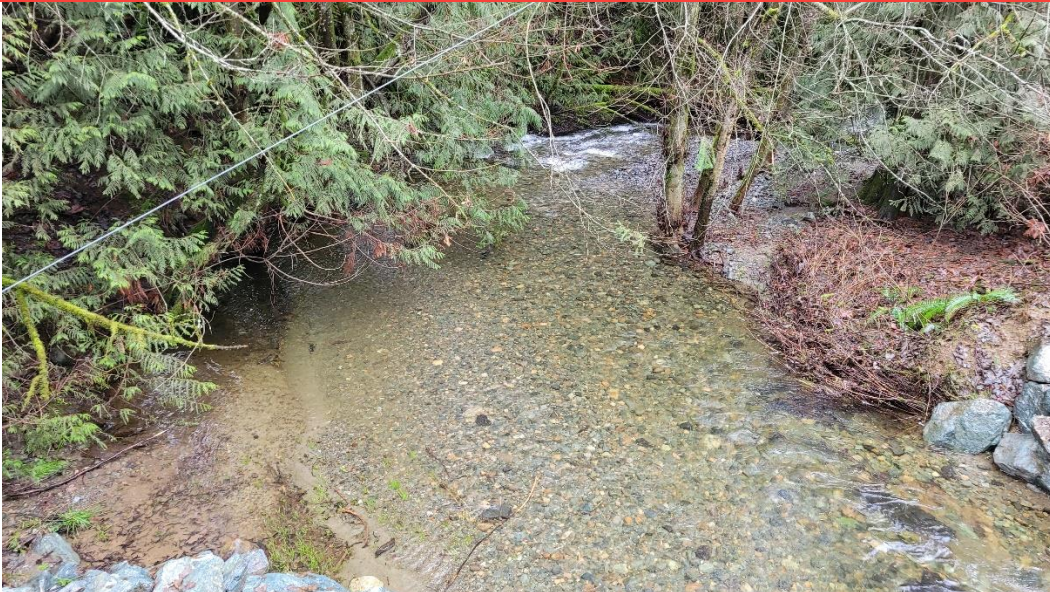
Photo 7:
Creek bed
conditions
(Jan 2023)

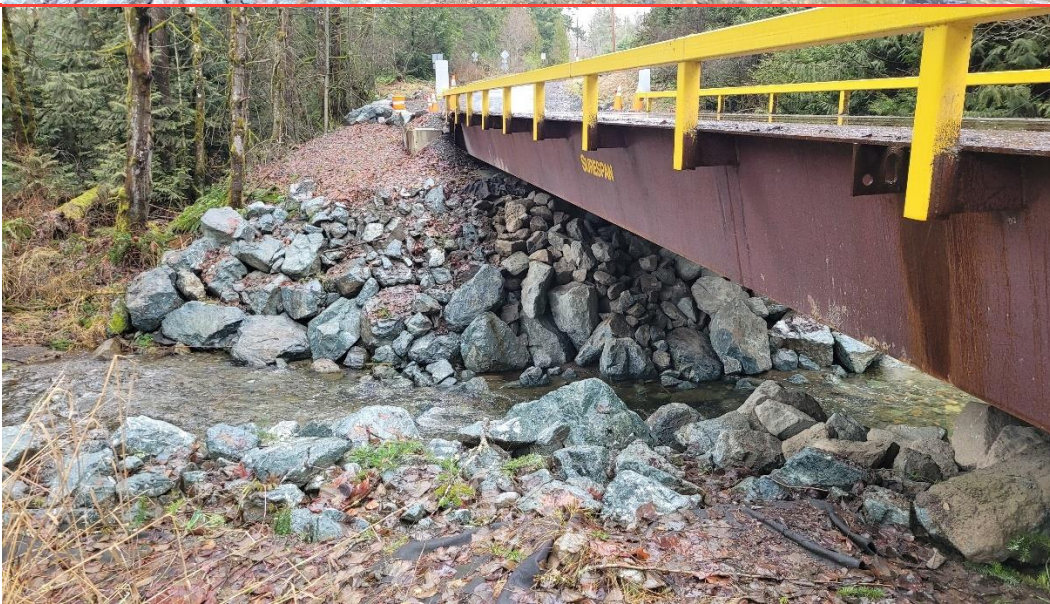
Photo: 8
Temporary
repair
condition
looking
towards
the west
bank
(Jan 2023)

Upon completion of the drilling and laboratory testing, WSP completed a stability analysis to review the short-term stability of the temporary repair condition. To increase the stability, the MoTI's contractor removed loose soils from the exposed creek banks, added a non-woven geotextile and placed riprap in the area of the temporary bridge crossing. The placed riprap ranged from about 1.5m at the toe to about 0.3m at the top.

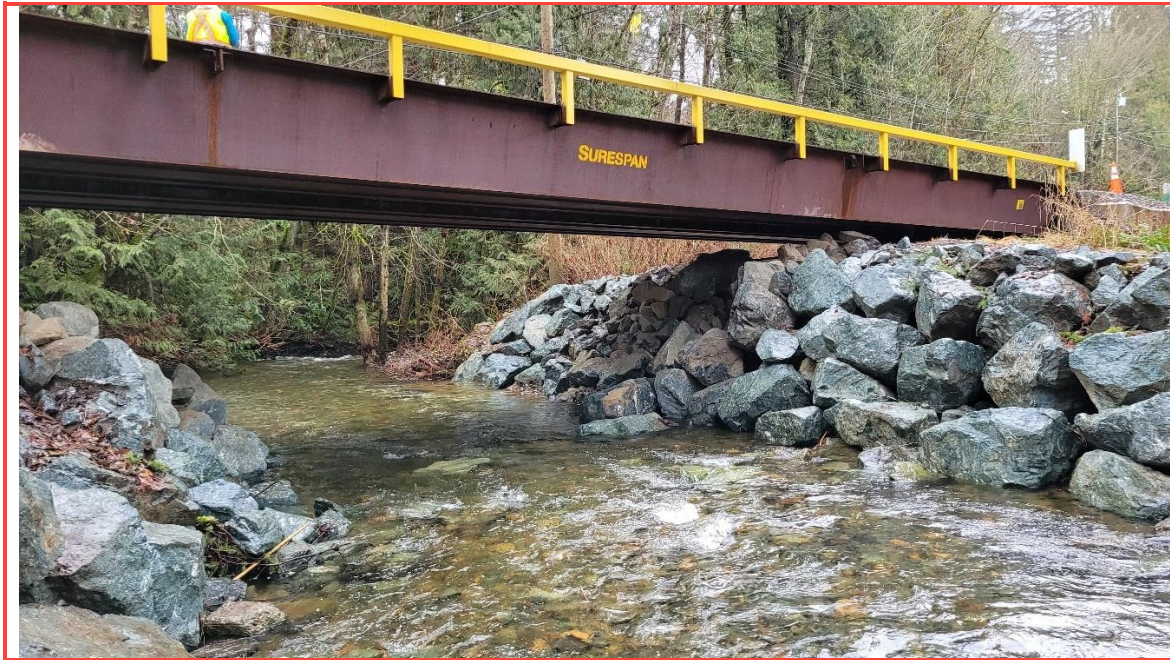
Photo: 9
Temporary
repair
condition
looking
towards
the east
bank.
