**Timber Evaluation, Tree Risk
Assessment and Cultural
Modified Trees Identification,
Initial Data Collection and
Reporting**

**Gulf Islands National Park
Reserve of Canada, Canal
Road, Pender Island, B.C.**

2023-01-11 | Revision #1

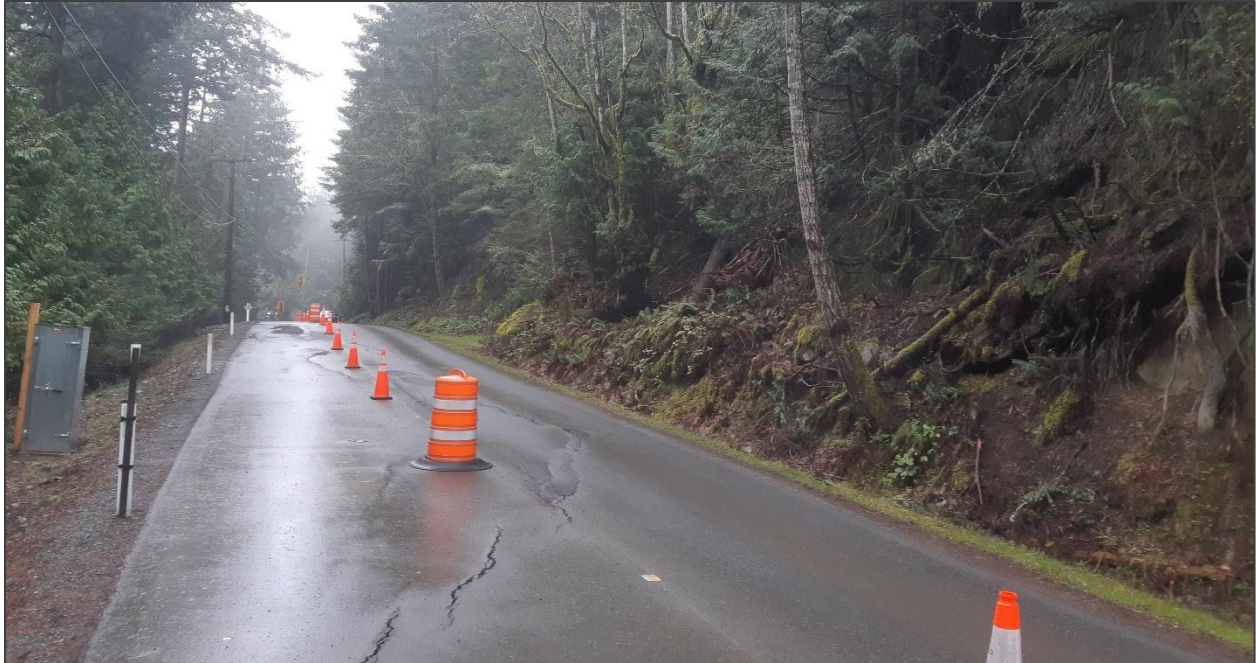
Figure 2. Canal Road on South Pender Island, BC - image of the longitudinal pavement crack and steep terrain above the road (view from the West to the East).

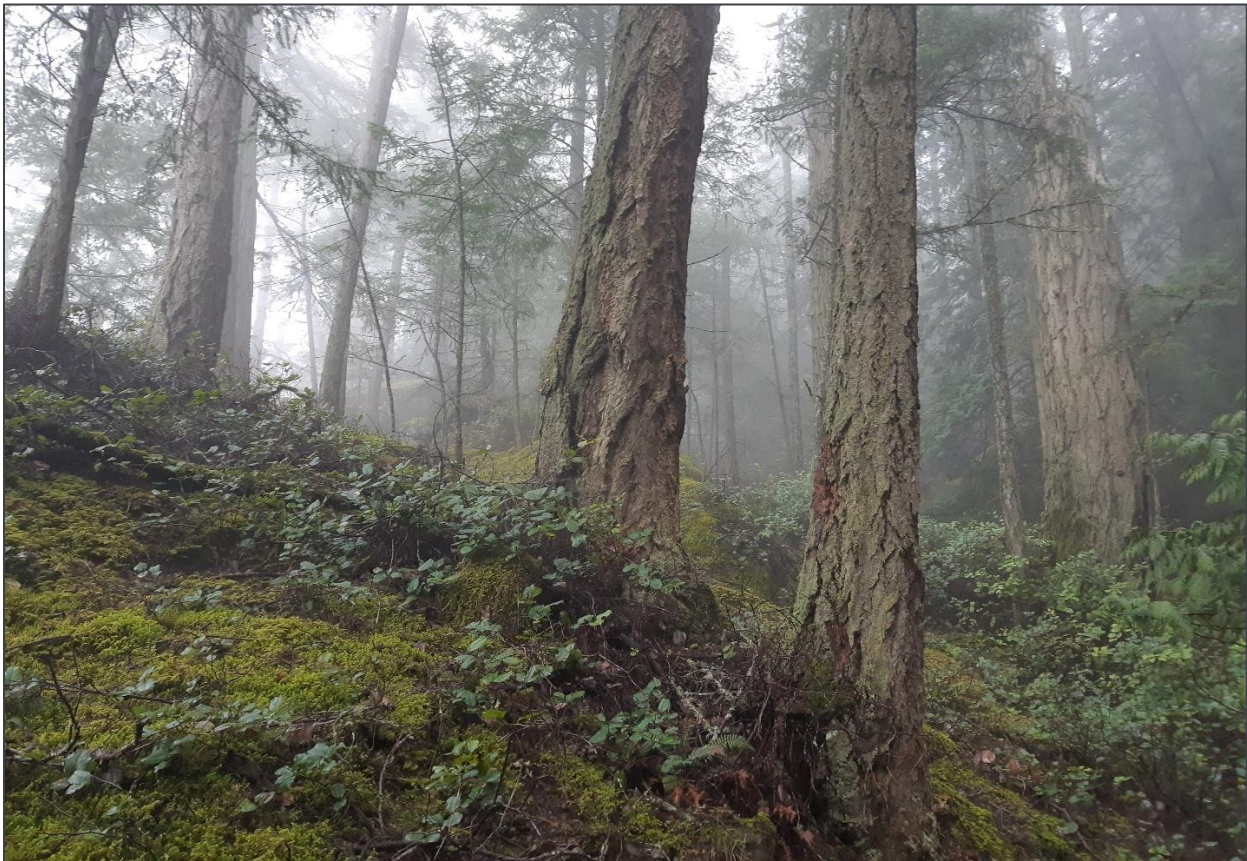
Figure 3. Spotted areas with old growth characteristics were identified.

The overall multi-layer forest stand characteristics is presented in detail above in a tabular format. The estimated age of the stand is more than 90 years with some trees acquiring old growth characteristics (see Figure 3). This stand appears to be spot burned more than 90 years ago (estimated).

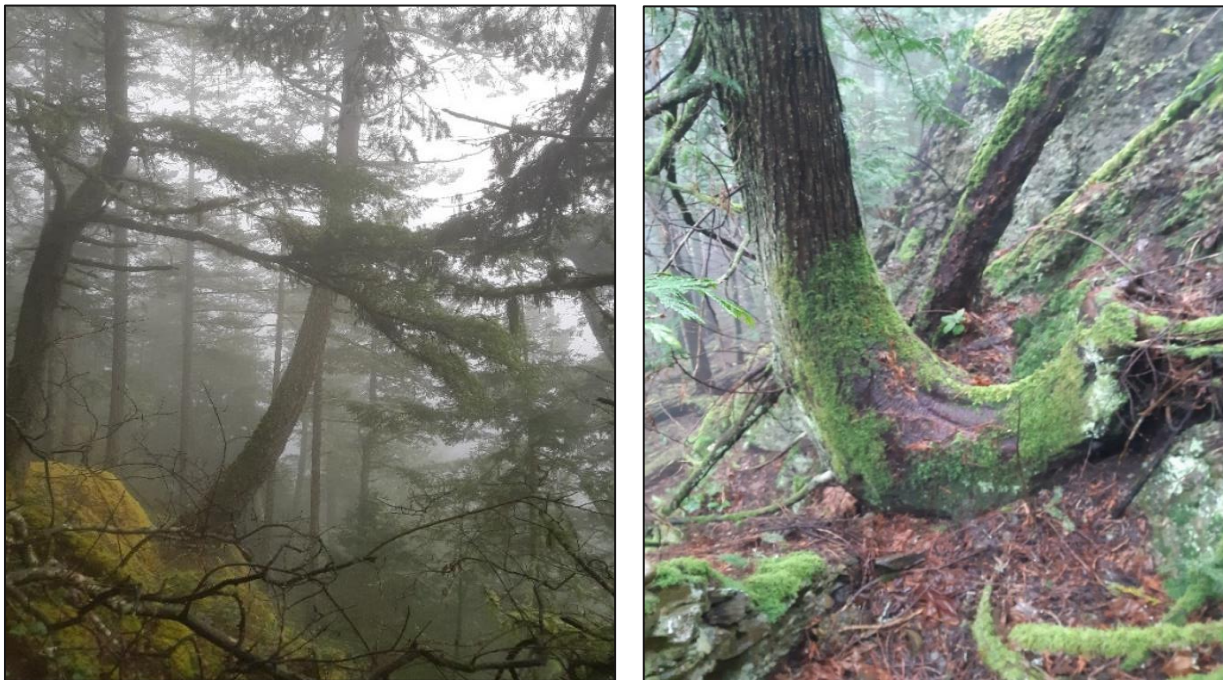
During the site visit I observed signs of unstable terrain like trees with “pistol butts” and large pieces of rock that appear have rolled from above (see figures 4 and 5).

Figure 4 and 5. Trees with their structure and overall form that has been impacted by unstable terrain.

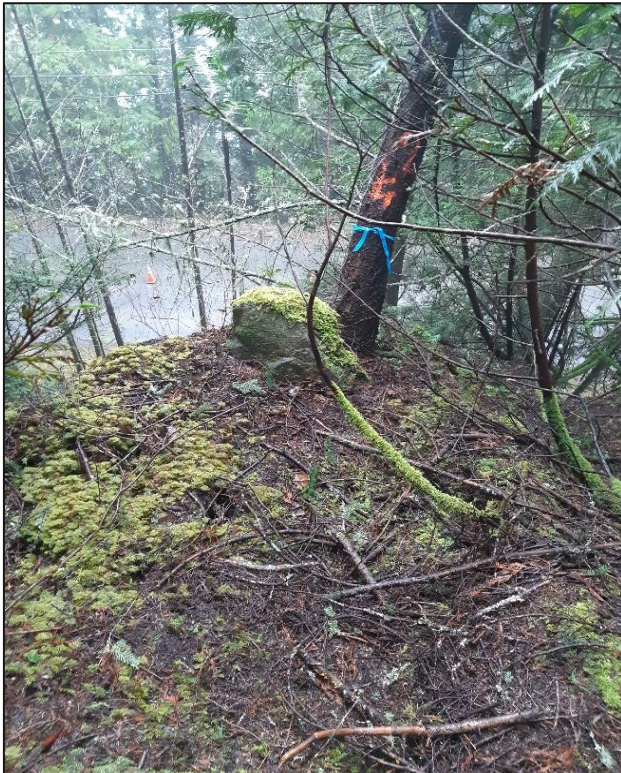
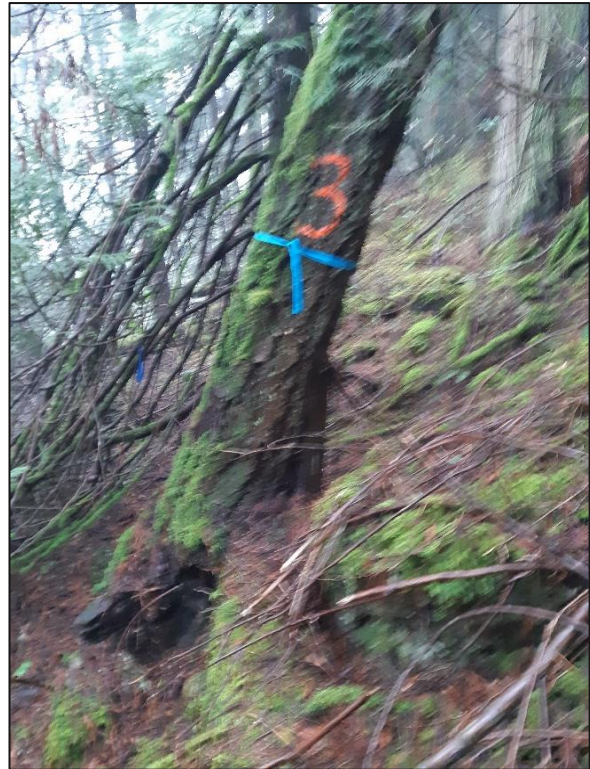
These trees were assessed for risk, on a limited visual assessment basis, and in the context of the current land uses. Two trees were deemed to be danger trees that would require hazard abatement to eliminate present and/or future risks (within a 1-year timeframe of the tree inventory or before any significant storm event) (see Figures 6 & 7).

Figure 6 and 7. Tree #2 and tree #3 proposed for removal.

- **Remove tree #2** with a dislocated root plate and leaning over the road.
- **Remove tree #3** with a pronounced lean and decayed roots. This tree is leaning SW on the adjacent tree. We recommend removal concurrent with tree #2

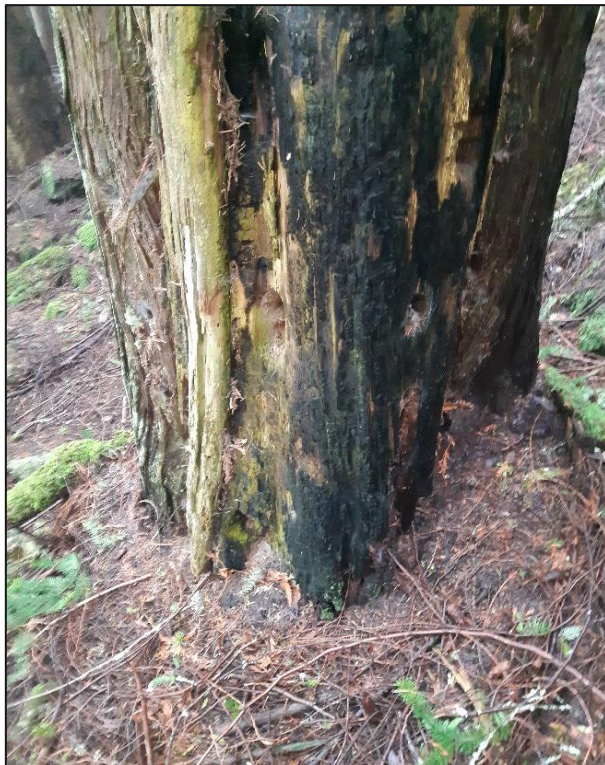
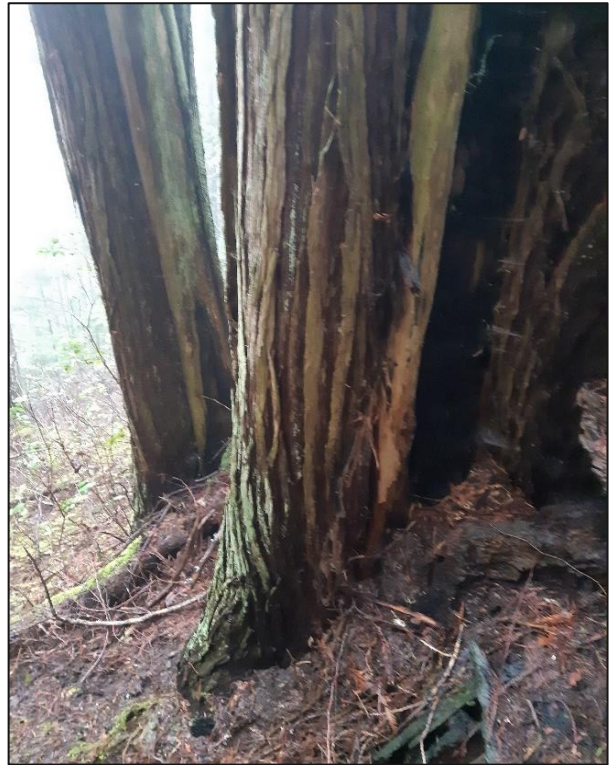
Figure 8 and 9. Trees with their structure and overall form that has been impacted by responses to historical damage and stress, no conclusive CMT identified.

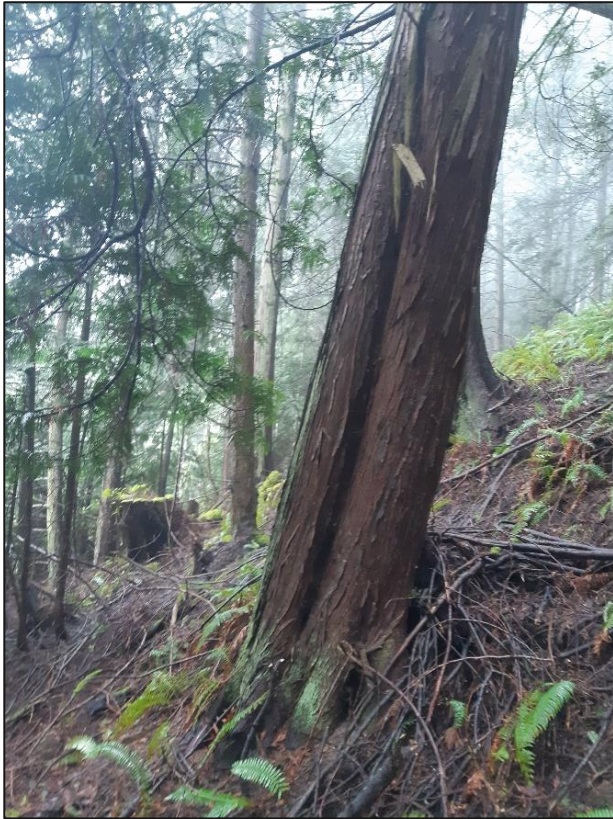
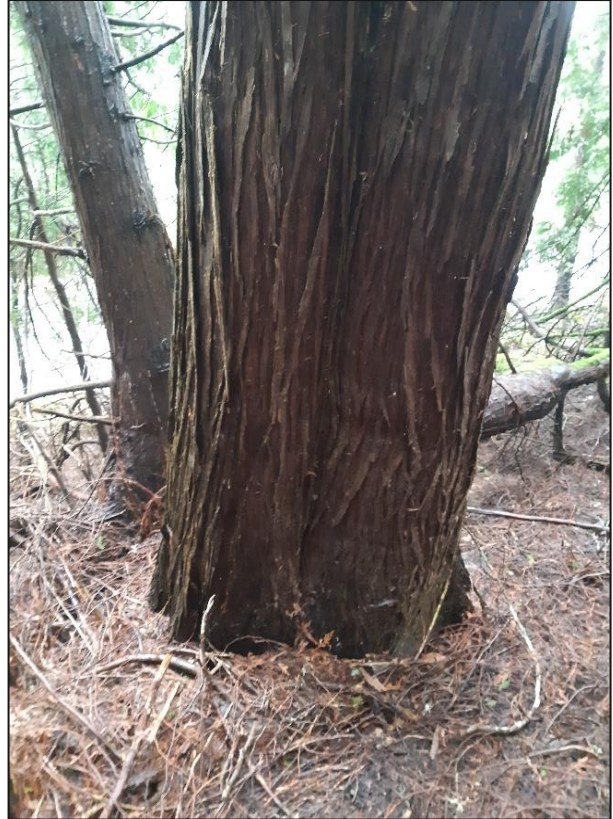
Figure 10 and 11. Trees with their structure and overall form that has been impacted by responses to historical damage and stress, no conclusive CMT identified.

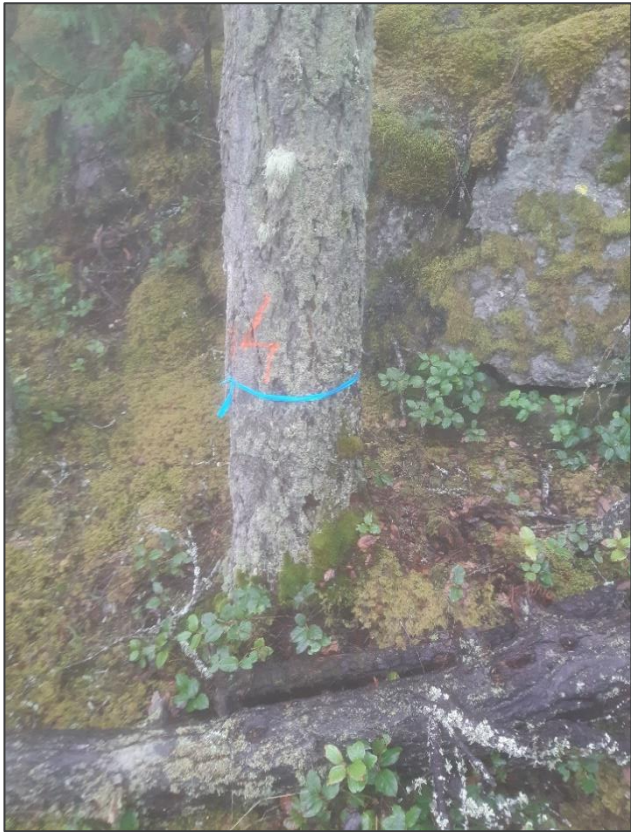
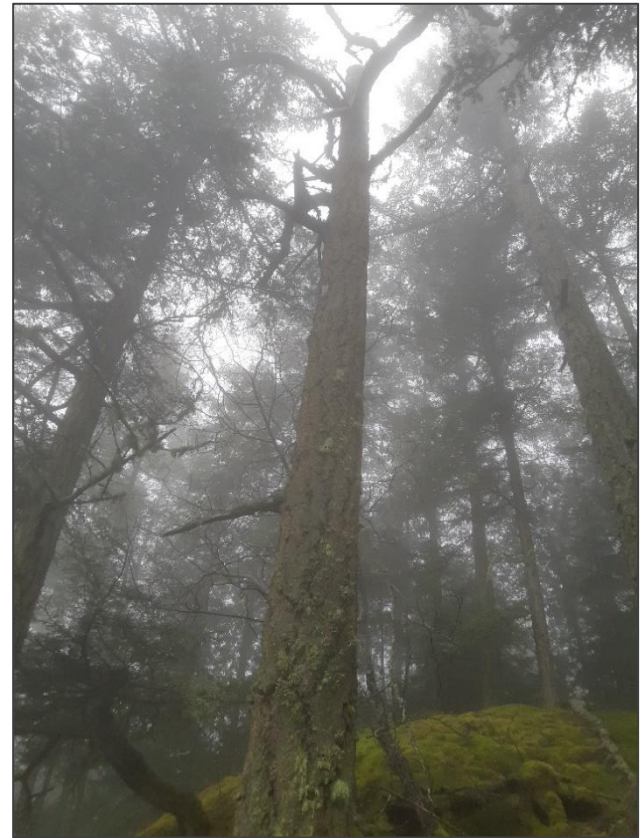
Photo 3 & 4. Tree #4 lower trunk and top images. High value wildlife tree.

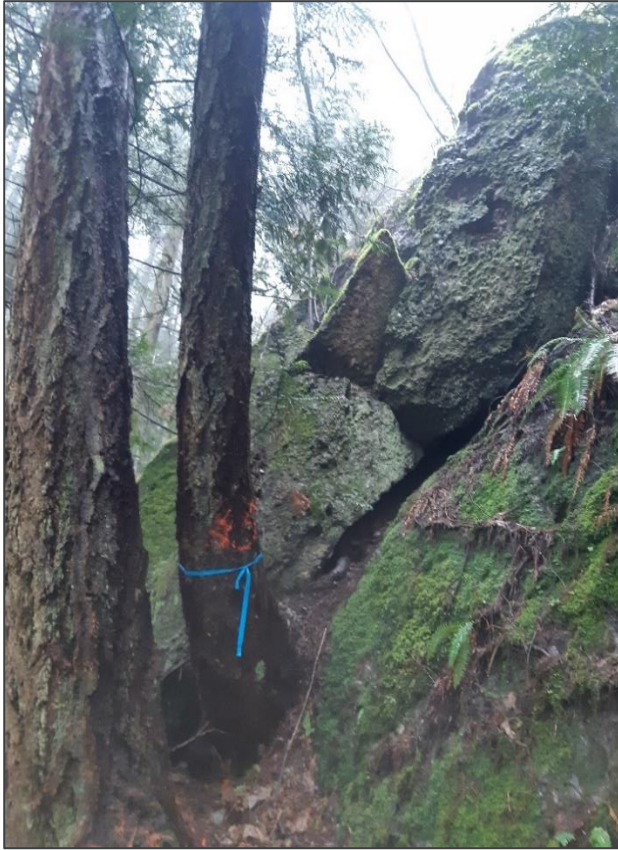
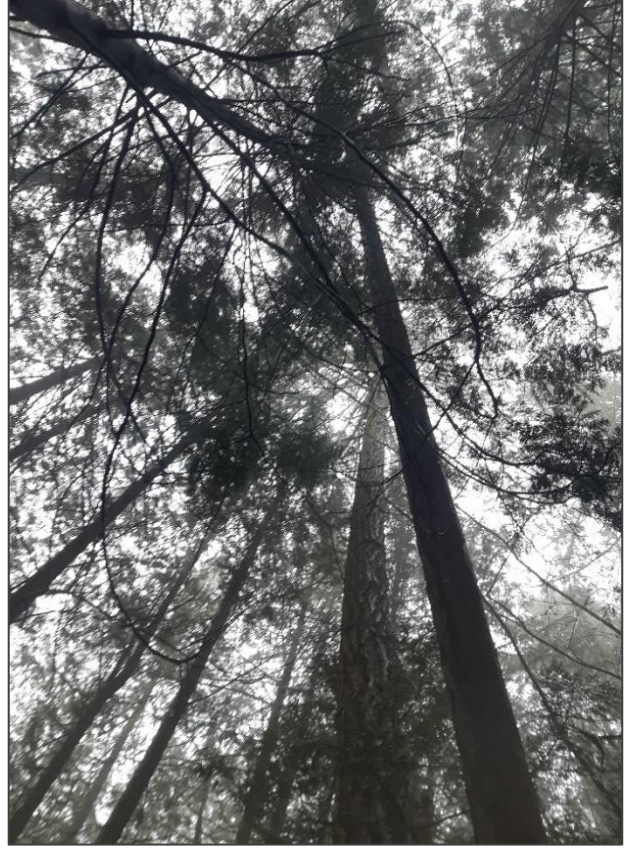
Photo 5 & 6. Tree #5 images of the base of trunk anchored in the rock and leaning trunk (corrected).

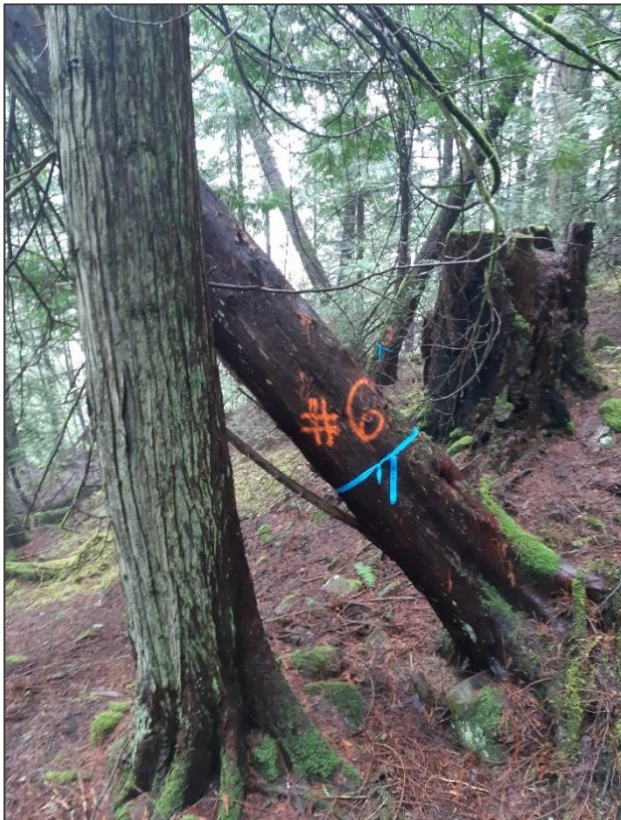
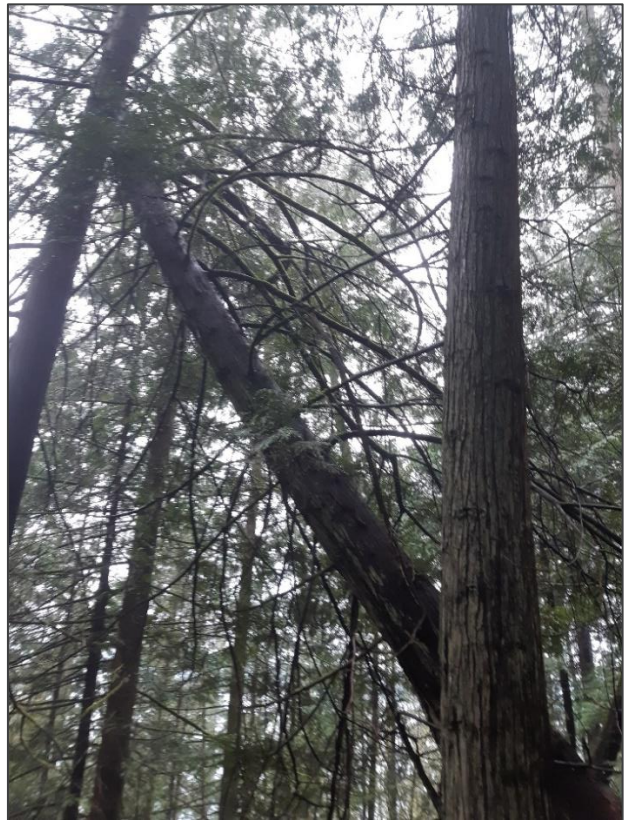
Photo 7 & 8. Tree #6 images of the lower and upper trunk leaning but corrected.

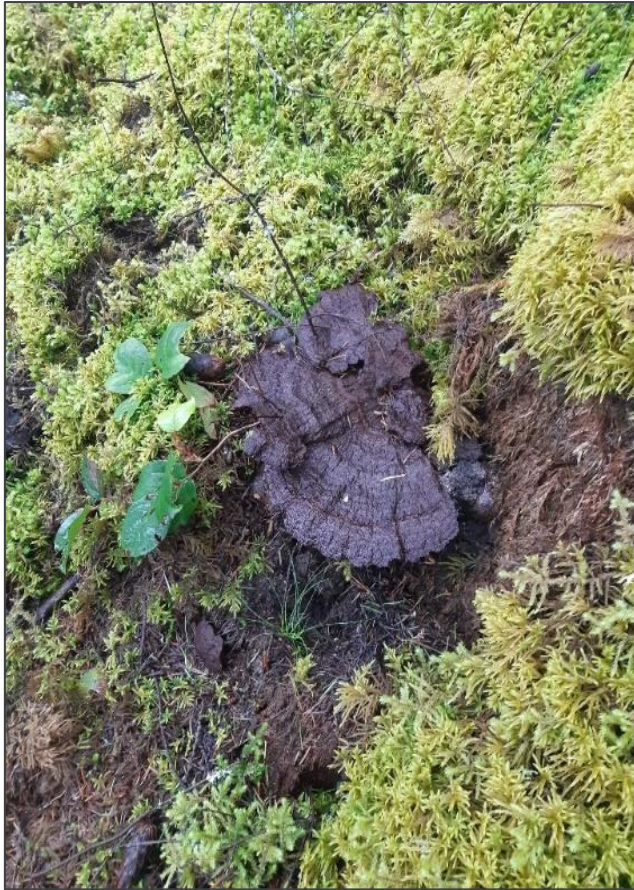
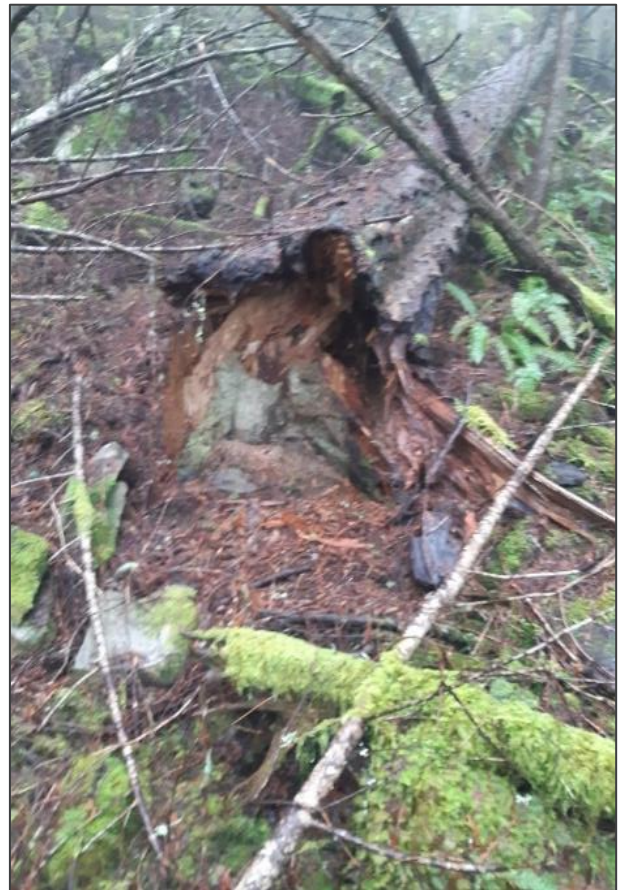
Signs of laminated root rot, Schweinitzii root and butt rot were also identified. This aspect needs to be taken in consideration when selecting trees to be retained along the proposed new forest edge.

Photo 9 & 10. Signs of Schweinitzii root and butt rot were identified.

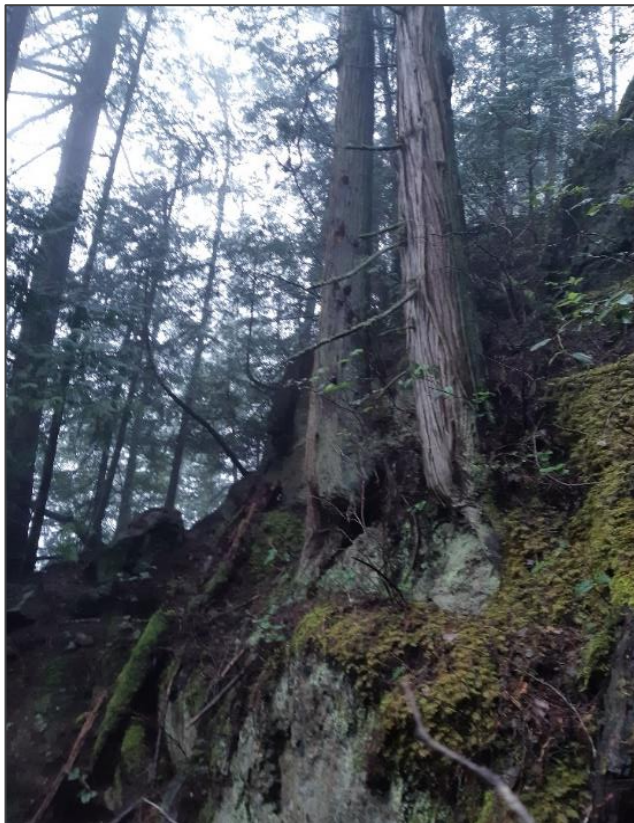
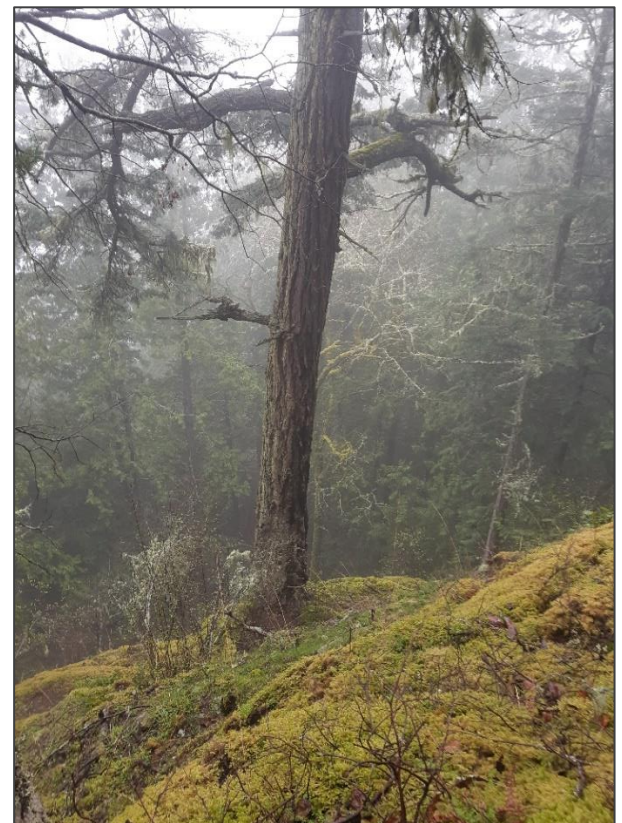
Photo 11 & 12. Trees growing on superficial soil, overview image.
