STRUCTURAL ENGINEERING

BC Ministry of Transportation
and Transit

01491 SACKUM O/H BRIDGE INSPECTION REPORT SUMMARY

Inspection Date: March 3rd, 2025

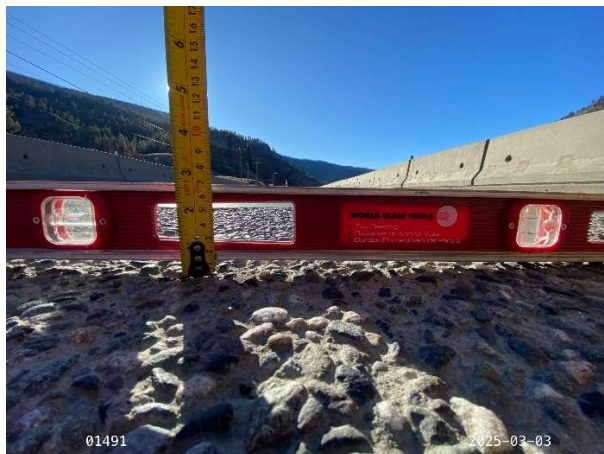
Figure 1: Span 1 north lane south wheel path rutting

- random spot checks indicate frequent large areas of delamination throughout (2024 05 21)
- wheelpaths have rutting/wear up to 13mm with loss of cement and some aggregate, areas of shallow spalling (2025 03 03)
- smoothly polished aggregates throughout with significant loss of cement (2023)

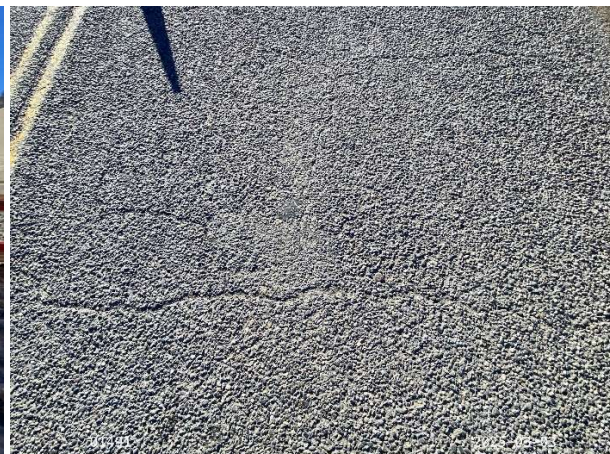
- Transverse and diagonal cracks throughout have increased in frequency, width, and length, some are now very wide (i.e. 2.5mm+) and potentially full depth (noted in span 1 east of midspan bays 3-4 – see subdeck)
- Occasional new areas of broken up concrete or spall, previous areas patched
- Rutting/wear in wheelpaths up to 13mm throughout with significant loss of cement and areas with loss of aggregates bordering on shallow spalls
- Frequent small spalls near joints and patches

Figure 2: Typical deck crack

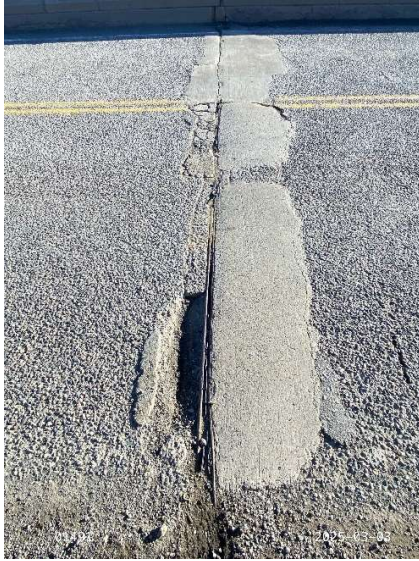
- At pier 1 north lane north wheel path 800x200 spall with exposed bar

Figure 3: Pier 1 joint

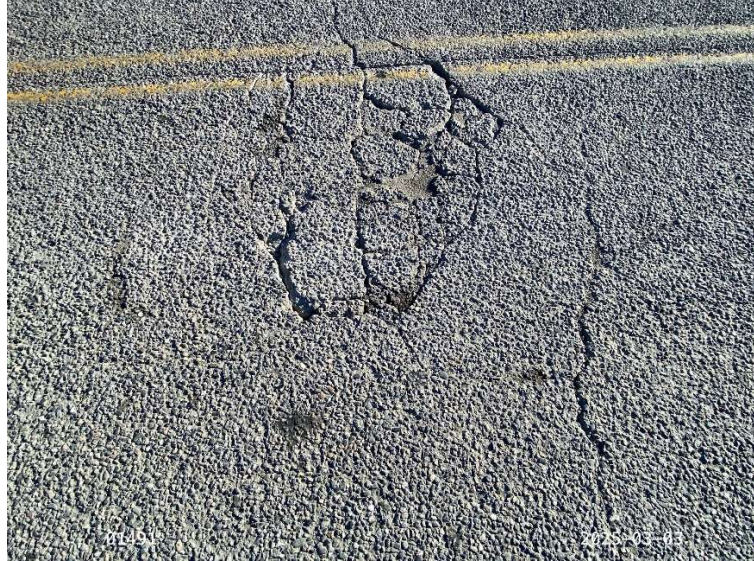
- North lane at 2/3 point near centreline large area loose concrete with small spalls, previously 2 wide cracks

Figure 4: Span 3 north lane 3m east of pier 3

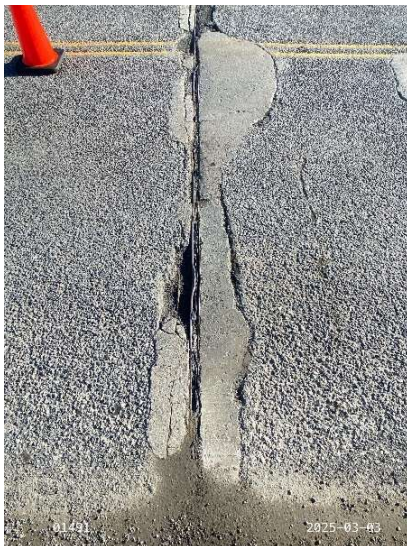
- At pier 5 north lane north wheelpath 450x160 spall with exposed bar

Figure 5: Pier 5 joint north lane

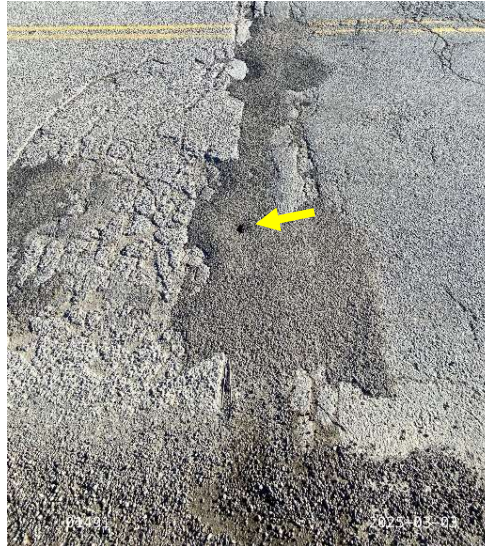
- West abutment north lane north wheel path small 20mmx20mm hole

Figure 6: West abutment joint

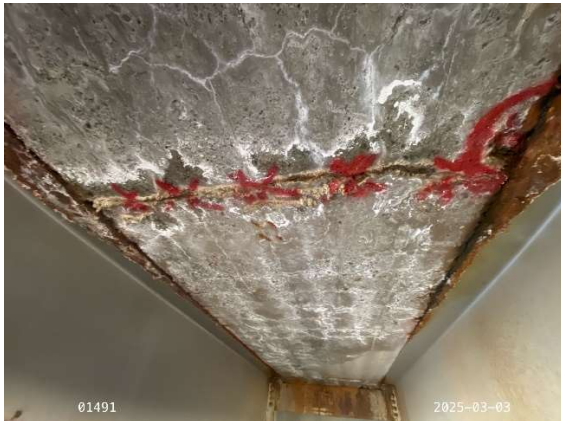
- Probable full depth crack east of midspan across bays 3-4 with heavy accumulation of efflorescence and water leaching (no recent rain)

Figure 7: Span 1 bay 4 east of diaphragm 1

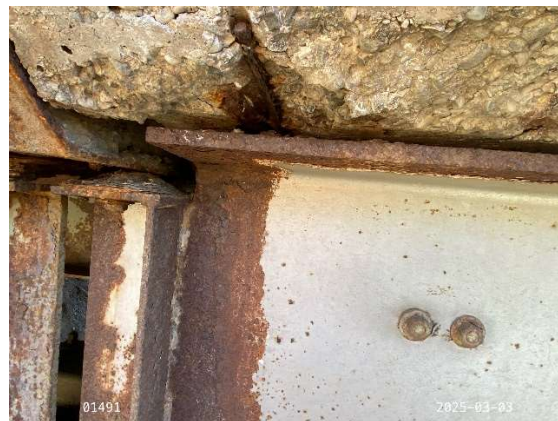
- North soffit at pier 1 spalled between top flange and deck with exposed corroded bar
- Significant lifting of deck off stringer F with daylight in a few locations
- Bay 5 at pier 2 large spall with exposed corroded bar

Figure 8: Pier 1 span 2 stringer F

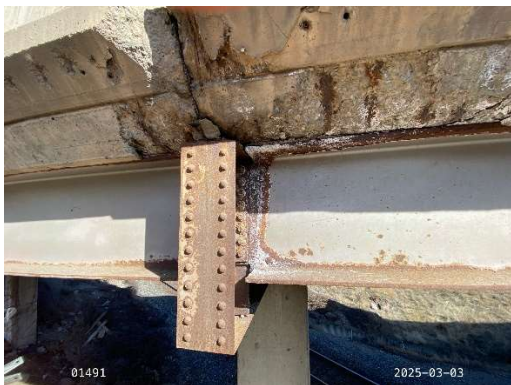
Figure 9: Pier 2 north end

- bay 5 at pier 1 spalling has fully exposed heavily corroded bottom mat, spalled area extends completely between stringers (2024 05 21)
- **bay 5 at pier 2 large spall with exposed corroded bar** (2025 03 03)

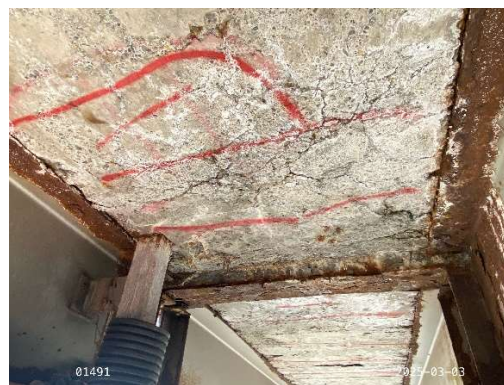
- Bay 5 at pier 5 extensive water leakage with efflorescence staining

Figure 10: Pier 5 span 6 bay 5

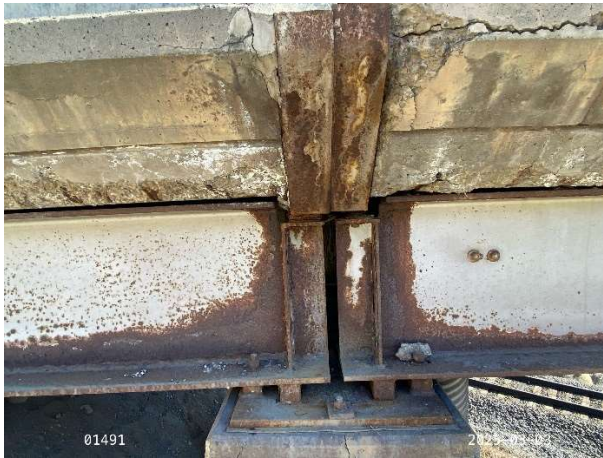
Figure 11: Pier 1 north end

- span 2 trimmer north end severely misaligned with stringer longitudinally (trimmer pushed approximately 30-50mm east, in contact and overlapping with span 1 trimmer) span 2 trimmer disconnected from stringer, span 1 heavily rust jacked (2025 03 03)
- span 2 bay 2 trimmer has heavy corrosion (2024 05 21)
- span 2 bay 4 trimmer been pushed down at north end, and slightly throughout due to rust jacking (2024 05 21)
- all trimmers have medium corrosion, most have heavy corrosion, some have rust jacking (2024 05 21)

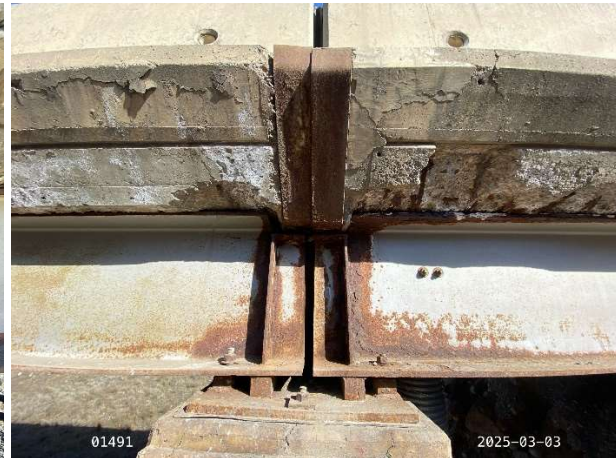
Figure 12: Pier 5 north end

- span 5 bay 4 at stringer E trimmer bolt missing (2024 05 21)
- north soffit trimmers pushed together and slightly overlapped (2025 03 03)

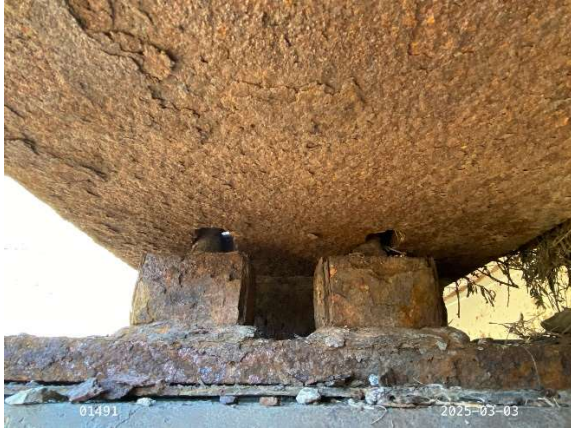
- Stringers
 - Span 2 at pier 1 stringer A bearing bolt slots have bolts pressed against south edge of slot; at pier 1 stringer F bearing bolt slots have bolts deforming north edge of slot
 - Deck lifting off top flange approximately 23mm with daylight at pier 1
- Bearings
 - Pier 1 span 1 bearing D tilted up on east side, bearing E slightly tilted up on east side
 - Pier 1 span 2 bearing D rust jacking below bearing (ends of bottom flanges misaligned with span 2 higher)
 - Pier 5 span 5 bearing D slightly tilted base plate; bearing F base plate slightly bowed
- Drains
 - Span 2 pier 1 stringer F drain plate bolted to stringer is bent and pulling off stringer, appears deck has shifted east compared to stringer

Figure 13: Pier 1 span 2 bearing F

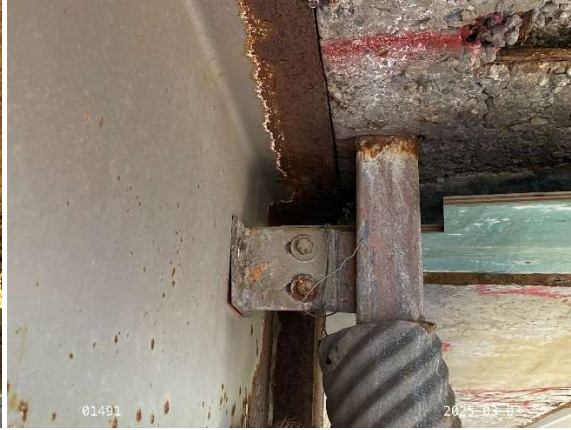
Figure 14: Pier 1 span 2 bay 5 drain anchor

- all drains completely filled with sand/gravel (2024 05 21)
- at pier 1 span 2 stringer F bracket bolting drain to stringer bent (drain moved towards east) (2025 03 03)
- span 4 at pier 3 stringer F drainpipe has medium corrosion (2024 05 21)

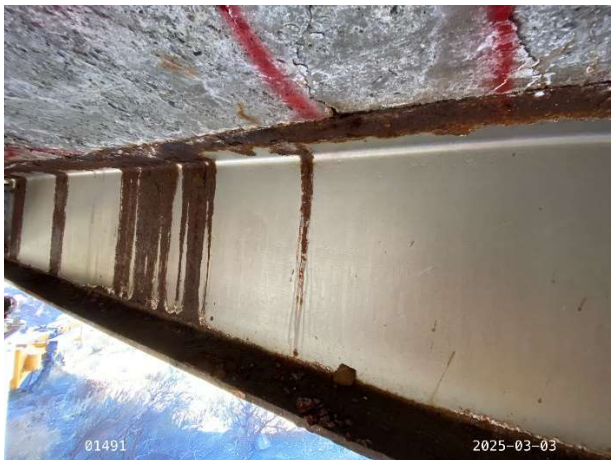
- Camber/Sag
 - Span 1 stringer F more significant sag
 - Stringers F minor sag

Figure 15: Span 1 stringer F south face

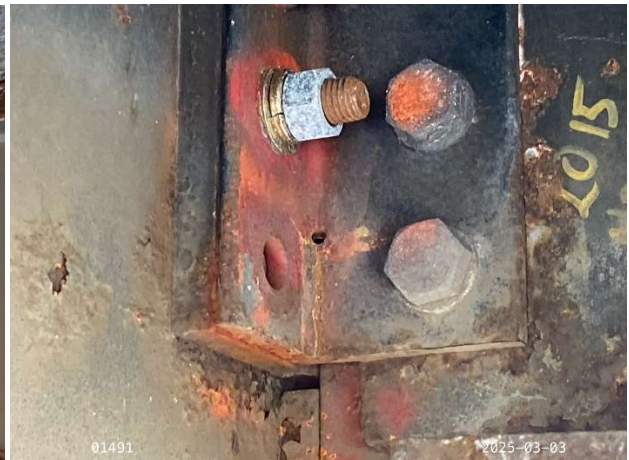
- Stringer F at pier 3 bay 5 L-plate to cap drilled approximately 30mm from bottom, does not appear to be cracked

Figure 16: Pier 3 span 3 stringer F south face
