## TECHNICAL MEMORANDUM

**DATE** 10 June 2021

**Reference No.** 19115216-034-TM--Rev0-2090

### **PRELIMINARY GEOTECHNICAL ASSESSMENT - ROCK WALL HIGHWAY NO.16 – MCBRIDE STREET AND 2<sup>nd</sup> AVENUE INTERSECTION IMPROVEMENTS (#37608) PRINCE RUPERT, BC**

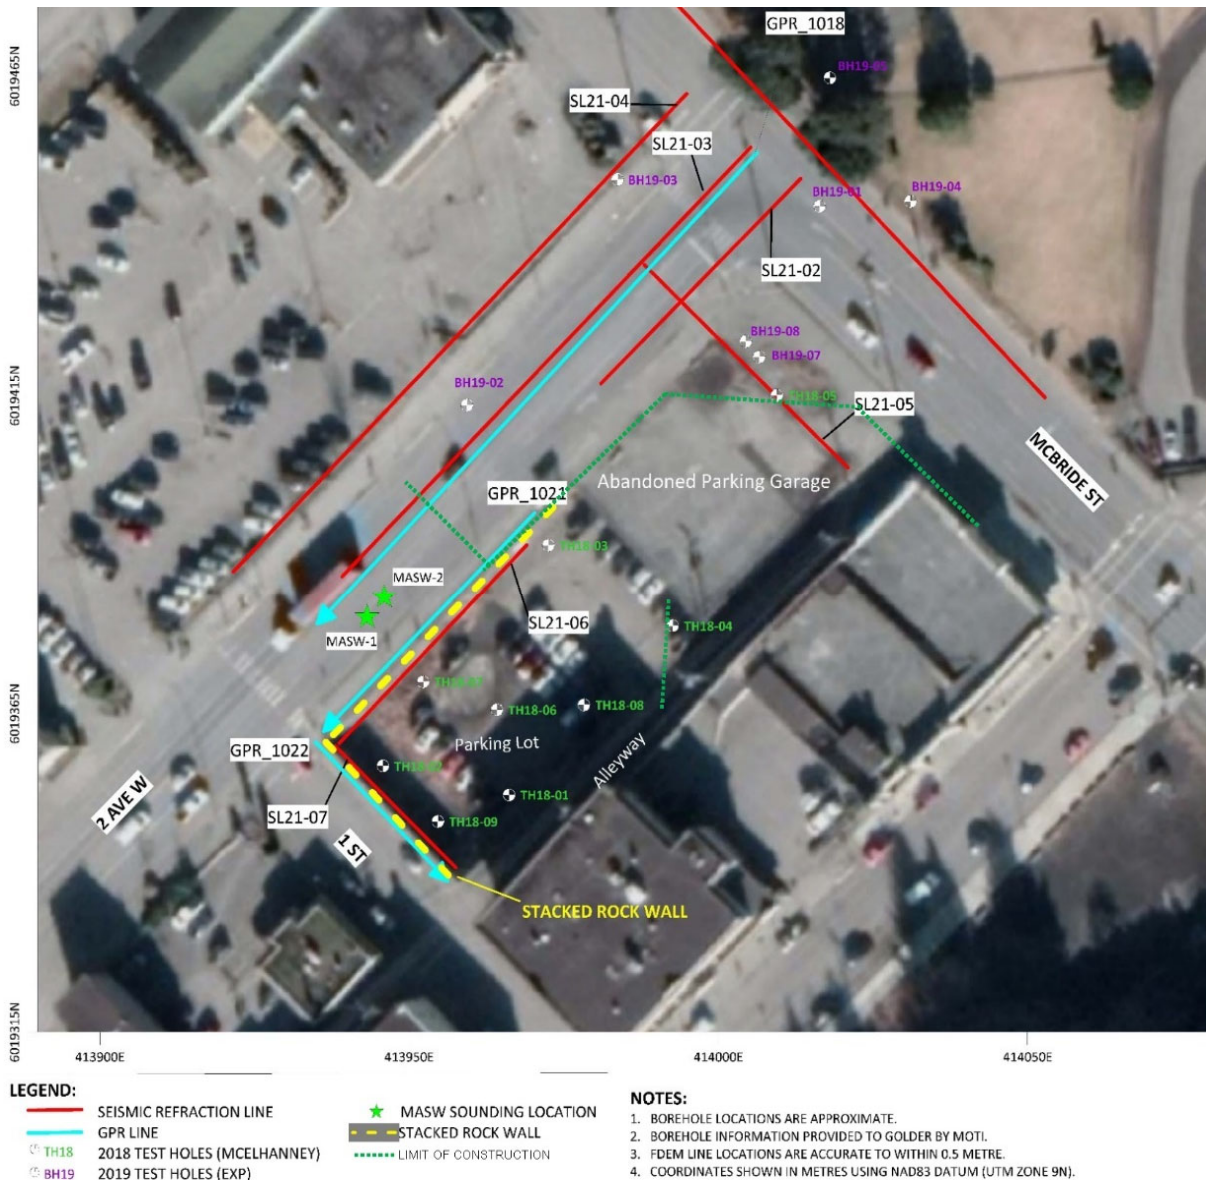
Figure 1: Site Plan

This preliminary geotechnical assessment site encompasses the rock wall which borders the approximately 17,000 m<sup>2</sup> parking lot at the northeast corner of 2<sup>nd</sup> Avenue West and 1<sup>st</sup> Street as shown in the 70% design drawings<sup>1</sup> provided by MoTI with select drawings shown in Attachment 1. The parking area at the base of the wall is about 3 to 5 m below the surrounding 2<sup>nd</sup> Ave W and 1<sup>st</sup> Street. The wall starts at 1<sup>st</sup> Street and runs approximately 56 m along 2<sup>nd</sup> Ave W and is presumed to end at the abandoned parking garage. The wall runs for about 30 m along 1<sup>st</sup> Street and ends at the existing laneway as seen in Figure 1.

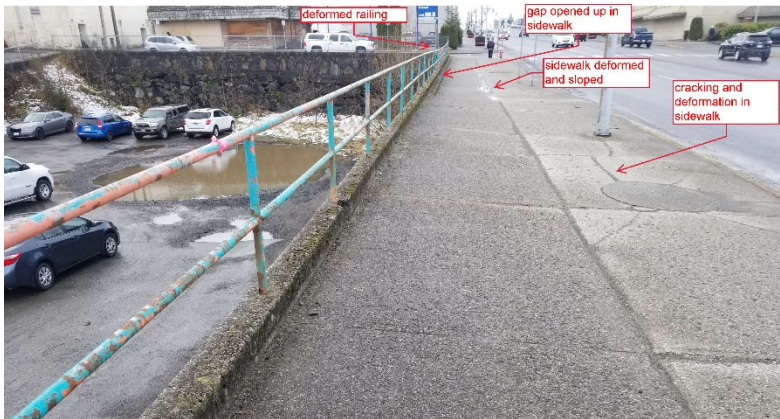
Vertical cracking was visible in the side-profile of the sidewalk above the rock wall along 2<sup>nd</sup> Ave W. The sidewalk near the intersection of 1<sup>st</sup> Street and 2<sup>nd</sup> Ave W was visibly deformed and sloping away from the wall crest (Figure 2). A gap in the concrete was visible between the sidewalk and the railing. Vertical cracks were visible in the sidewalk sidewall.

**Figure 2: View of sidewalk above rock wall along 2 Ave W. Cracking and sidewalk deformation visible. Looking south from bus stop.**

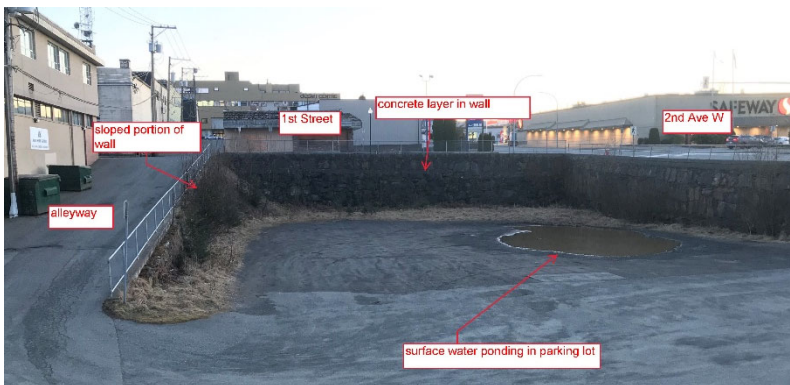
Along the alleyway between 2<sup>nd</sup> Ave W and 3<sup>rd</sup> Ave W, another rock wall segment was observed, see the left side of Figure 3. The corner section of the rock wall intersecting the alleyway and 1<sup>st</sup> Street was estimated at about a 1.3 H : 1 V (Horizontal : Vertical) soil slope and vegetated with grass and deciduous shrubs. A rock wall may be present behind the soil slope.

**Figure 3: View of rock wall looking southwest from the NE corner of the parking lot.**

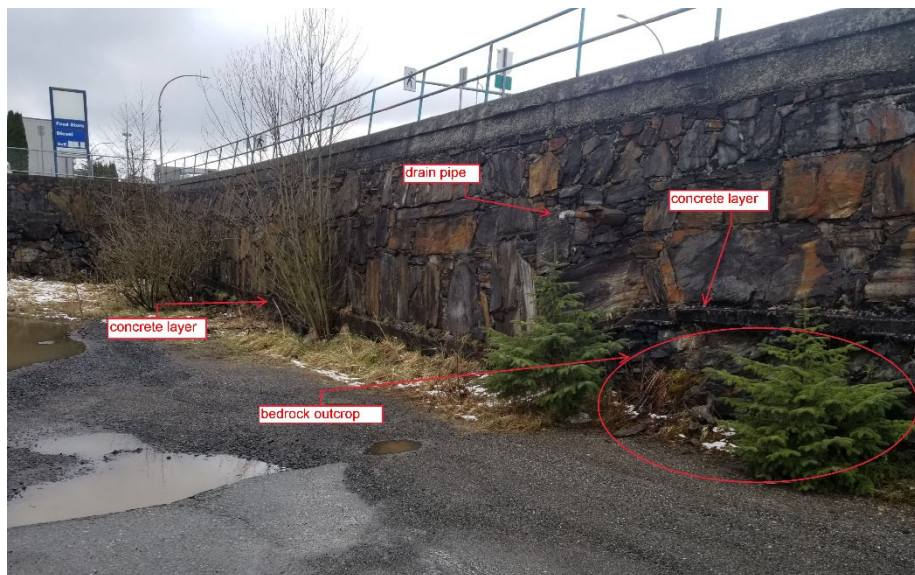
The rock wall consists of locally derived schist boulders with cement mortar between boulders in most areas, as seen in Figure 4. The lower portion of the wall along 1<sup>st</sup> Street does not appear to have any mortar between the boulders. The mortar/cement is generally in poor condition and gaps were visible between boulders where mortar has fallen out. It is unclear whether the mortar extends the entire depth of the rock wall or is merely holding together the facing.

Figure 4: View of rock wall along 2<sup>nd</sup> Ave W looking south approximately mid way along the wall.

Seepage was visible on the rock wall face along 2<sup>nd</sup> Ave W. Drainage pipes were visible emptying out of the rock wall and onto the parking lot surface (Figure 4).

A bedrock outcrop was noted at the base of the wall approximately 30 metres northeast from the corner of 1<sup>st</sup> and 2<sup>nd</sup> Avenue. The outcrop was topped with a layer of concrete approximately 0.2 m thick that may have been used to create a leveling pad for the overlying boulder placement. At the northeast end bedrock became shallower and outcropped along the rock wall (Figure 4).

A 0.3 m thick row of concrete was visible extending horizontally along the 2<sup>nd</sup> Ave W rock wall from the base to about 0.6 m up the wall at the corner of 1<sup>st</sup> Street and 2<sup>nd</sup> Ave W (Figure 4). A 0.3 m thick row of concrete was also visible extending horizontally mid-way up the wall along the 1<sup>st</sup> Street portion in Figure 5. The original intent and details of the current condition of the concrete layers, including potential reinforcement and horizontal extent behind the rock wall, are unknown.

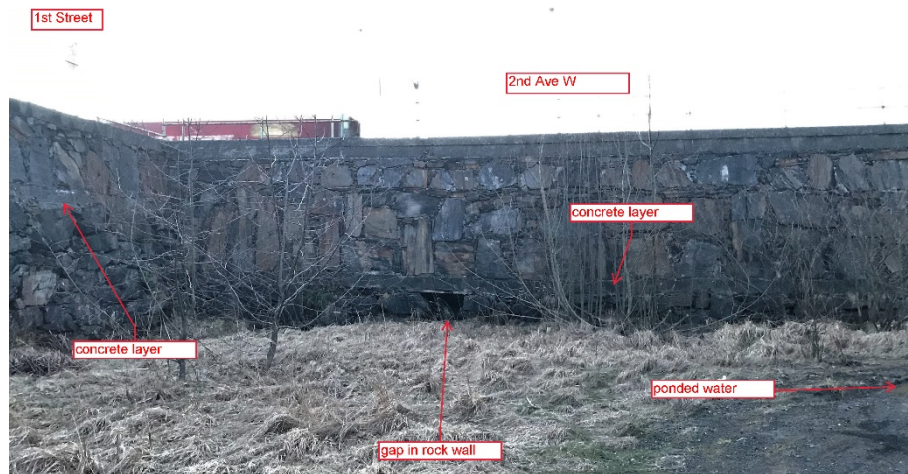
The parking area appeared to have poor drainage and ponded water was visible in the parking lot near the corner of 1<sup>st</sup> Street and 2<sup>nd</sup> Ave W. The surface water from the pond appeared to flow towards a gap in the base of the rock wall (Figure 5).

**Figure 5: View of rock wall at the corner of 1st Street and 2nd Ave with vegetation and gap visible in the base of the wall. Taken from the south end of the parking lot looking west.**
