Ministry of Environment
Inspection Record

EP System: <u>AMS</u>	Inspection Status: <u>FINAL</u>
System Number: <u>105809</u>	Inspection No: <u>23605</u>
EP System Status: <u>Active</u>	Inspection Date: <u>2015-11-14</u>
Region: <u>West Coast</u>	Office: <u>Nanaimo</u>
Trigger: <u>Incident</u>	Incidents of Non-Compliance Observed: <u>Yes</u>
Non-Compliance Decision Matrix Level: <u>Level 2</u>	Non-Compliance Decision Matrix Category: <u>Category A</u>
Inspector Name(s): <u>Laura Hunse</u>	Risk Ranking: <u>1 to 2 = Medium</u>
Audit: <u></u>	Total Non-Compliance(s): <u>2</u>
Regulated Party: <u>Cobble Hill Holdings (BC0754588)</u>	
Regulated Party Contact(s): <u>Marty Block (director), Pete Craig (SIRM operations manager)</u>	
Mailing Address: <u>Cobble Hill Holdings Ltd. (BC0754588) c/o Herald Street Law 101 - 536 Herald Street Victoria BC V8W S61</u>	
Phone No: <u>(250)743-3333</u>	Fax No: <u></u>
Contact Email: <u>marty.sia@shaw.ca</u>	
Location Description or Site Address: <u>460 Stebbings Road, Shawnigan Lake</u>

Authorization: PR-105809	Cobble Hill Holdings Ltd. (BC0754588)
CVIS IR #:	November 14, 2015 Site Inspection Photos

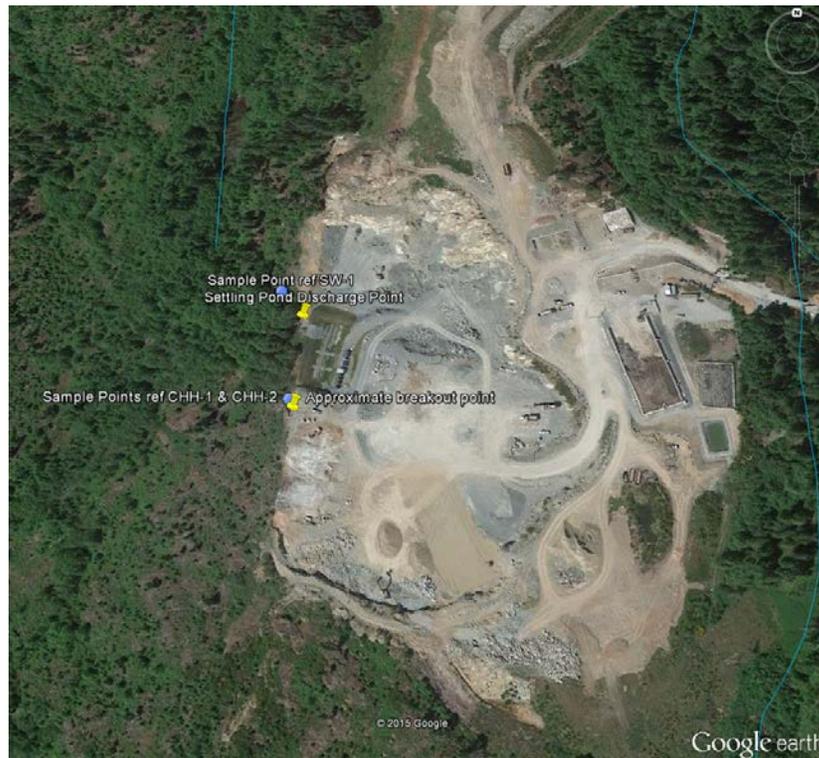
Photo 1
Site Map with approx. sample points for reference

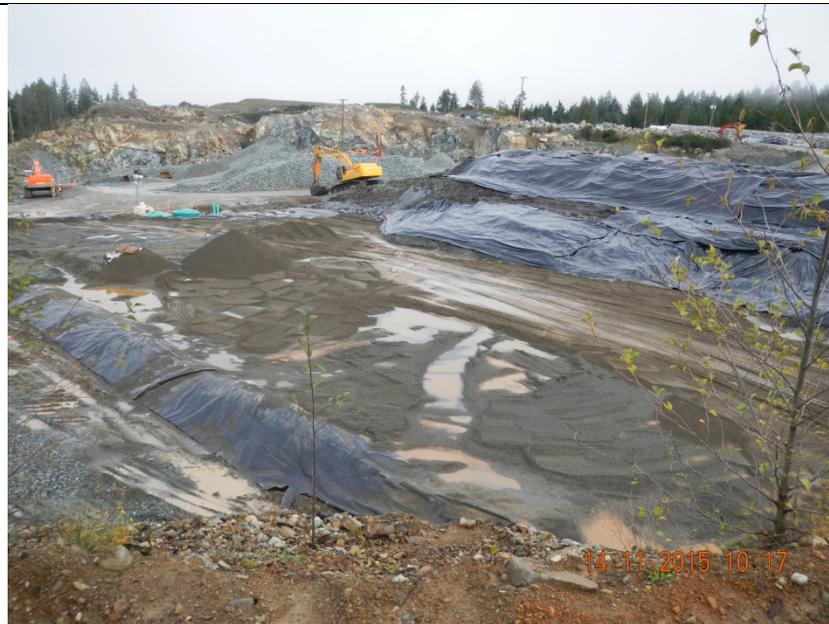
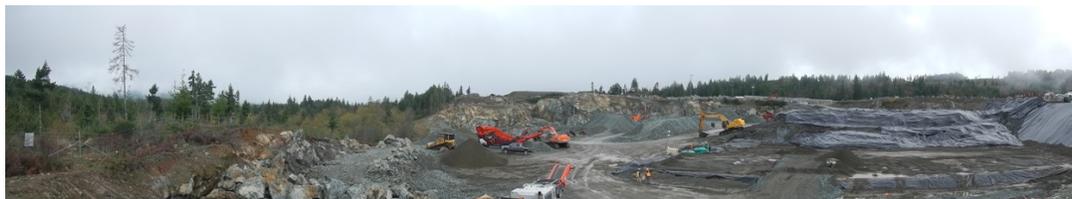
Photo 2
Contained landfill area and 180° view of site looking north (Nov 14)

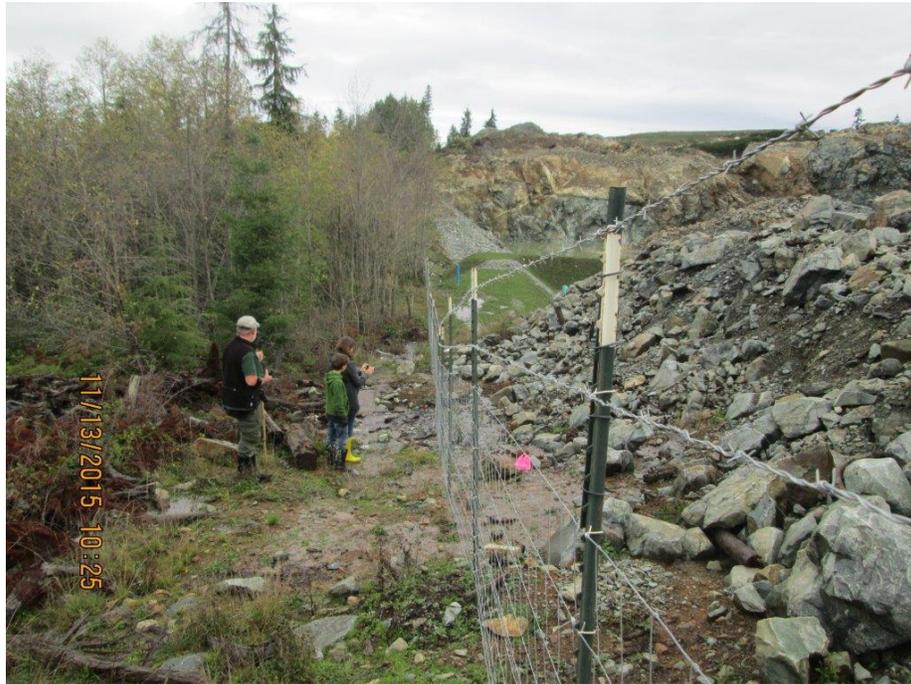
Photo 3
CVRD
Bylaw
photo from
Nov 13
a.m., prior
to channel
diversion
looking
north

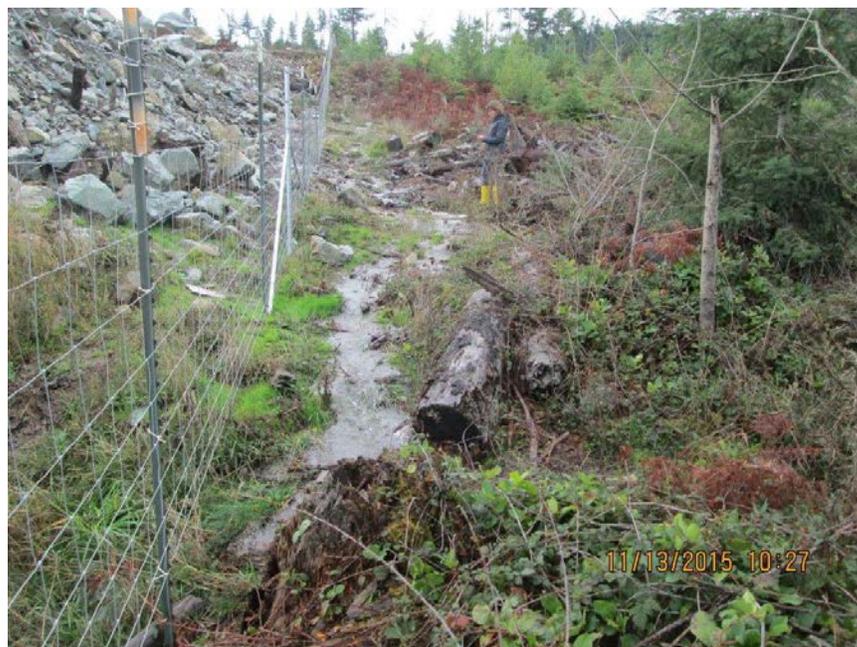
Photo 4
CVRD
Bylaw
photo from
Nov 13
a.m., prior
to channel
diversion
looking
south

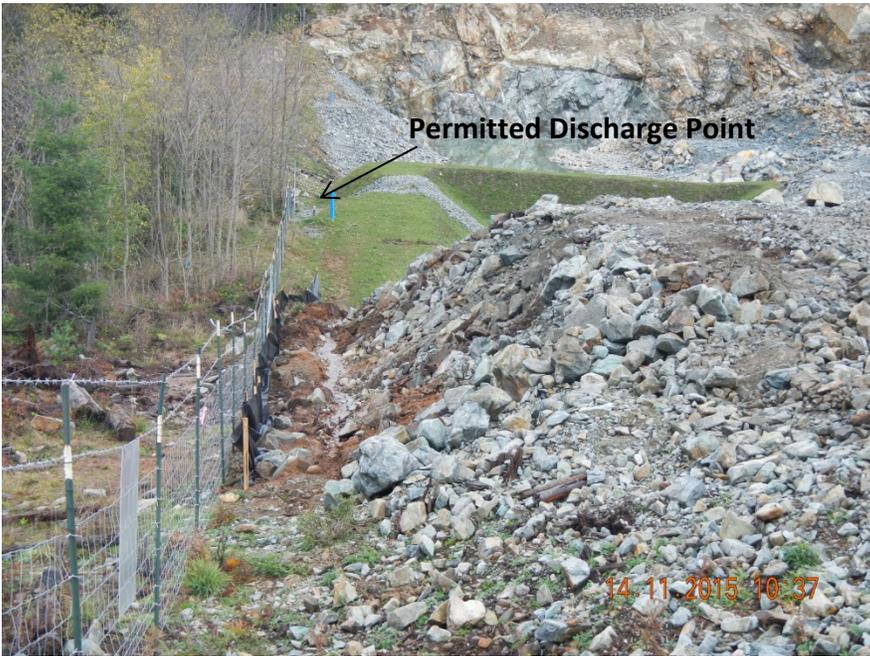
The water management system did not divert and channel the seepage from the toe of the disturbed earth and rock pile at the west boundary effectively to the settling pond at a time of high precipitation, i.e. works were not maintained in good working order in contravention with section 2.12 of the permit and in accordance with the Environmental Procedures Manual, Rev 1.0 (July 2015) sections 7.2 and 7.8. In further contravention of section 2.12, the permittee did not immediately notify the Director upon discovery of the water leaving the property boundary. Director was first notified by CVRD bylaw officer Nino Morano on the morning of the event. Permittee was cooperative and thoroughly responsive and took appropriate remedial action as required. Emergency procedures were followed as prescribed by the ERP.

<p>Photo 5</p> <p>Site of seepage. Ditching and silt fencing installed Nov 13</p>

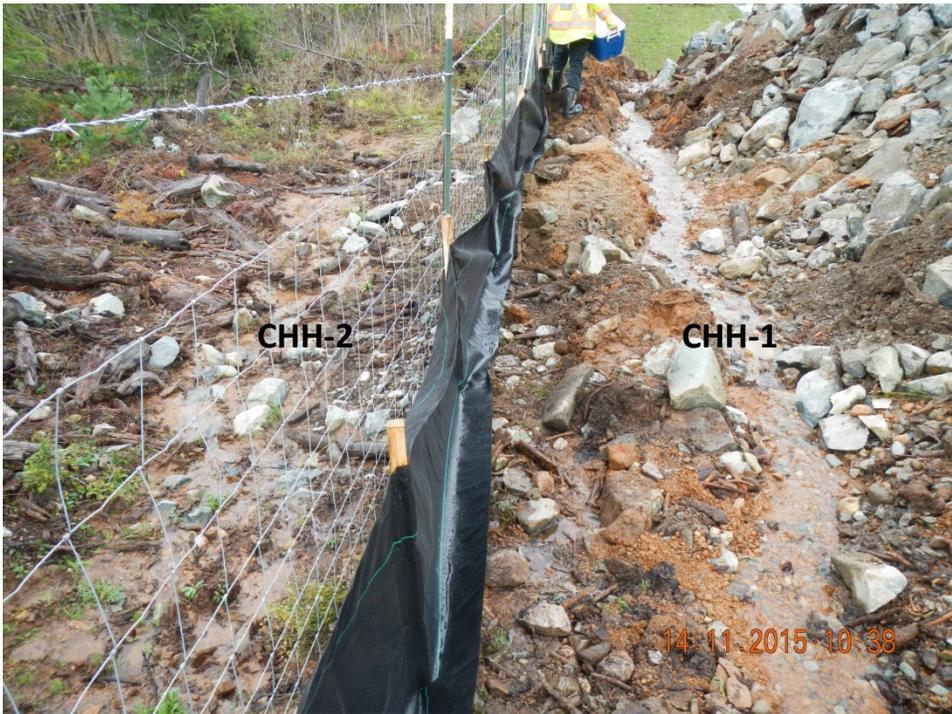
<p>Photo 6</p> <p>Nov 14 Sample sites on either side of western perimeter fence (CHH-1 – inside perimeter; CHH-2 – outside perimeter)</p>

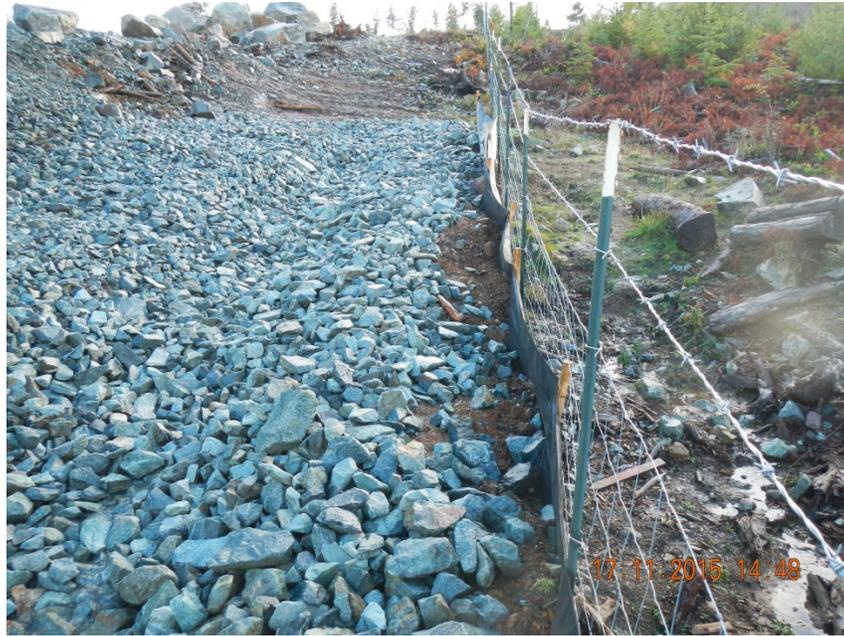
Photo 7
Nov 17 photo shows perimeter ditching lengthened, widened, lined with geotextile, and covered with clear crushed rock.

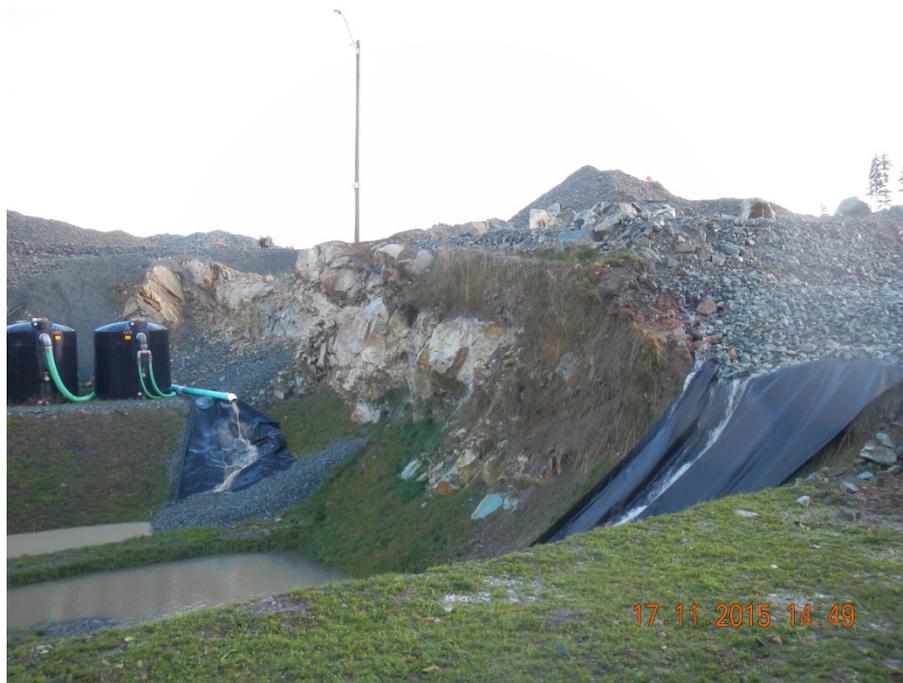
Photo 8
Nov 17 perimeter ditching channeling to settling pond

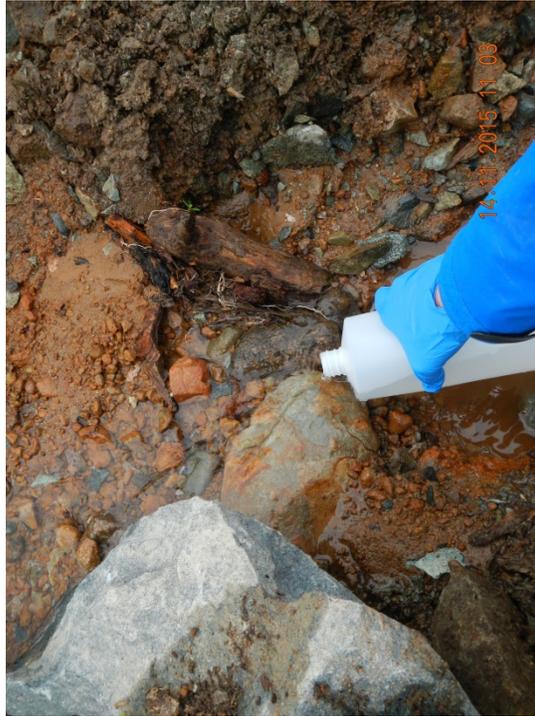
Photo 7

Sample CHH-1
inside west
perimeter fence
(Nov 14)

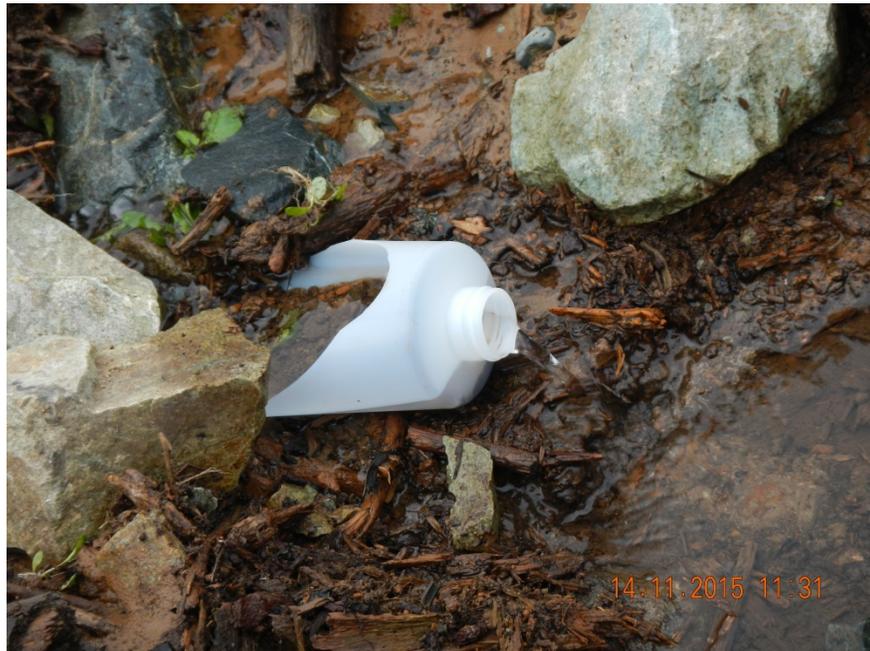
Photo 8

CHH-2 sample
site, outer
perimeter. Note
spout fashioned
from lab bottle to
allow sufficient
flow volume and
depth to sample
from trickle (Nov
14)

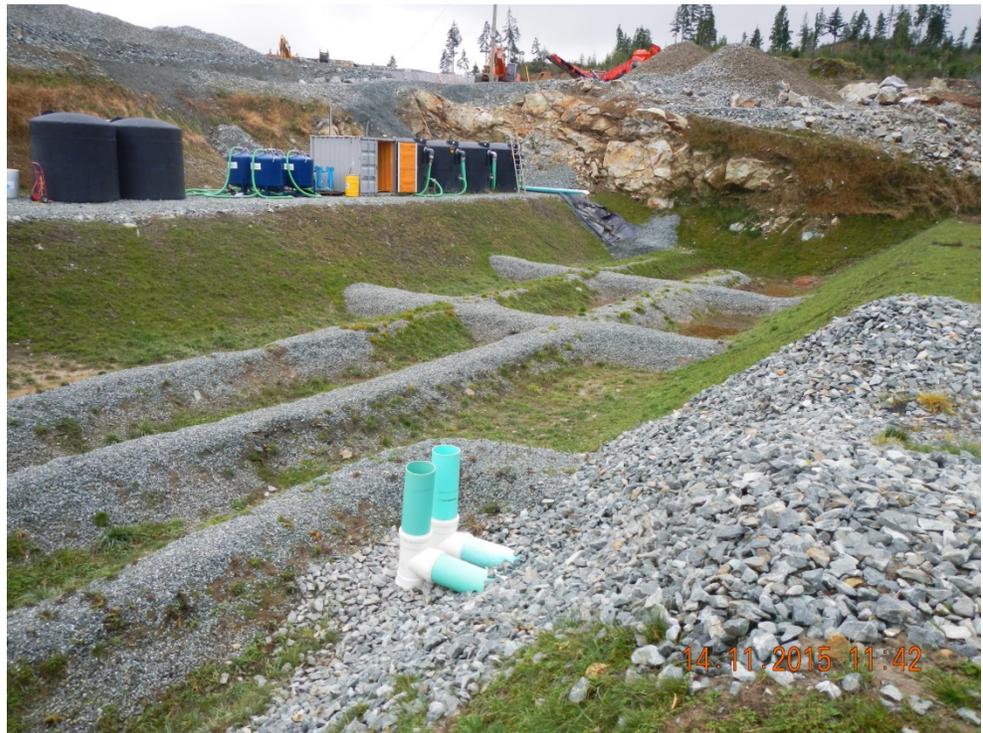
Photo 9

Settling pond on Nov 14. Note no significant standing water. Pond was discharging through outlet on the day previous to the inspection (Nov 13) during periods of high precipitation

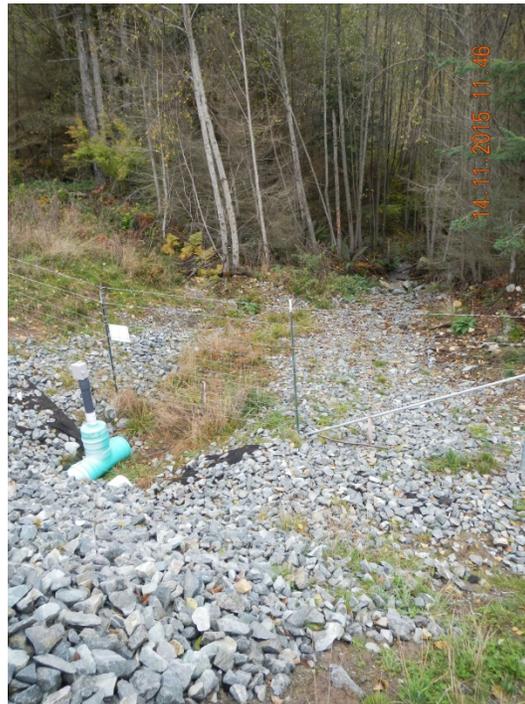
Photo 10

No flow from discharge point at time of inspection (Nov 14)

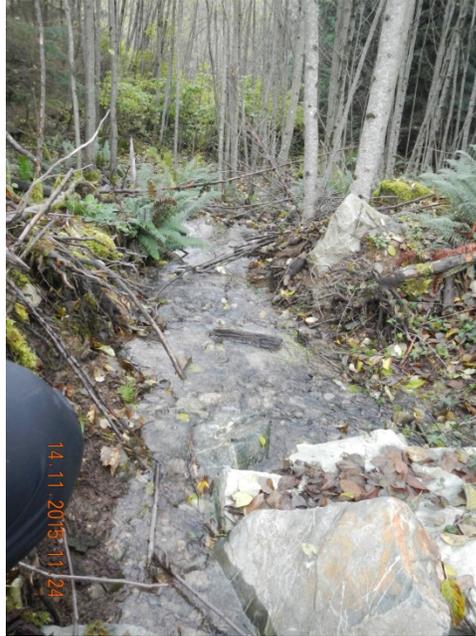
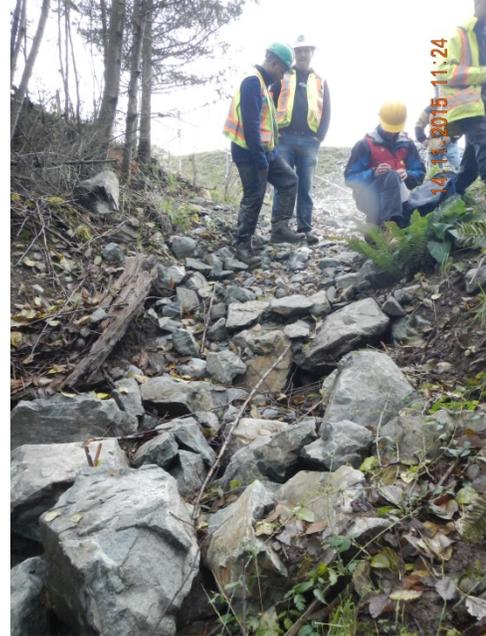
Photo 11

Nov 14 Sample site at ephemeral stream breakout point, approximately 15 m downstream of settling pond surface discharge point (Sample named SW-1)
