From: SPOMO1701@outlook.com
To: Environmental.Compliance ENV:EX; marty@chholdings.ca
Subject: SPO MO1701-Status Update October 30,, 2018
Date: Tuesday, October 30, 2018 10:12:16 PM
Attachments: [Oct 30, 2018 CHH Progress Report.pdf](#)

| FIELD REVIEW REPORT | | DATE: Oct 30, 2018 | ISLANDER PROJECT No.: 2087 |
| REPORT No: 31 | STAGE OF CONSTRUCTION: Landfill Closure | WEATHER: Sun 8°C | PAGE: 1 of 3 |
| PROJECT: Cobble Hill Landfill 2017 Minor Construction Works | | | |

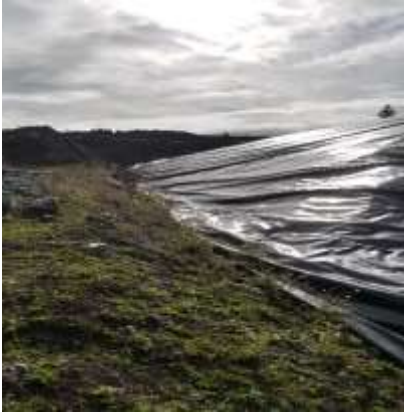
PEA – liner near NE corner

- **PEA**
 - Liner appears to be in good condition, with no noticeable changes since the date of our last inspection
- **Leachate and Leak Detention facility**
 - Total leachate collected: = 5.49 m³
 - Total leachate stored = 36.17 m³
 - Total leachate transported = 0 m³
- **Soil Management Area (SMA)**
 - All works are in good condition and no noticeable changes since the date of our last inspection
- **Contact Water Containment Pond**
 - All works are in good condition and no noticeable changes since the date of our last inspection
- **cut-off ditch upland of PEA**
 - All works are in good condition, ditch still performing well.
