| FIELD REVIEW REPORT | | DATE: Nov 15, 2018 | ISLANDER PROJECT No.: 2087 |
| REPORT No: 32 | STAGE OF CONSTRUCTION: Landfill Closure | WEATHER: Cloud 13°C | PAGE: 1 of 3 |
| PROJECT: Cobble Hill Landfill 2017 Minor Construction Works | | | |

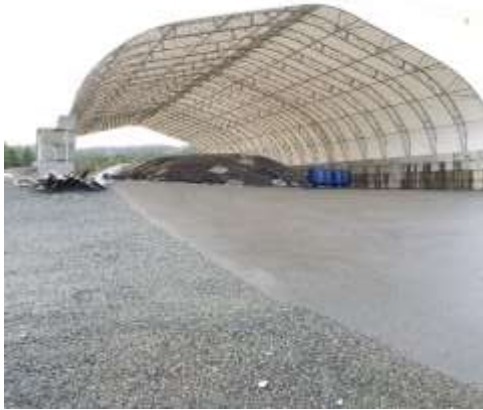
SMA - looking south

- **PEA**
 - Liner appears to be in good condition, with no noticeable changes since the date of our last inspection
- **Leachate and Leak Detention facility**
 - Total leachate collected: = 7.93 m³
 - Total leachate stored = 44.10 m³
 - Total leachate transported = 0 m³
- **Soil Management Area (SMA)**
 - All works are in good condition and no noticeable changes since the date of our last inspection
- **Contact Water Containment Pond**
 - All works are in good condition and no noticeable changes since the date of our last inspection
- **cut-off ditch upland of PEA**
 - All works are in good condition, ditch still performing well.
