| FIELD REVIEW REPORT | | DATE: Dec 15, 2018 | ISLANDER PROJECT No.: 2087 |
| REPORT No: 34 | STAGE OF CONSTRUCTION: Landfill Closure | WEATHER: Cloud 5°C | PAGE: 1 of 3 |
| PROJECT: Cobble Hill Landfill 2017 Minor Construction Works | | | |

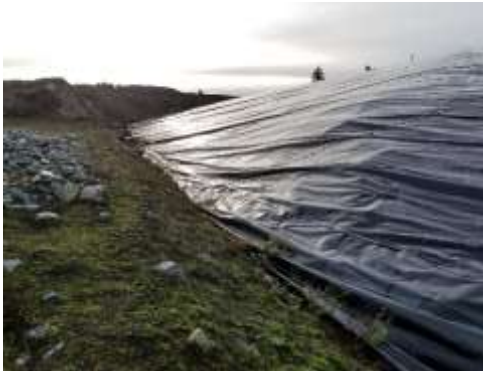
PEA – liner near NE corner

- **PEA**
 - Liner appears to be in good condition, with no noticeable changes since the date of our last inspection
- **Leachate and Leak Detention facility**
 - Total leachate collected: = 5.69 m³
 - Total leachate stored = 54.67 m³
 - Total leachate transported = 0 m³
- **Soil Management Area (SMA)**
 - All works are in good condition and no noticeable changes since the date of our last inspection
- **Contact Water Containment Pond**
 - All works are in good condition and no noticeable changes since the date of our last inspection
- **cut-off ditch upland of PEA**
 - All works are in good condition, ditch still performing well.
