**From:** [SPOMO1701@outlook.com](mailto:SPOMO1701@outlook.com)  
**To:** [Environmental.Compliance ENV:EX; marty@chholdings.ca](mailto:Environmental.Compliance ENV:EX; marty@chholdings.ca)  
**Subject:** SPO MO1701-Status Update December 30, 2018  
**Date:** Monday, December 31, 2018 6:51:59 PM  
**Attachments:** [Dec 30, 2018 CHH Progress Report.pdf](#)

<b>FIELD REVIEW REPORT</b>		DATE: <b>Dec 30, 2018</b>	ISLANDER PROJECT No.: <b>2087</b>
REPORT No: <b>35</b>	STAGE OF CONSTRUCTION: <b>Landfill Closure</b>	WEATHER: <b>Cloud 3°C</b>	PAGE: <b>1 of 3</b>
PROJECT: <b>Cobble Hill Landfill 2017 Minor Construction Works</b>			
TO: <b>CHH</b>	ATTENTION: <b>Marty Block</b>		
CC:

The field review included the inspection of the following items included in the detailed summary of works section of the *Cobble Hill Landfill — 2017 Minor Construction Works, Detailed Construction Plan (Sperling Hansen Associates, September 13, 2017)*:

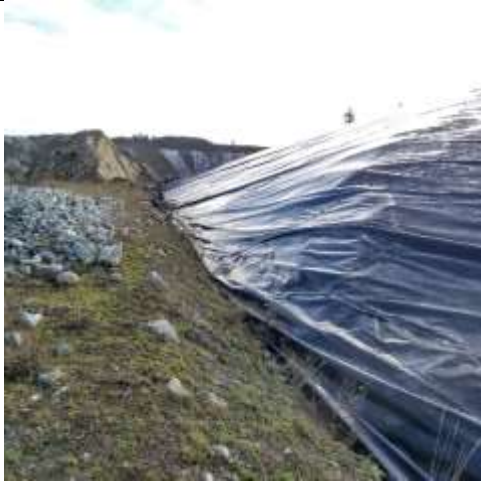
**PEA – liner near NE corner**

- **PEA**
  - Liner appears to be in good condition, with no noticeable changes since the date of our last inspection
- **Leachate and Leak Detention facility**
  - Total leachate collected: = 5.28 m<sup>3</sup>
  - Total leachate stored = 59.95 m<sup>3</sup>
  - Total leachate transported = 0 m<sup>3</sup>
- **Soil Management Area (SMA)**
  - All works are in good condition and no noticeable changes since the date of our last inspection
- **Contact Water Containment Pond**
  - All works are in good condition and no noticeable changes since the date of our last inspection
- **cut-off ditch upland of PEA**
  - All works are in good condition, ditch still performing well.
