**From:** [SPOMO1701@outlook.com](mailto:SPOMO1701@outlook.com)  
**To:** [Environmental.Compliance ENV:EX; marty@chholdings.ca](mailto:Environmental.Compliance ENV:EX; marty@chholdings.ca)  
**Subject:** SPO MO1701-Status Update January 30, 2019  
**Date:** Wednesday, January 30, 2019 11:04:37 PM  
**Attachments:** [Jan 30, 2019 CHH Progress Report.pdf](#)

<b>FIELD REVIEW REPORT</b>		DATE: <b>Jan 30, 2019</b>	ISLANDER PROJECT No.: <b>2087</b>
REPORT No: <b>37</b>	STAGE OF CONSTRUCTION: <b>Landfill Closure</b>	WEATHER: <b>Clouds 7°C</b>	PAGE: <b>1 of 3</b>
PROJECT: <b>Cobble Hill Landfill 2017 Minor Construction Works</b>			
TO: <b>CHH</b>	ATTENTION: <b>Marty Block</b>		
CC:

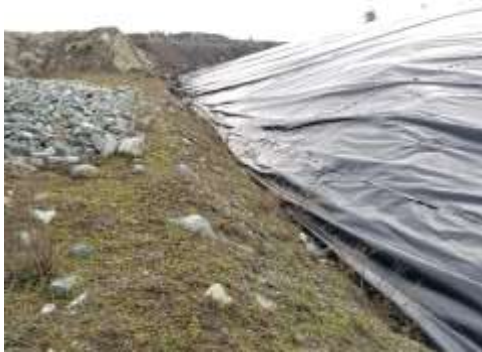
**PEA – liner near NE corner**

- **PEA**
  - Liner appears to be in good condition, with no noticeable changes since the date of our last inspection
- **Leachate and Leak Detention facility**
  - Total leachate collected: = 3.30 m<sup>3</sup>
  - Total leachate stored = 5.28 m<sup>3</sup>
  - Total leachate transported = 62.04 m<sup>3</sup>
- **Soil Management Area (SMA)**
  - All works are in good condition and no noticeable changes since the date of our last inspection
- **Contact Water Containment Pond**
  - All works are in good condition and no noticeable changes since the date of our last inspection
- **cut-off ditch upland of PEA**
  - All works are in good condition, ditch still performing well.
