Report Number: 057193

**Re: An Investigation Referral, Spill Prevention Order MO1701, 460 Stebbings Road, Malahat, BC V0R 2L0 Contaminated Landfill Soil Leachate Collection System, Effluent**

Authorization: MO1701	Cobble Hill Holdings Ltd. near Shawnigan Lake, BC
NRIS IR #: 57192	June 15, 2017 Site Inspection Photos

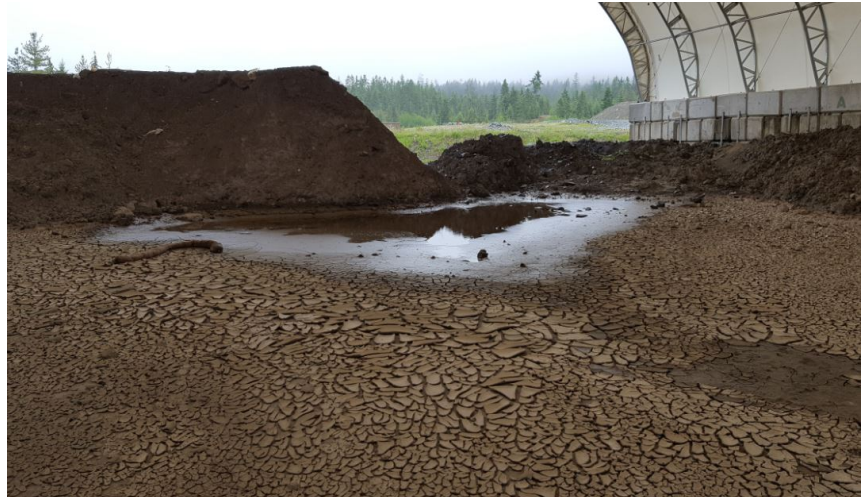
Photo 1

Viewing southwest towards the Leachate in the SMA.

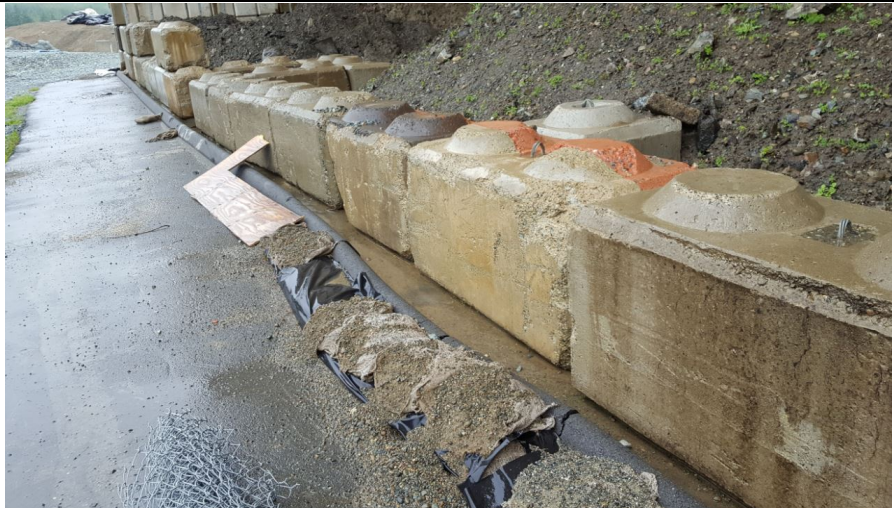
Photo 2

Viewing west towards the SMA where the containment berm issues were observed.

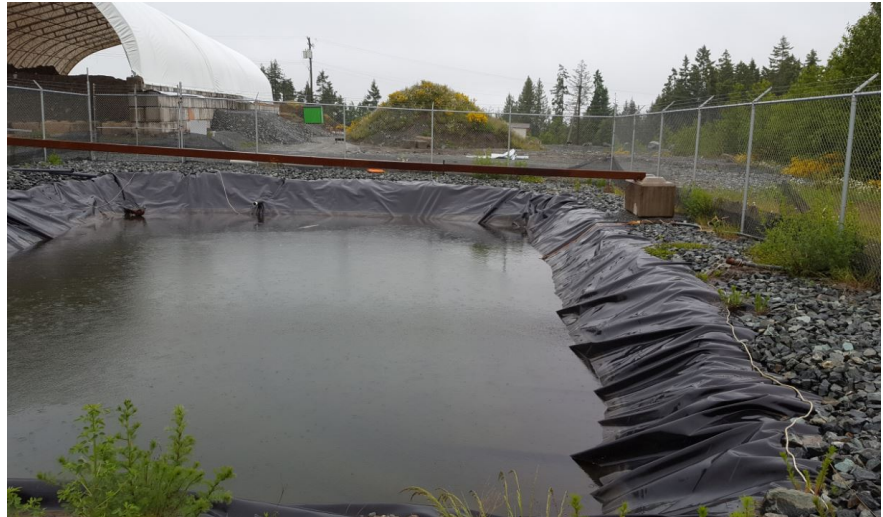
Photo 4

Details/Findings:	<p>The collection and temporary storage of Leachate at the Facility was not carried out sufficiently as leachate was observed discharging into the environment via the tear in the landfill cell liner.</p> <p>In addition to this, the volume of water within the containment pond appeared to be lower than the last time the site was inspected on April 6, 2017 (Photo #4). As noted in the previous inspection, there have been discrepancies identified over the leachate volumes being reported. This, in conjunction with the lowered levels of leachate observed in the containment pond, has warranted further investigation. For this reason, the records of the volume of Leachate collected, stored and transported off-site were requested.</p>
Compliance:	Out
Actions to be taken:	<p>SIRM immediately sent out a labour crew to control the leak in the landfill cell liner. The discharge from the tear in the liner was stopped by SIRM staff shortly after the inspection on June 15, 2017. Rahim Gaidhar (SIRM) provided a follow-up report (via email) of the repair work completed to the liner on June 19, 2017.</p> <p>As the last inspection was completed in April, there should be no additional sag in the containment pond liner due to the previously noted frost heave. Please provide the rationale as to why the levels in the containment pond have decreased from the inspection completed on April 6, 2017 to June 15, 2017.</p>

Viewing north towards the containment pond.

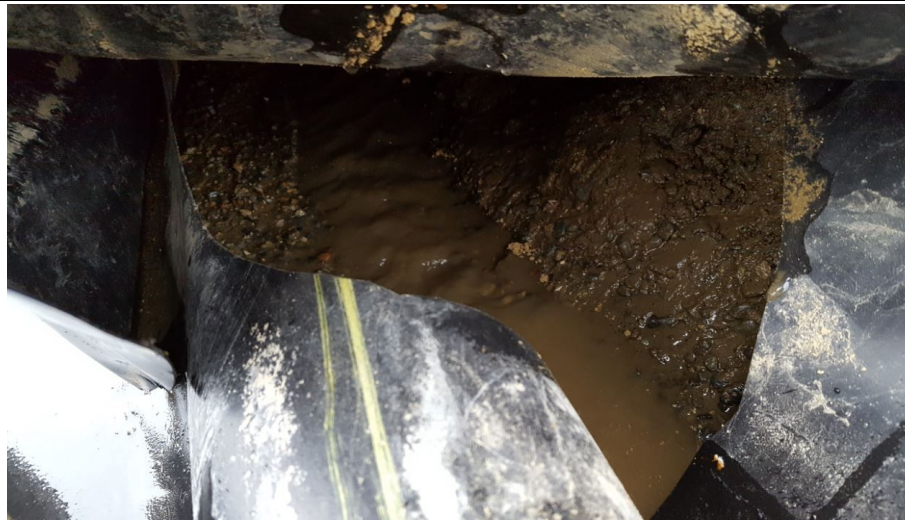
Photo 5

1.a - The landfill cell liner was not secured and impermeable due to some tears resulting in a discharge of Leachate into the environment

Viewing the tear in the landfill cell liner and the associated stormwater flow entering the landfill cell.

Compliance:	Out
Actions to be taken:	<p>Please continue to complete regular inspections of the landfill cell liner on-site and patch up any existing tears and/or openings currently visible on the surface of the liner.</p>

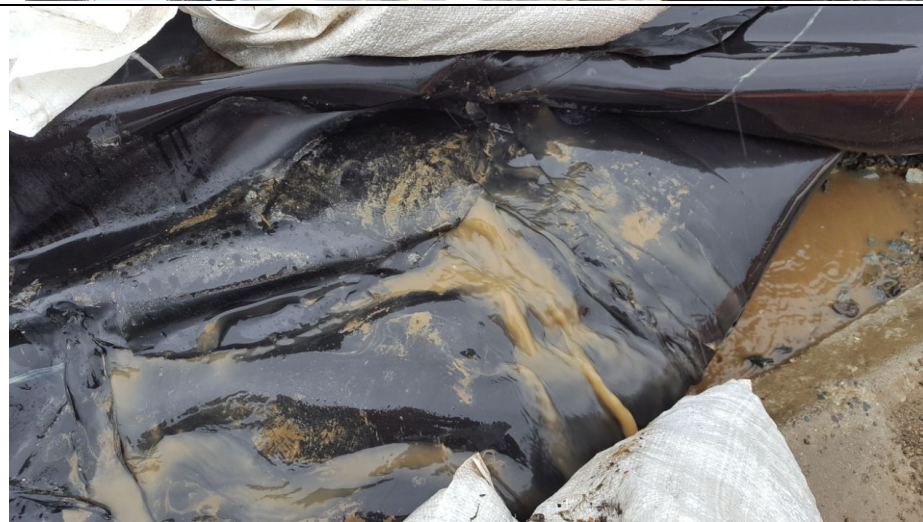
Photo 6

Viewing the Leachate discharge location from the north side of the landfill cell liner.

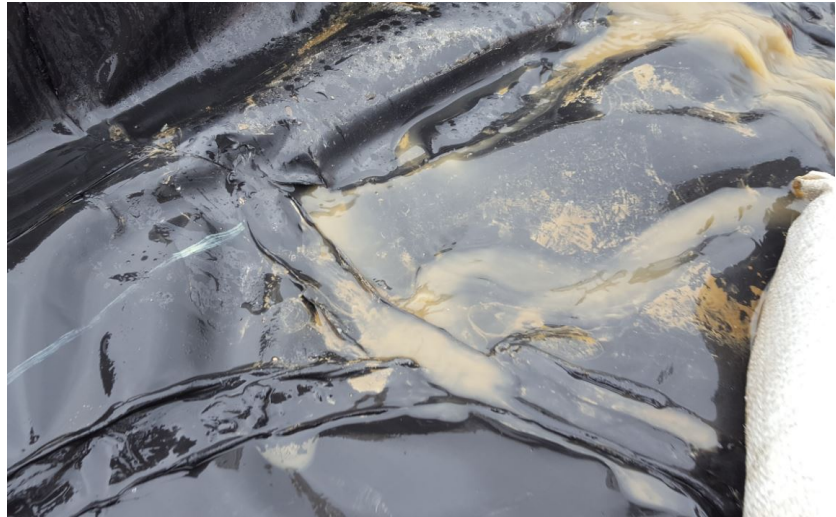
Photo 7

1.c - The landfill cell liner was not maintained in good working order resulting in a discharge of Leachate into the environment

Viewing the tear along the weld where leachate was observed discharging to ground.

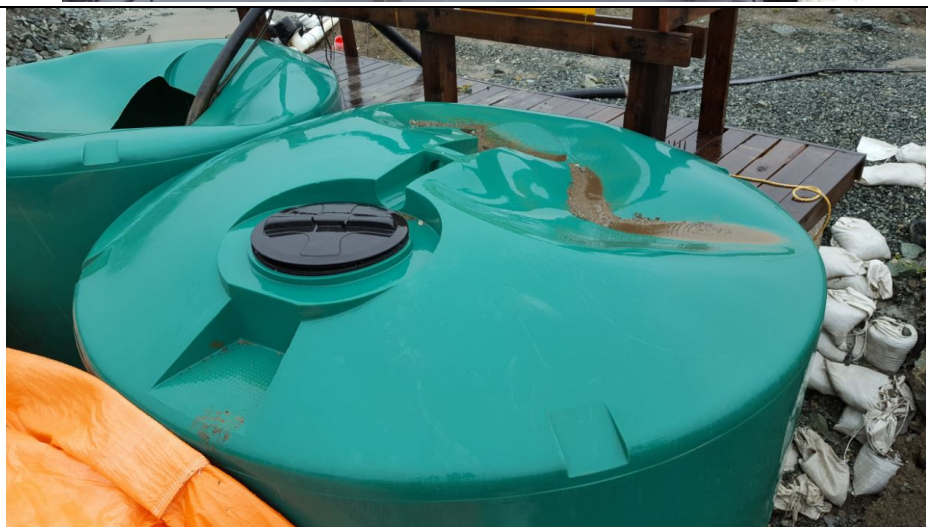
Photo 8

Viewing the uncovered leak detection tank.

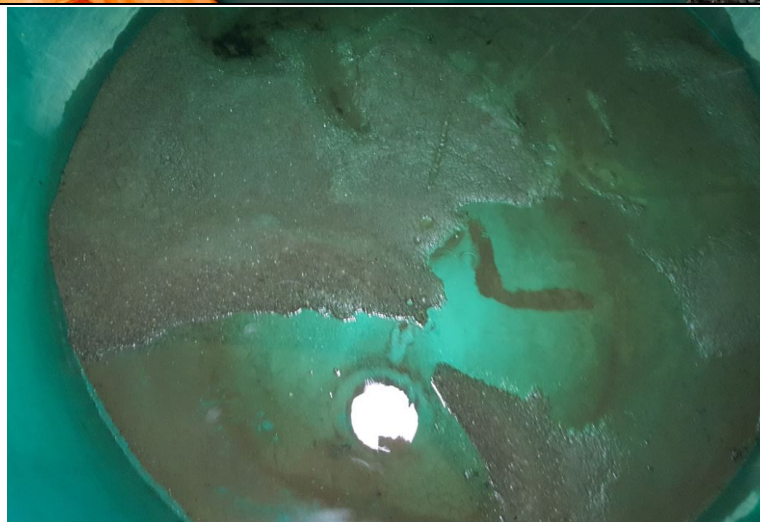
Photo 9

Viewing inside of the leak detection tank.
