Report Number: 056323

Re: Warning Letter, Spill Prevention Order MO1701

Authorization: MO1701	Cobble Hill Holdings Ltd. near Shawnigan Lake, BC
NRIS IR #: 56323	May 18, 2017 Site Inspection Photos

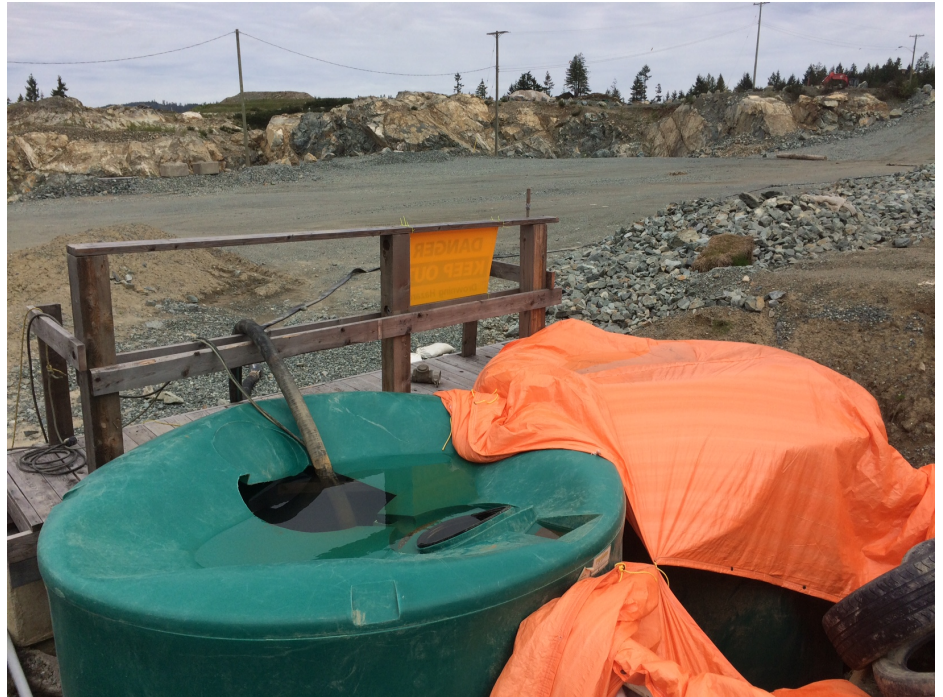
Photo 1

Details/Findings:	<p>On May 18, 2017, Director AJ Downie (Mr. Downie), accompanied by Hemmera Envirochem Inc. staff, were on-site completing a visual inspection of the landfill cell. During the visual inspection, Mr. Downie observed that the leachate collection tank was at capacity (See Photo 1).</p> <p>Following the inspection, Mr. Downie informed Environmental Protection Officer, Connor Fraleigh (EPO Fraleigh), of the inspection findings. EPO Fraleigh contacted Rahim Gaidhar (SIRM) via phone at 4:55 PM on May 18, 2017, regarding the leachate collection tank and the leak detection piping. Mr. Gaidhar was not aware that the leachate collection tank was at capacity or that damage had occurred to the leak detection piping. Mr. Gaidhar told EPO Fraleigh that he would contact the on-site staff immediately and have the leachate collection tank pumped up to the collection pond (it was scheduled to be pumped out on May 19, 2017). It was confirmed that the tank had been pumped out in an email from Mr. Gaidhar on May 18, 2017.</p>

Viewing northeast towards the leachate collection tank which is at capacity.

Compliance:	In
Actions to be taken:	Please ensure that the leachate collection works are inspected on a more frequent basis so as to prevent an escape or spill of leachate into the environment.
Requirement Description:	1. c: All works for the collection and temporary storage of Leachate generated at the Facility are inspected regularly and maintained in good working order; and
Details/Findings:	<p>During the visual inspection, Mr. Downie observed that the piping that leads from the landfill cell to the leak detection tank had been severed (See Photo 2). On May 19, 2017, a field crew was dispatched to repair the leak detection piping. The leak detection piping was repaired on May 19, 2017, and modification to the works was finalized on May 20, 2017. Photographs of the completed repair work were provided by Mr. Gaidhar via email on May 21, 2017.</p>
Compliance:	Out
Actions to be taken:	Please ensure that the leachate collection works are inspected on a more frequent basis so as to prevent an escape or spill of leachate into the environment.

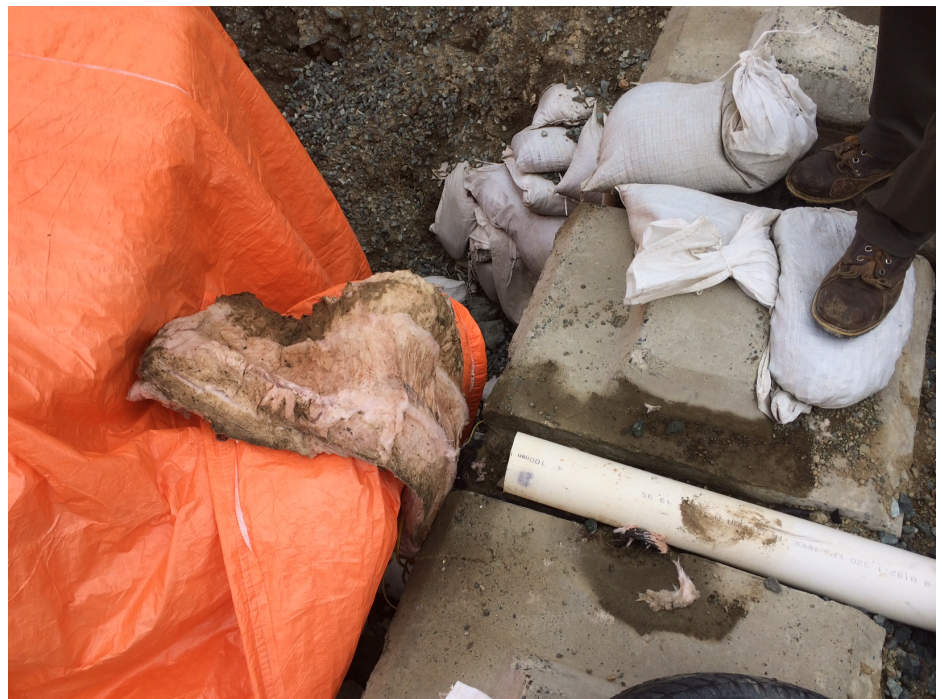
Photo 2

Section 1. c. - All works for the collection and temporary storage of leachate were not maintained in good working order, specifically, the leak detection piping had been disconnected from the collection tank.

Viewing the disconnected leak detection system piping.
