**From:** [SPOMO1701@outlook.com](mailto:SPOMO1701@outlook.com)  
**To:** [Environmental.Compliance ENV:EX; marty@chholdings.ca](mailto:Environmental.Compliance ENV:EX; marty@chholdings.ca)  
**Subject:** SPO MO1701-Status Update February 15, 2019  
**Date:** February 15, 2019 22:04:34  
**Attachments:** [Feb 15, 2019 CHH Progress Report.pdf](#)

<b>FIELD REVIEW REPORT</b>		DATE: <b>Feb 15, 2019</b>	ISLANDER PROJECT No.: <b>2087</b>
REPORT No: <b>38</b>	STAGE OF CONSTRUCTION: <b>Landfill Closure</b>	WEATHER: <b>Snow 0°C</b>	PAGE: <b>1 of 3</b>
PROJECT: <b>Cobble Hill Landfill 2017 Minor Construction Works</b>			
TO: <b>CHH</b>	ATTENTION: <b>Marty Block</b>		
CC:

The field review included the inspection of the following items included in the detailed summary of works section of the *Cobble Hill Landfill — 2017 Minor Construction Works, Detailed Construction Plan (Sperling Hansen Associates, September 13, 2017)*:

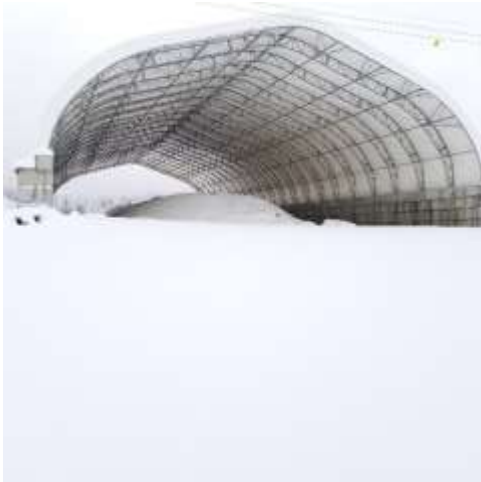
**SMA - looking south**

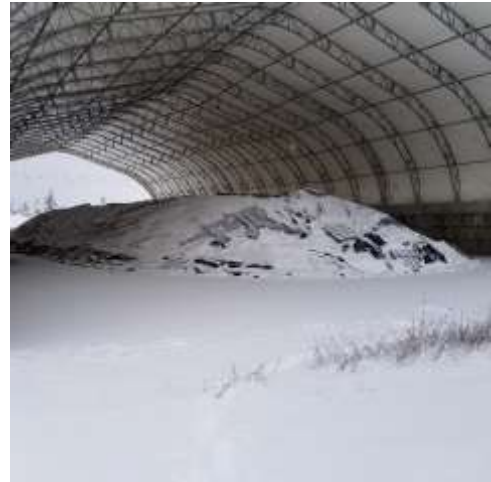
**SMA – looking north**

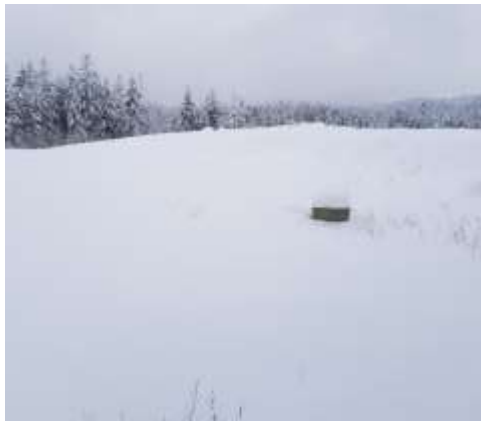
**Contact water containment Pond**

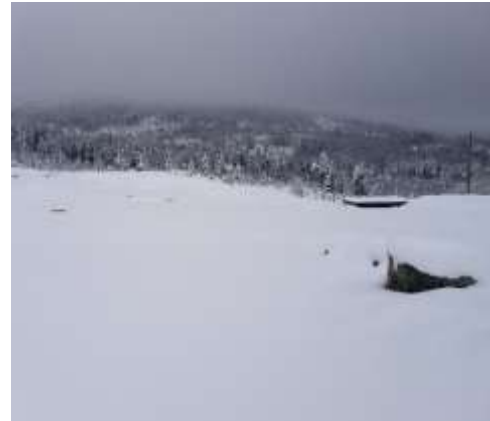
**Leak and leachate detection works**

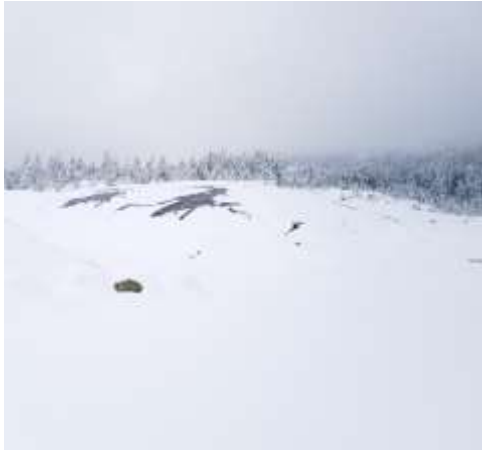
- **PEA**
  - Liner appears to be in good condition, with no noticeable changes since the date of our last inspection
- **Leachate and Leak Detention facility**
  - Total leachate collected: = 2.03 m<sup>3</sup>
  - Total leachate stored = 7.31 m<sup>3</sup>
  - Total leachate transported = 0 m<sup>3</sup>
- **Soil Management Area (SMA)**
  - All works are in good condition and no noticeable changes since the date of our last inspection
- **Contact Water Containment Pond**
  - All works are in good condition and no noticeable changes since the date of our last inspection
- **cut-off ditch upland of PEA**
  - All works are in good condition, ditch still performing well.

**PEA – liner near NE face**

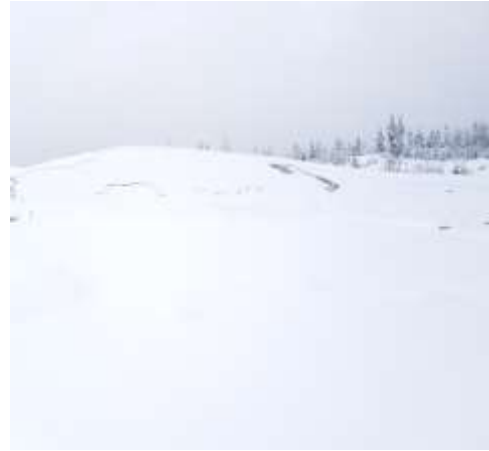
**PEA– North face**
