**From:** [SPOMO1701@outlook.com](mailto:SPOMO1701@outlook.com)  
**To:** [Environmental.Compliance.ENV:EX:marty@chholdings.ca](mailto:Environmental.Compliance.ENV:EX:marty@chholdings.ca)  
**Subject:** SPO MO1701-Status Update April 30, 2019  
**Date:** April 30, 2019 20:03:35  
**Attachments:** [CHH Status Report April 30, 2019.pdf](#)

<b>FIELD REVIEW REPORT</b>		DATE: <b>April 30, 2019</b>	ISLANDER PROJECT No.: <b>2087</b>
REPORT No: <b>43</b>	STAGE OF CONSTRUCTION: <b>Landfill Closure</b>	WEATHER: <b>Sun 17°C</b>	PAGE: <b>1 of 3</b>
PROJECT: <b>Cobble Hill Landfill 2017 Minor Construction Works</b>			
TO: <b>CHH</b>	ATTENTION: <b>Marty Block</b>		
CC:

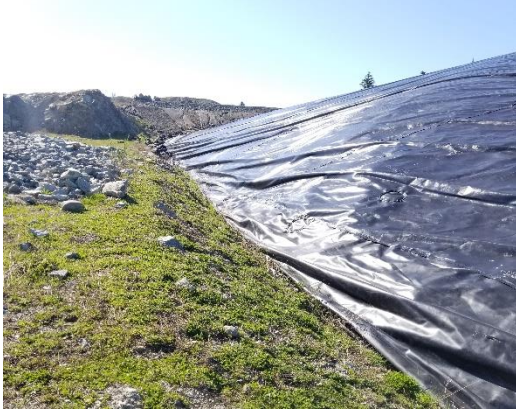
**PEA – liner near NE corner**

- **PEA**
  - Liner appears to be in good condition, with no noticeable changes since the date of our last inspection
- **Leachate and Leak Detention facility**
  - Total leachate collected: = 2.44 m<sup>3</sup>
  - Total leachate stored = 29.06 m<sup>3</sup>
  - Total leachate transported = 0 m<sup>3</sup>
- **Soil Management Area (SMA)**
  - All works are in good condition and no noticeable changes since the date of our last inspection
- **Contact Water Containment Pond**
  - All works are in good condition and no noticeable changes since the date of our last inspection
- **cut-off ditch upland of PEA**
  - All works are in good condition, ditch still performing well.
