**From:** SPOMO1701@outlook.com <SPOMO1701@outlook.com>  
**Sent:** Tuesday, July 2, 2019 11:14 PM  
**To:** EnvironmentalCompliance@gov.bc.ca; marty@chholdings.ca  
**Subject:** SPO MO1701-Status Update June 30, 2019

<b>FIELD REVIEW REPORT</b>		DATE: <b>JUNE 30, 2019</b>	ISLANDER PROJECT No.: <b>2087</b>
REPORT No: <b>47</b>	STAGE OF CONSTRUCTION: <b>Landfill Closure</b>	WEATHER: <b>Sun 24°C</b>	PAGE: <b>1 of 3</b>
PROJECT: <b>Cobble Hill Landfill 2017 Minor Construction Works</b>			
TO: <b>CHH</b>	ATTENTION: <b>Marty Block</b>		
CC:

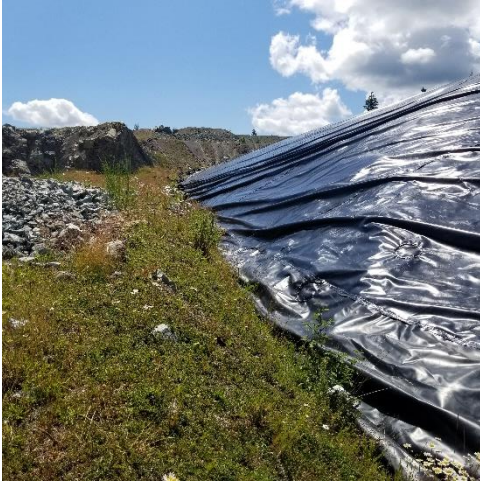
- **PEA**
  - Liner appears to be in good condition, with no noticeable changes since the date of our last inspection
- **Leachate and Leak Detention facility**
  - Total leachate collected: = 1.42 m<sup>3</sup>
  - Total leachate stored = 36.58 m<sup>3</sup>
  - Total leachate transported = 0 m<sup>3</sup>
- **Soil Management Area (SMA)**
  - All works are in good condition and no noticeable changes since the date of our last inspection
- **Contact Water Containment Pond**
  - All works are in good condition and no noticeable changes since the date of our last inspection
- **cut-off ditch upland of PEA**
  - All works are in good condition, ditch still performing well.

**PEA – liner near NE corner**
