From: SPOMO1701@outlook.com
To: [Environmental Compliance ENV:EX; marty@chholdings.ca](#)
Subject: SPO MO1701-Status Update March 30, 2019
Date: April 1, 2019 20:50:23
Attachments: [CHH Status Report Mar 30, 2019.pdf](#)

FIELD REVIEW REPORT		DATE: March 30, 2019	ISLANDER PROJECT No.: 2087
REPORT No: 41	STAGE OF CONSTRUCTION: Landfill Closure	WEATHER: Sun 17.5°C	PAGE: 1 of 3
PROJECT: Cobble Hill Landfill 2017 Minor Construction Works			
TO: CHH	ATTENTION: Marty Block		
CC:

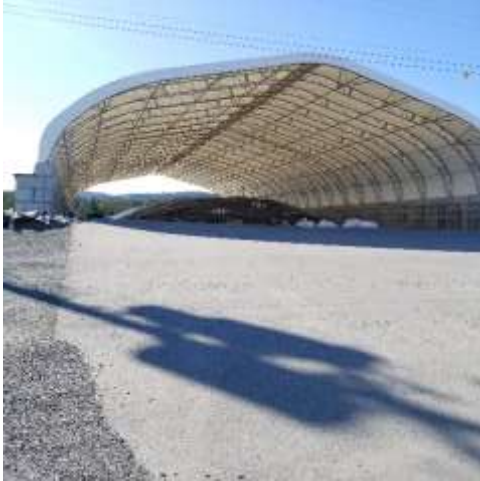
SMA - looking south

- **PEA**
 - Liner appears to be in good condition, with no noticeable changes since the date of our last inspection
- **Leachate and Leak Detention facility**
 - Total leachate collected: = 5.59 m³
 - Total leachate stored = 22.86 m³
 - Total leachate transported = 0 m³
- **Soil Management Area (SMA)**
 - All works are in good condition and no noticeable changes since the date of our last inspection
- **Contact Water Containment Pond**
 - All works are in good condition and no noticeable changes since the date of our last inspection
- **cut-off ditch upland of PEA**
 - All works are in good condition, ditch still performing well.
