From: SPOMO1701@outlook.com
To: [Environmental Compliance ENV:EX; marty@chholdings.ca](#)
Subject: SPO MO1701-Status Update May 15, 2019
Date: May 15, 2019 20:05:06
Attachments: [CHH Status Report May 15, 2019.pdf](#)

FIELD REVIEW REPORT		DATE: May 15, 2019	ISLANDER PROJECT No.: 2087
REPORT No: 44	STAGE OF CONSTRUCTION: Landfill Closure	WEATHER: Rain 16°C	PAGE: 1 of 3
PROJECT: Cobble Hill Landfill 2017 Minor Construction Works			
TO: CHH	ATTENTION: Marty Block		
CC:

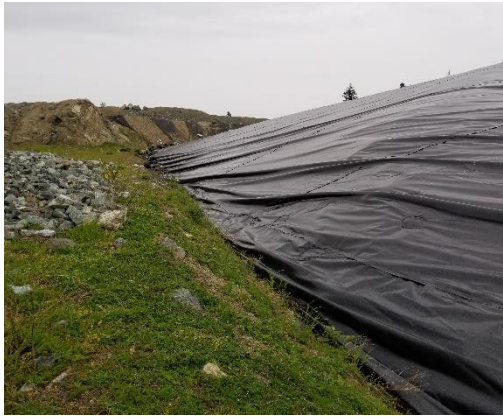
PEA – liner near NE corner

- **PEA**
 - Liner appears to be in good condition, with no noticeable changes since the date of our last inspection
- **Leachate and Leak Detention facility**
 - Total leachate collected: = 1.83 m³
 - Total leachate stored = 30.89 m³
 - Total leachate transported = 0 m³
- **Soil Management Area (SMA)**
 - All works are in good condition and no noticeable changes since the date of our last inspection
- **Contact Water Containment Pond**
 - All works are in good condition and no noticeable changes since the date of our last inspection
- **cut-off ditch upland of PEA**
 - All works are in good condition, ditch still performing well.
