SITE INSPECTION REPORT

Cobble Hill Landfill Closure

PROJECT # : PRJ18074

File #: 18074- SIR#1

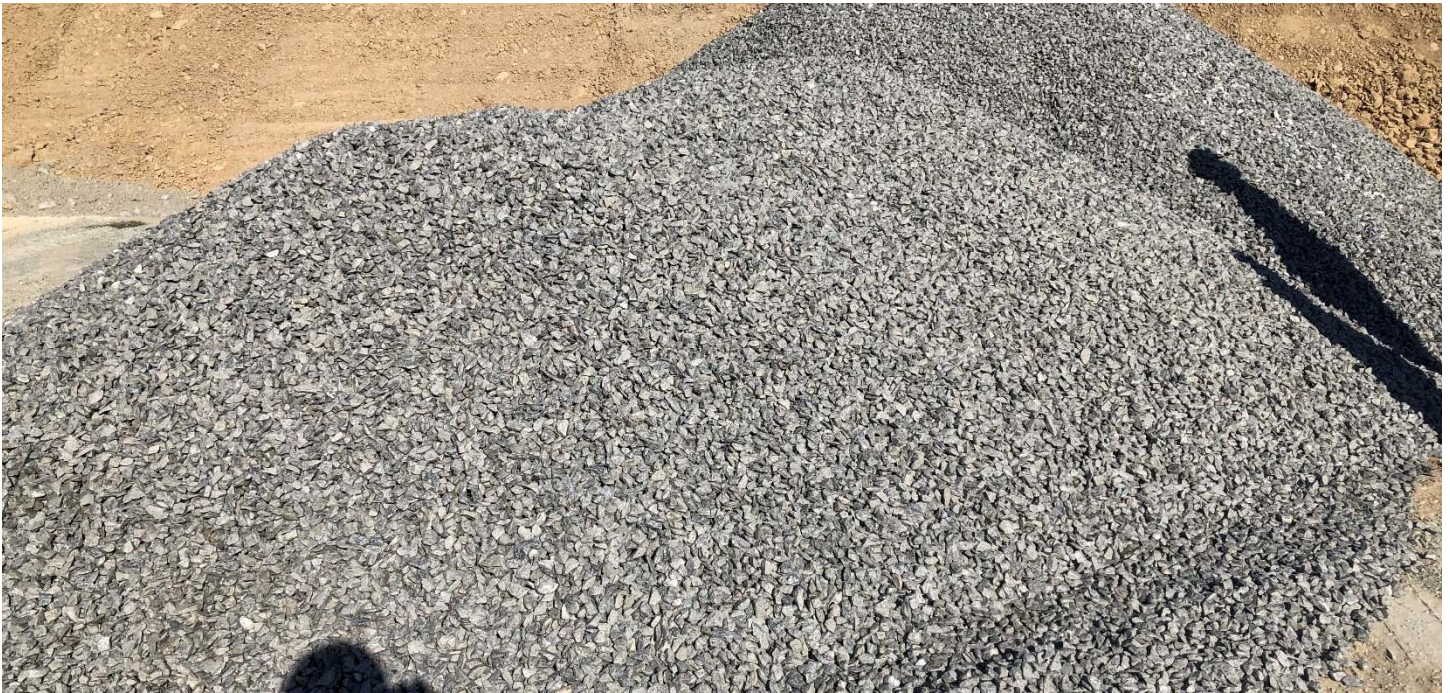
Picture # 1: SHA visually inspected the stockpile of proposed clear crush drainage gravel. SHA visual inspection of the material confirmed that the rock is uniform in quality, angular in nature, and free from excesses of flat and elongated particles, organic material, salt, and foreign objects. The material appears to be washed to eliminate fines. The material appears suitable for proposed use as the 200 mm thick drainage layer in the permanent encapsulation area (PEA) cover system.

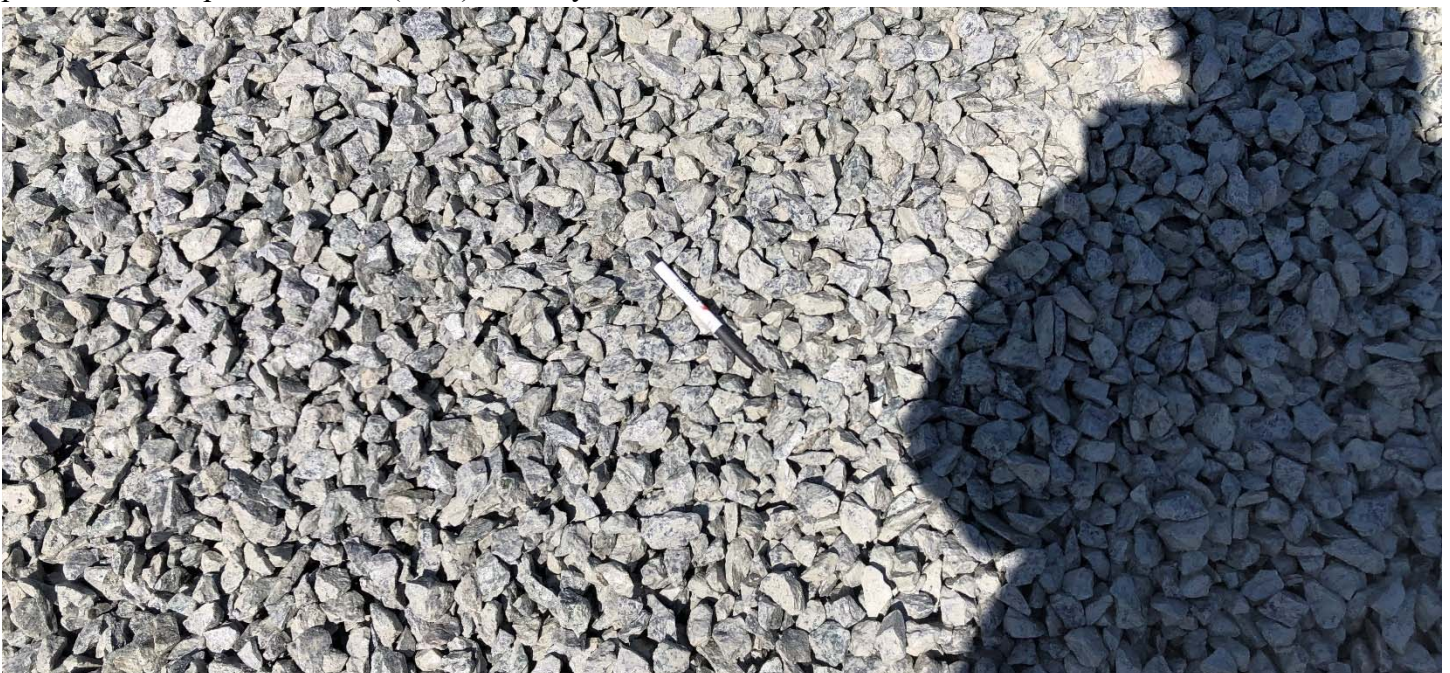
Picture # 2: Close up photo of the proposed clear crush drainage gravel. Pen for scale.

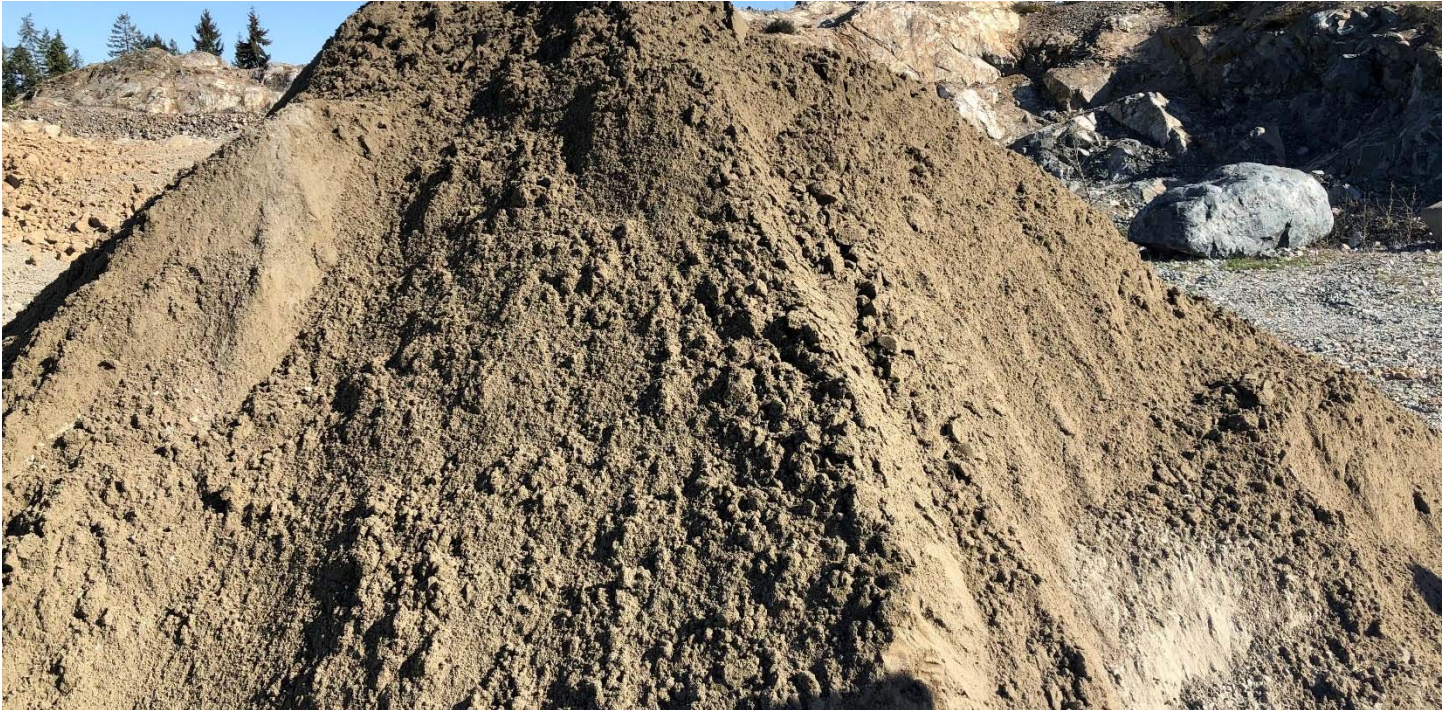
Picture # 3: SHA visually inspected the stockpile of proposed sand. SHA inspection confirmed that the material is a fine sand that appears suitable for proposed use as the 50mm thick sand layer above the PEA geomembrane.

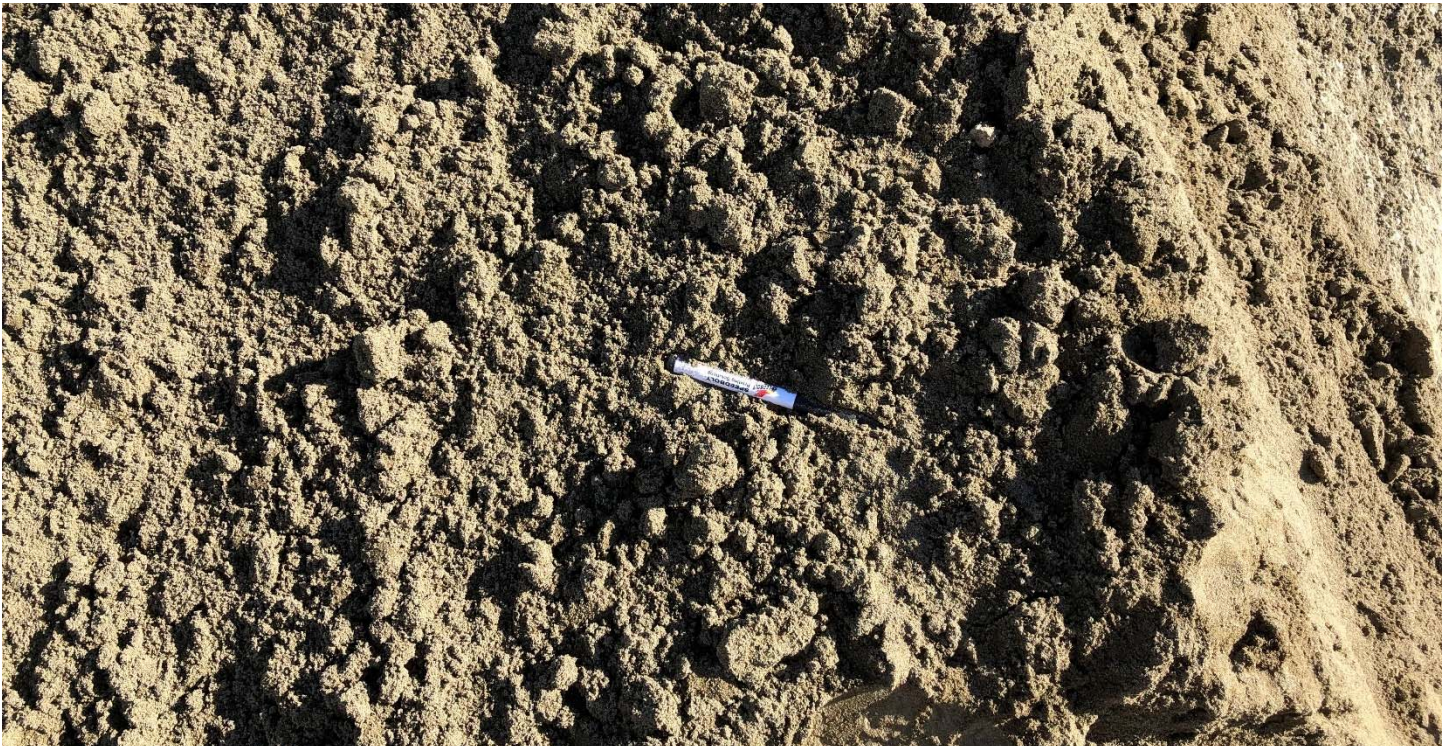
Picture # 4: Close up of proposed sand stockpile. Pen for scale.

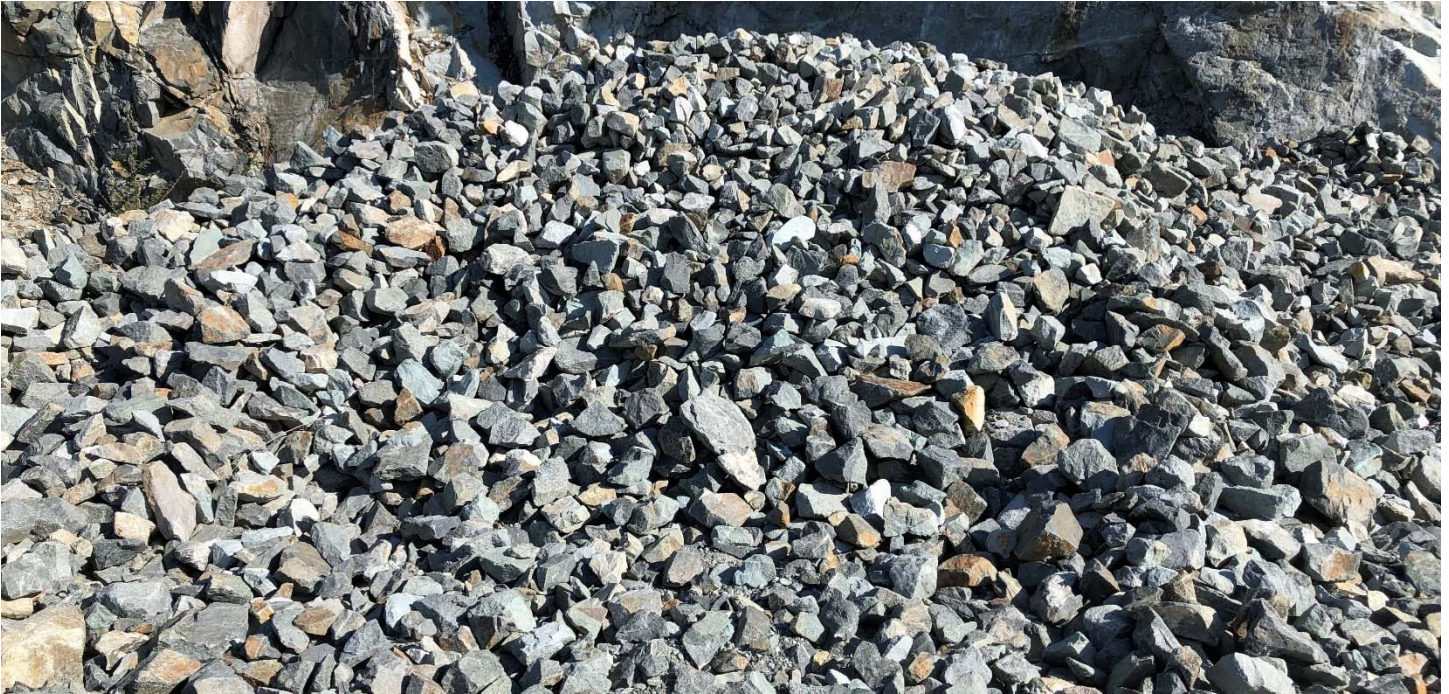
Picture #5: SHA inspected the stockpile of blast rock. SHA inspection confirmed that the material appears suitable for proposed use of backfill in the soak away trench.

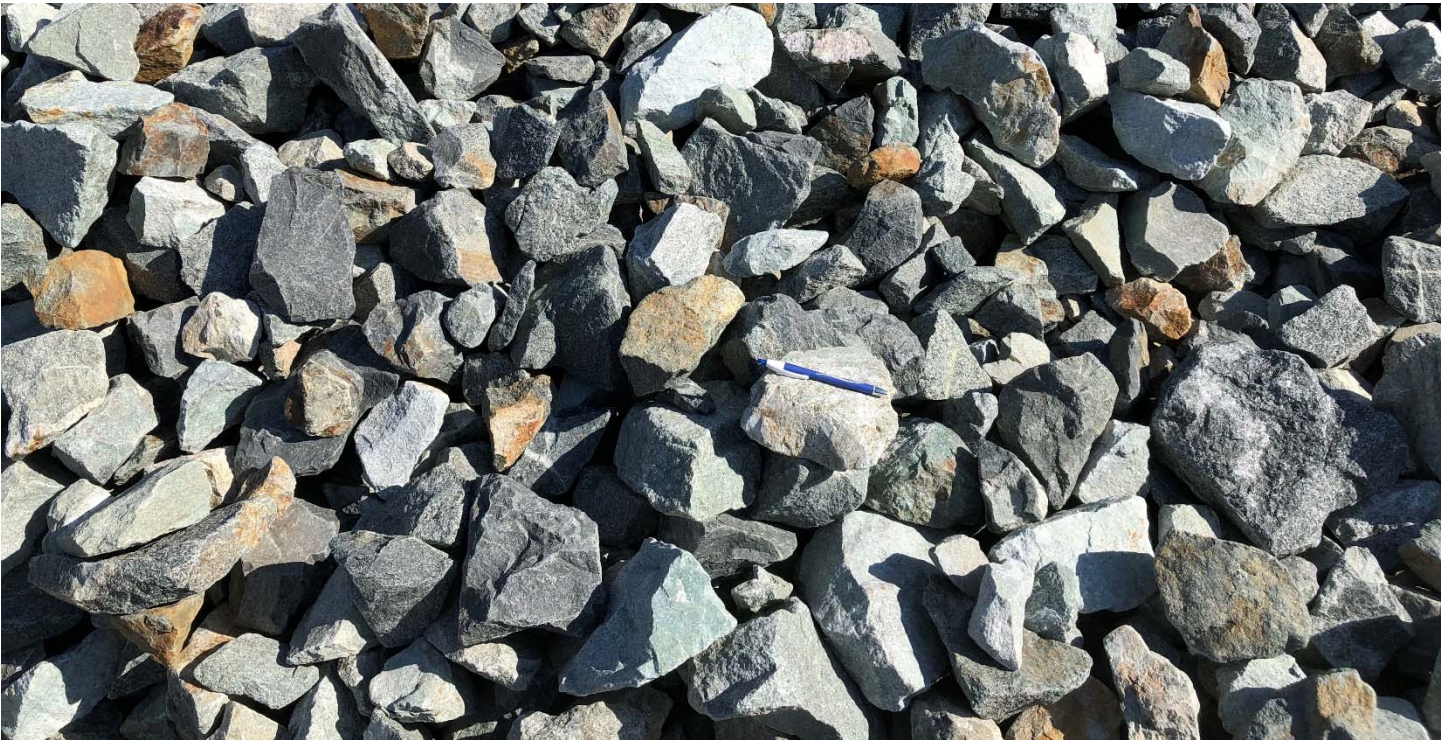
Picture #6: Close up of blast rock stockpile. Pen for scale.

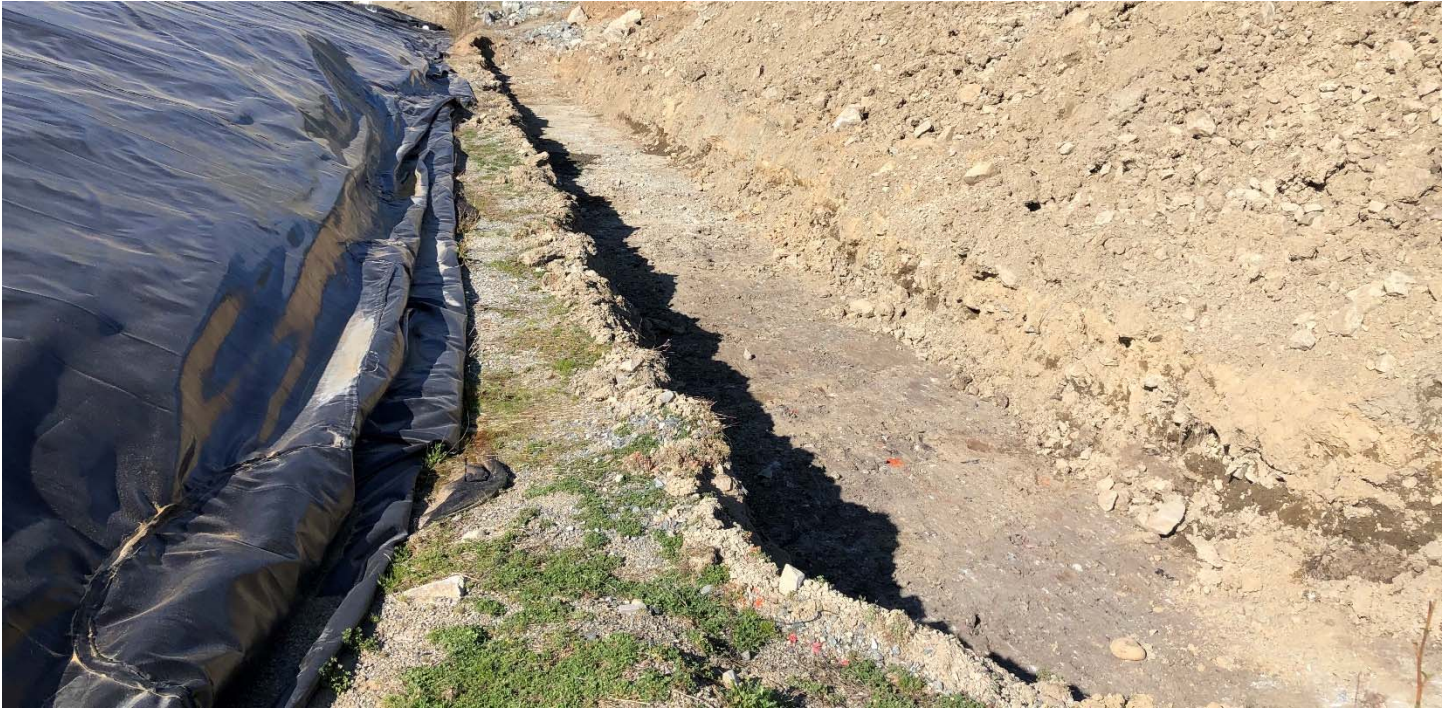
Picture #7: Soak away trench excavated along north toe of the PEA. SHA confirmed that the trench is 2 metres wide by 1 meter deep, as per design.

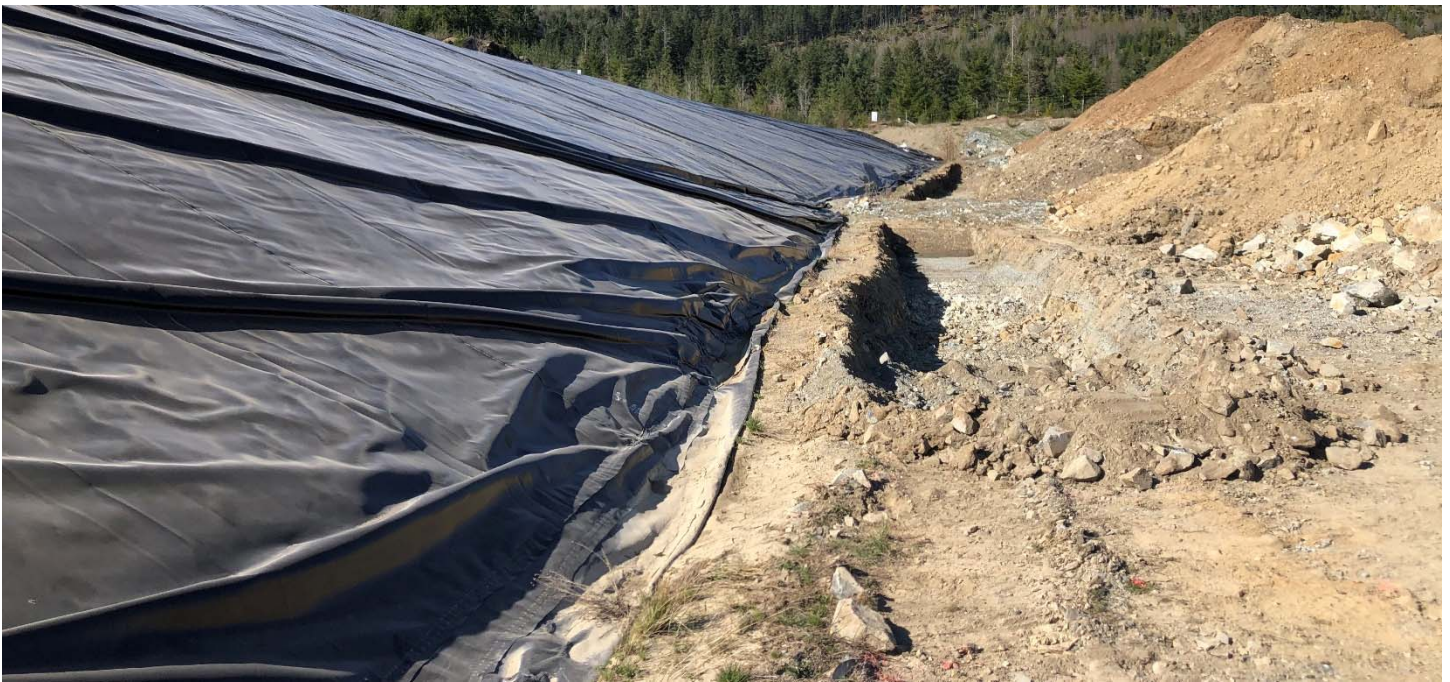
Picture #8: Soak away trench excavated along north toe of the PEA. SHA confirmed that the trench is 2 metres wide by 1 meter deep, as per design.

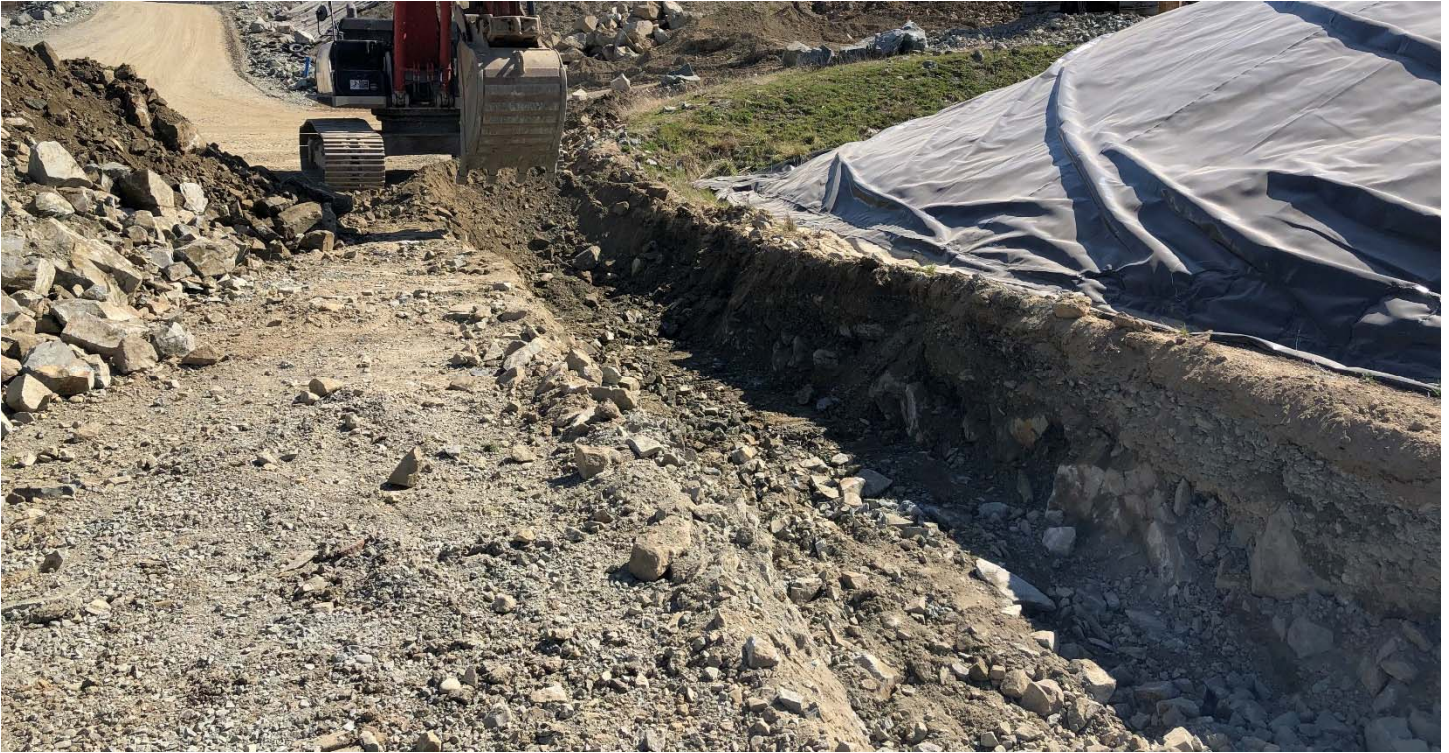
Picture #9: Allterra excavating soak away trench at north west toe of PEA.

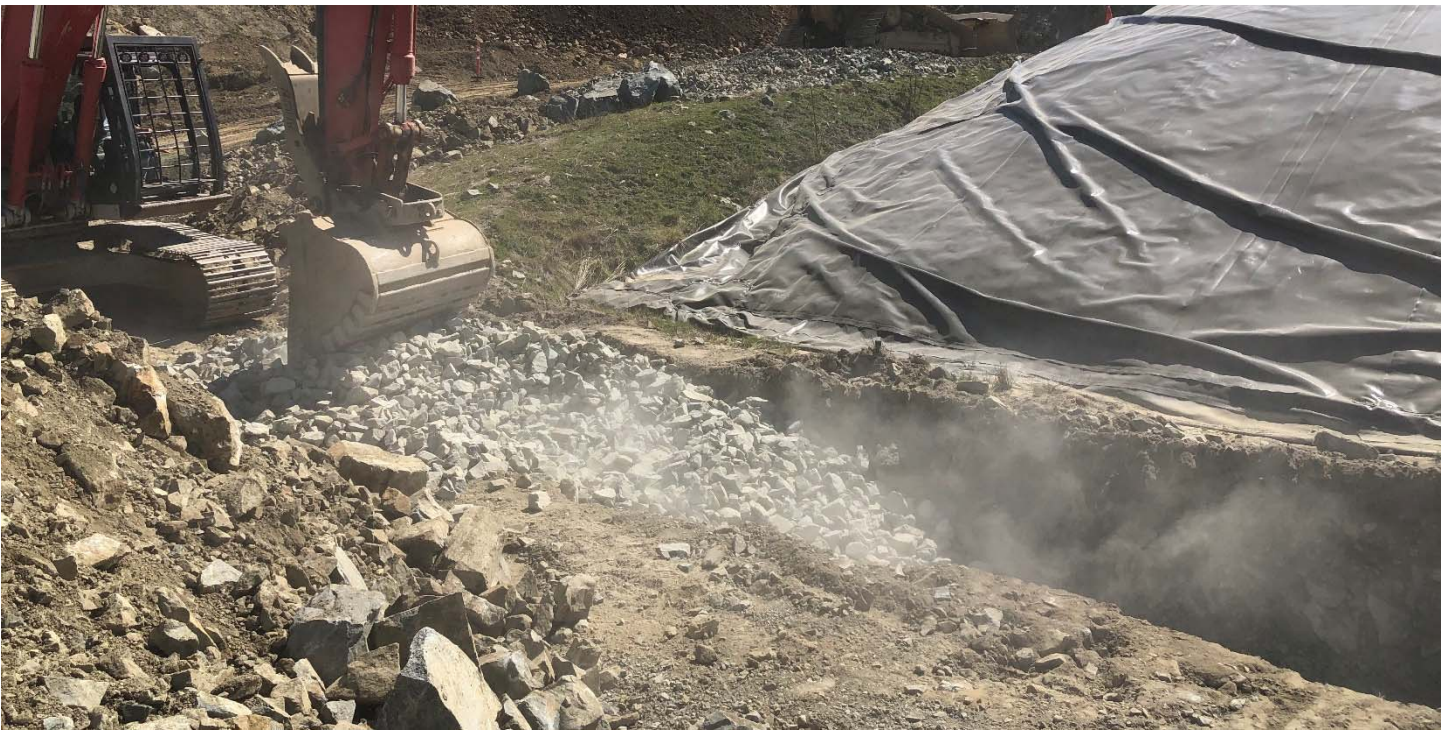
Picture #10: Allterra backfilling soakaway trench with blast rock, starting at the northwest toe of the PEA.

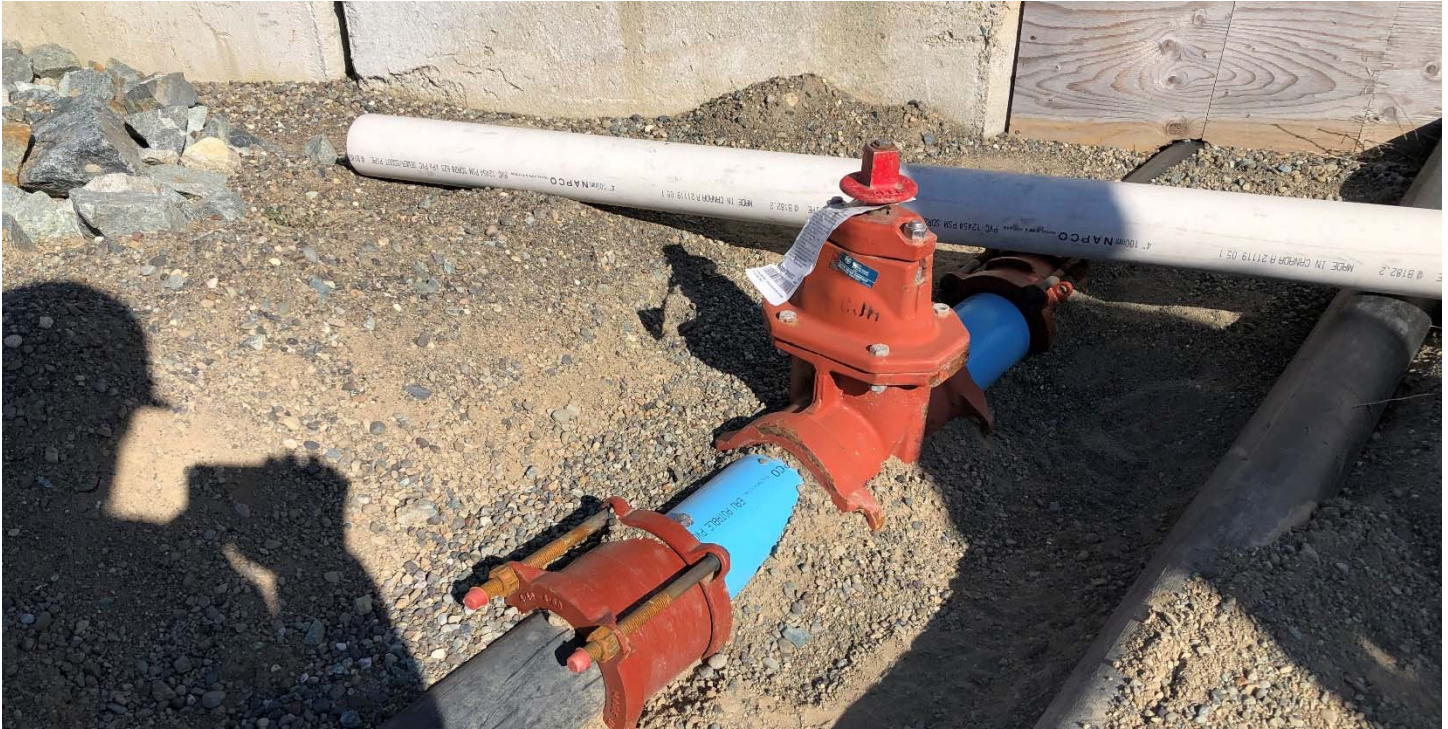
Picture #11: Allterra installed a leachate pipe valve at the south side of the Leachate Storage Facility. This valve has replaced the existing leachate pipe valve located midway between the Leachate Storage Facility and PEA.

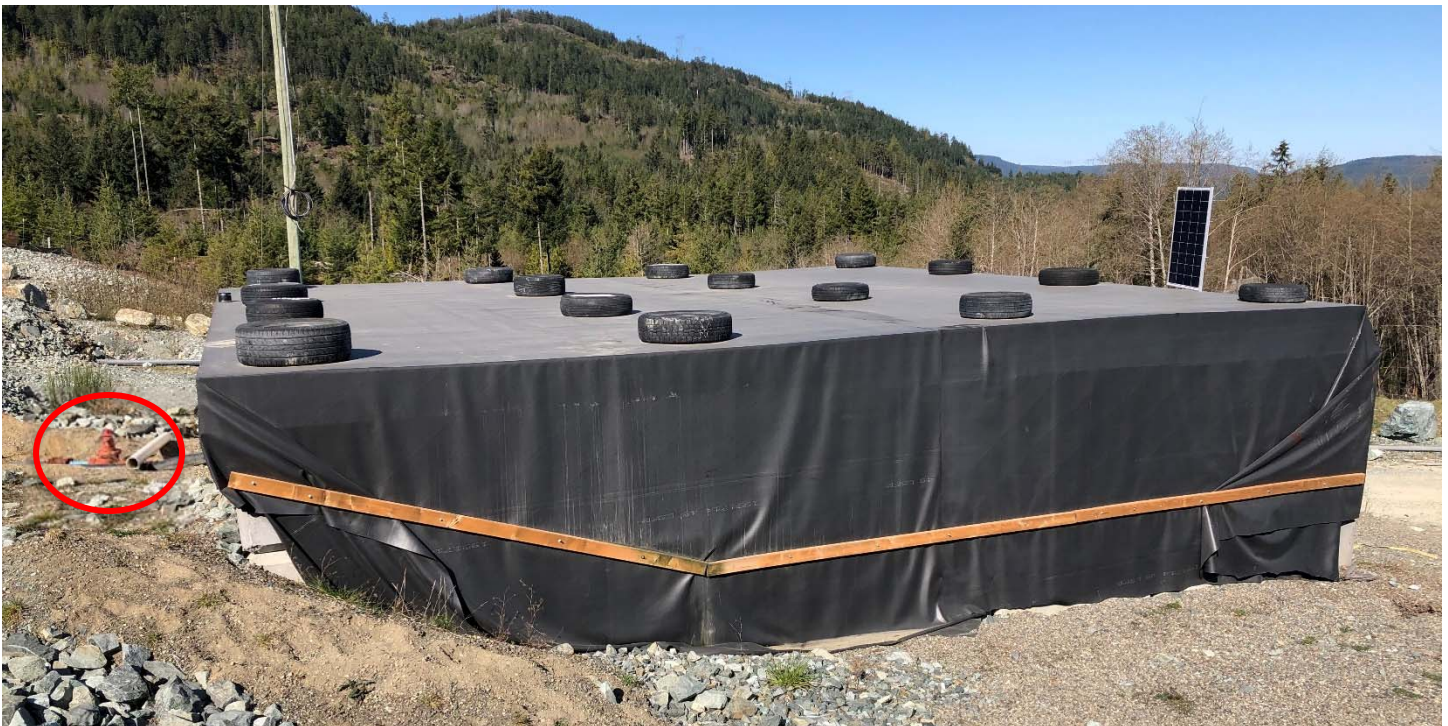
Picture #12: New valve location at south side of Leachate Storage Facility.

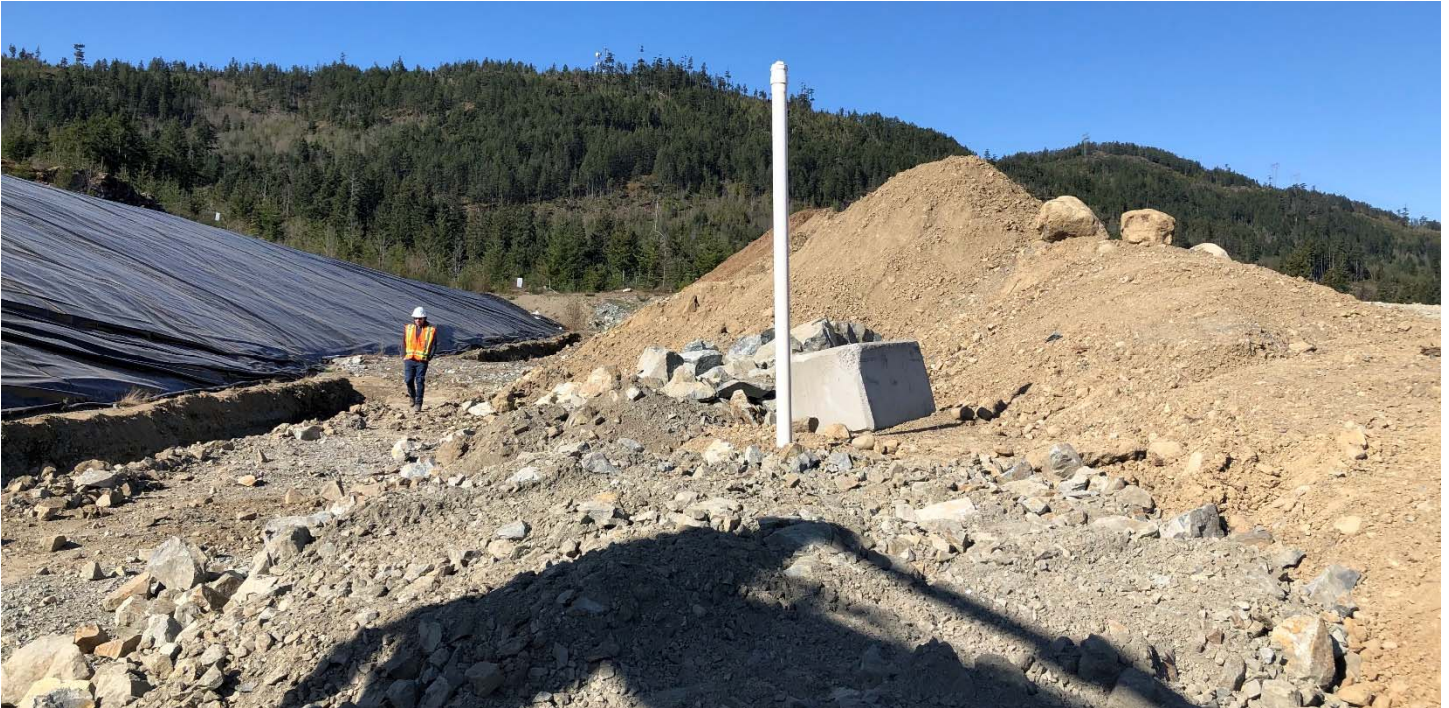
Picture #13: Allterra installed groundwater well extensions on existing groundwater wells.

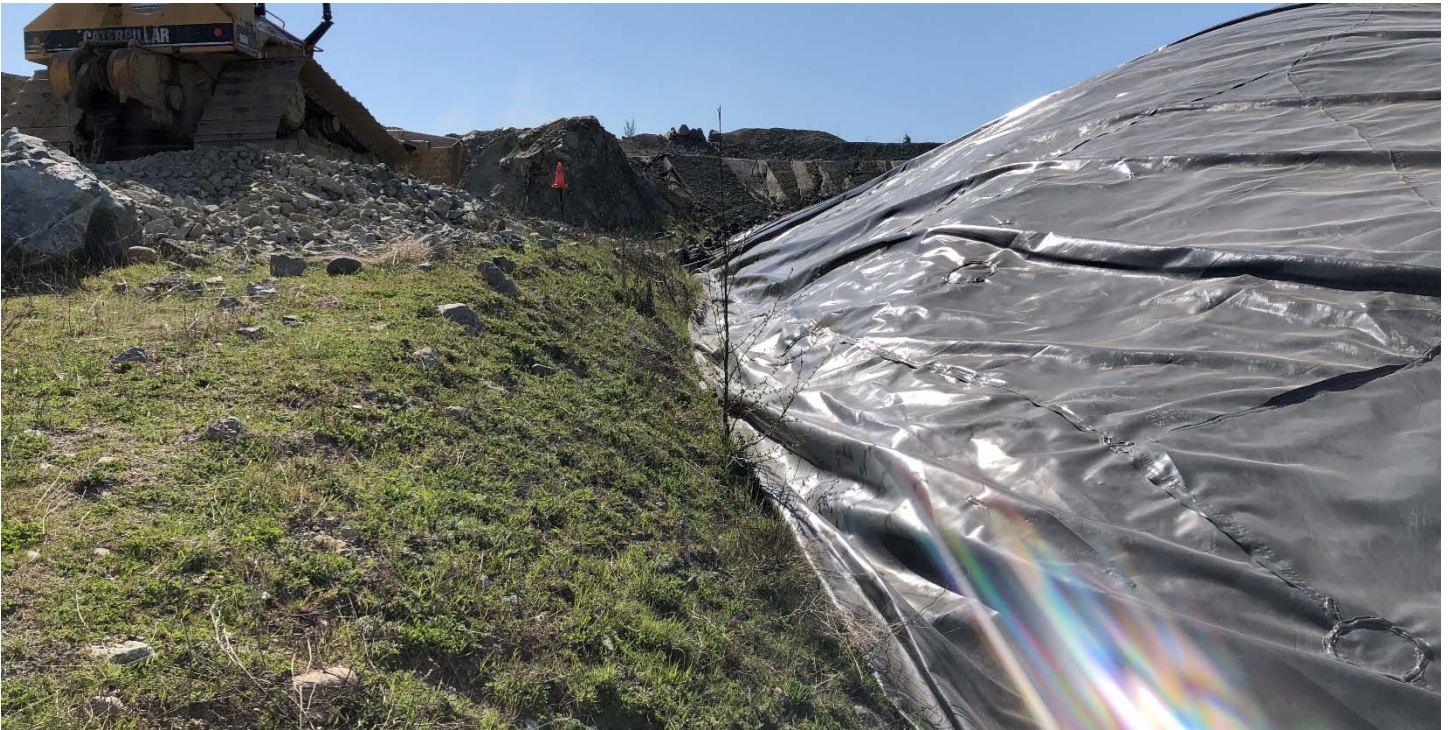
Picture #14: Soak away trench on the east side of the PEA has not been developed yet. Soakaway design for this area to be discussed.

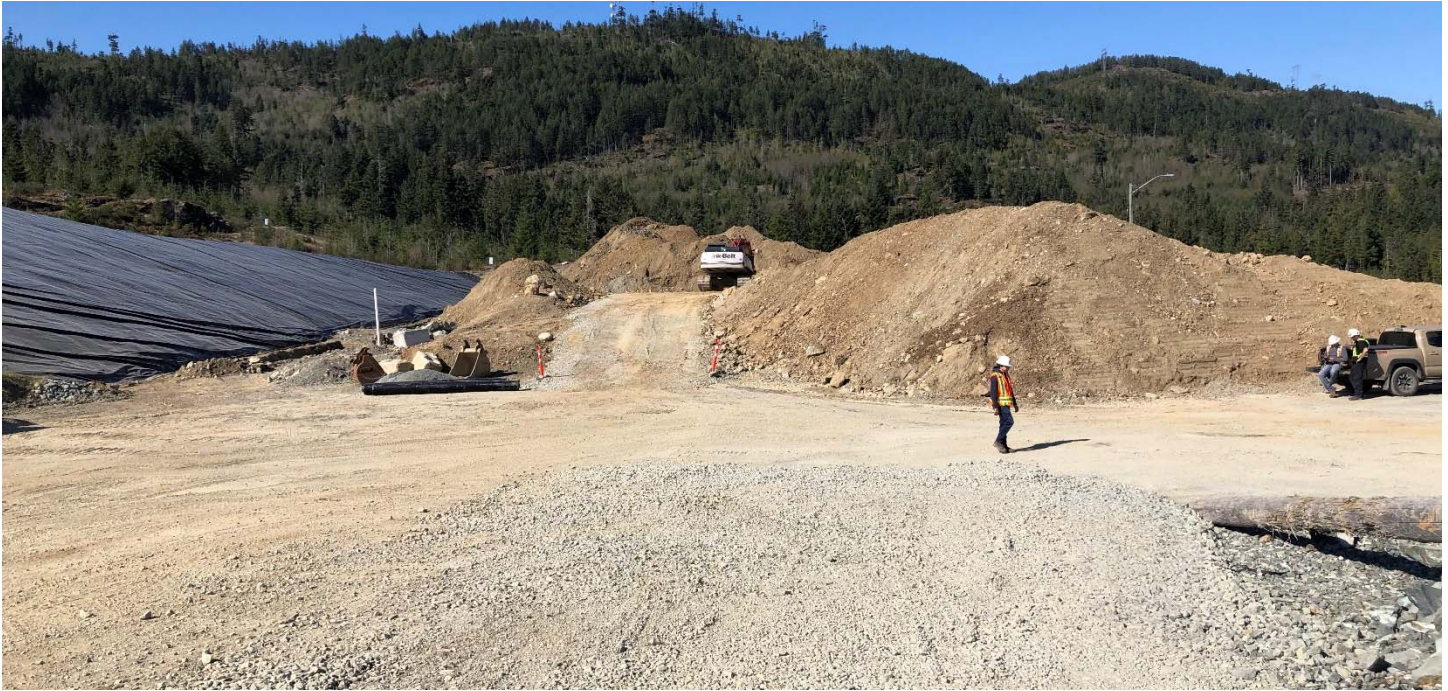
Picture# 15: Fill material stockpiled on the north side of the PEA.
