From: spomo1701@outlook.com
Sent: Monday, April 30, 2018 9:00 PM
To: Environmental Compliance ENV:EX; marty@chholdings.ca
Subject: SPO MO1701-Status Update April 30, 2018
Attachments: Apr 30, 2018 CHH Progress Report.pdf

FIELD REVIEW REPORT		DATE: April 30 2018	ISLANDER PROJECT No.: 2087
REPORT No: 19	STAGE OF CONSTRUCTION: Landfill Closure	WEATHER: Cloudy/Rain	1 of 3 PAGE: 3
PROJECT: Cobble Hill Landfill 2017 Minor Construction Works			
TO: CHH	ATTENTION: Marty Block		
CC:

The field review included the inspection of the following items included in the detailed summary of works section of the *Cobble Hill Landfill — 2017 Minor Construction Works, Detailed Construction Plan (Sperling Hansen Associates, September 13, 2017)*

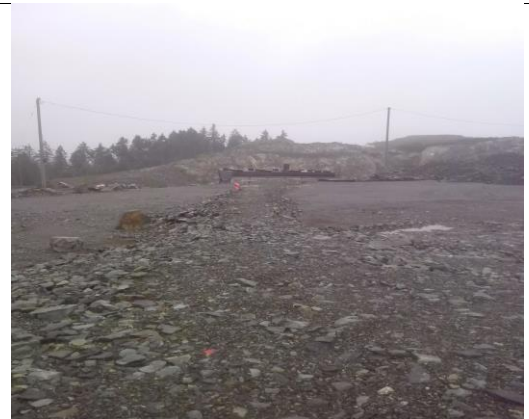
Pipe trenching and Leachate and Leak Detention facility

- **PEA**
 - Liner appears to be in good condition, and no noticeable changes since the date of our last inspection
- **Leachate and Leak Detention facility**
 - Total leachate collected: = **7.93 m³**
 - Total leachate stored = **71.74 m³**
 - Total leachate transported = **0 m³** (leachate removal to a permitted facility is scheduled for this week)
- **Soil Management Area (SMA)**
 - All works are in good condition and no noticeable changes since the date of our last inspection
- **Contact Water Containment Pond**
 - All works are in good condition and no noticeable changes since the date of our last inspection
- **cut-off ditch upland of PEA**
 - All works are in good condition, ditch still performing well.
