<b>FIELD REVIEW REPORT</b>		DATE: <b>March 27, 2018</b>	ISLANDER PROJECT No.: <b>2087</b>
REPORT No: <b>17</b>	STAGE OF CONSTRUCTION: <b>Landfill Closure</b>	WEATHER: <b>Rain &amp; cloudy</b>	PAGE: <b>1 of 3</b>
PROJECT: <b>Cobble Hill Landfill 2017 Minor Construction Works</b>			
TO:	<b>CHH</b>	ATTENTION:	<b>Marty Block</b>
CC:

The field review included the inspection of the following items included in the detailed summary of works section of the *Cobble Hill Landfill — 2017 Minor Construction Works, Detailed Construction Plan (Sperling Hansen Associates, September 13, 2017)*:

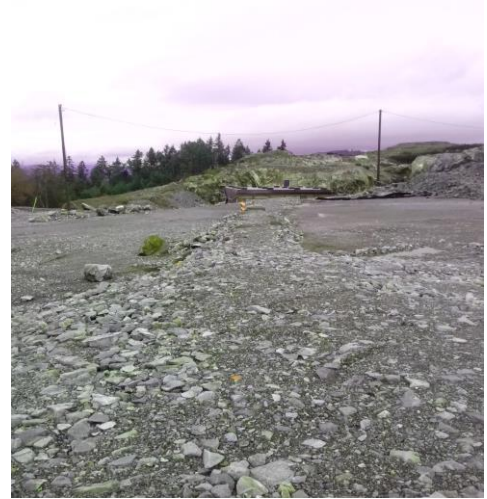
**Leak and leachate detection works**

- **PEA**
  - Liner appears to be in good condition, with no noticeable changes since the date of our last inspection
- **Leachate and Leak Detention facility**
  - Total leachate collected: = 5.59 m<sup>3</sup>
  - Total leachate stored = 52.53 m<sup>3</sup>
  - Total leachate transported = 0 m<sup>3</sup>
- **Soil Management Area (SMA)**
  - All works are in good condition and no noticeable changes since the date of our last inspection
- **Contact Water Containment Pond**
  - All works are in good condition and no noticeable changes since the date of our last inspection
- **cut-off ditch upland of PEA**
  - All works are in good condition, ditch still performing well.
