From: SPOMO1701@outlook.com
Sent: Thursday, May 31, 2018 8:39 PM
To: Environmental Compliance ENV:EX; marty@chholdings.ca
Subject: SPO MO1701-Status Update May 30, 2018
Attachments: May 30, 2018 CHH Progress Report.pdf

FIELD REVIEW REPORT		DATE: May 30 2018	ISLANDER PROJECT No.: 2087
REPORT No: 21	STAGE OF CONSTRUCTION: Landfill Closure	WEATHER: Cloud/Sunny	1 of 3 PAGE:
PROJECT: Cobble Hill Landfill 2017 Minor Construction Works			
TO: CHH	ATTENTION: Marty Block		
CC:

The field review included the inspection of the following items included in the detailed summary of works section of the *Cobble Hill Landfill — 2017 Minor Construction Works, Detailed Construction Plan (Sperling Hansen Associates, September 13, 2017)*

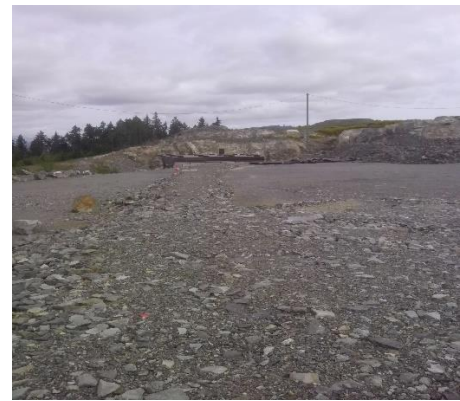
Pipe trenching and Leachate and Leak Detention facility

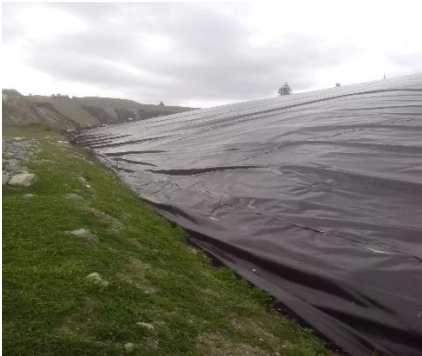
PEA – liner near NE corner

- **PEA**
 - Liner appears to be in good condition, and no noticeable changes since the date of our last inspection
- **Leachate and Leak Detention facility**
 - Total leachate collected: = **4.36 m³**
 - Total leachate stored = **26.01 m³**
 - Total leachate transported = **0 m³**
- **Soil Management Area (SMA)**
 - All works are in good condition and no noticeable changes since the date of our last inspection
- **Contact Water Containment Pond**
 - All works are in good condition and no noticeable changes since the date of our last inspection
- **cut-off ditch upland of PEA**
 - All works are in good condition, ditch still performing well.
