From: SPOMO1701@outlook.com
To: Environmental.Compliance ENV:EX; marty@chholdings.ca
Subject: SPO MO1701-Status Update August 30, 2018
Date: Thursday, August 30, 2018 10:56:53 PM
Attachments: [Aug 30, 2018 CHH Progress Report.pdf](#)

FIELD REVIEW REPORT		DATE: August 30, 2018	ISLANDER PROJECT No.: 2087
REPORT No: 27	STAGE OF CONSTRUCTION: Landfill Closure	WEATHER: Sun, 25 °C	PAGE: 1 of 3
PROJECT: Cobble Hill Landfill 2017 Minor Construction Works			
TO: CHH	ATTENTION: Marty Block		
CC:

The field review included the inspection of the following items included in the detailed summary of works section of the *Cobble Hill Landfill — 2017 Minor Construction Works, Detailed Construction Plan (Sperling Hansen Associates, September 13, 2017)*:

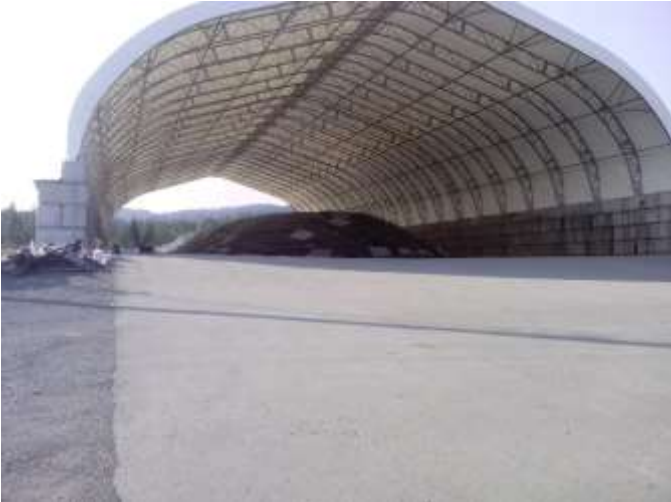
SMA - looking south

- **PEA**
 - Liner appears to be in good condition, with no noticeable changes since the date of our last inspection
- **Leachate and Leak Detention facility**
 - Total leachate collected: = 3.66 m³
 - Total leachate stored = 59.54 m³
 - Total leachate transported = 0 m³
- **Soil Management Area (SMA)**
 - All works are in good condition and no noticeable changes since the date of our last inspection
- **Contact Water Containment Pond**
 - All works are in good condition and no noticeable changes since the date of our last inspection
- **cut-off ditch upland of PEA**
 - All works are in good condition, ditch still performing well.
