From: spomo1701@outlook.com
To: [Environmental Compliance ENV:EX; marty@chholdings.ca](#)
Subject: SPO MO1701 20180228 Status Update
Date: Wednesday, February 28, 2018 11:13:54 PM
Attachments: [Feb 28, 2018 CHH Progress Report.pdf](#)

FIELD REVIEW REPORT		DATE: February 28 2018	ISLANDER PROJECT No.: 2087
REPORT No: 15	STAGE OF CONSTRUCTION: Landfill Closure	WEATHER: Cloudy 1 deg	PAGE: 1 of 3
PROJECT: Cobble Hill Landfill 2017 Minor Construction Works			
TO: CHH	ATTENTION: Marty Block		
CC:

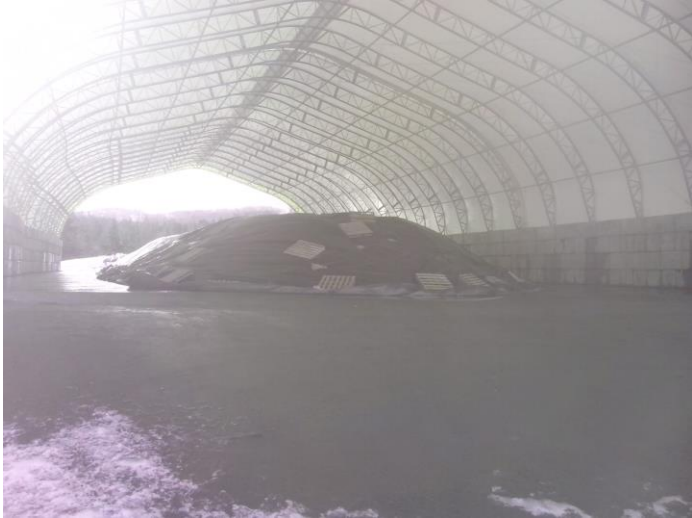
SMA - looking south

- **PEA**
 - Liner appears to be in good condition, with no noticeable changes since the date of our last inspection
- **Leachate and Leak Detention facility**
 - Total leachate collected: = **8.03 m³**
 - Total leachate stored = **37.5 m³**
 - Total leachate transported = **0 m³**
- **Soil Management Area (SMA)**
 - All works are in good condition and no noticeable changes since the date of our last inspection
- **Contact Water Containment Pond**
 - All works are in good condition and no noticeable changes since the date of our last inspection
- **cut-off ditch upland of PEA**
 - All works are in good condition, ditch still performing well.
