Report Date: August 27, 2017

Report Number: 061132

Re: An Investigation Referral, Permit 105719, Chieftain Metals Inc. - Tulsequah Chief Mine, Effluent

Authorization: 105719	Client Name: Chieftain Metals Inc.
NRIS IR #: 61132	(Date) Site Inspection Photos: 2017-07-12

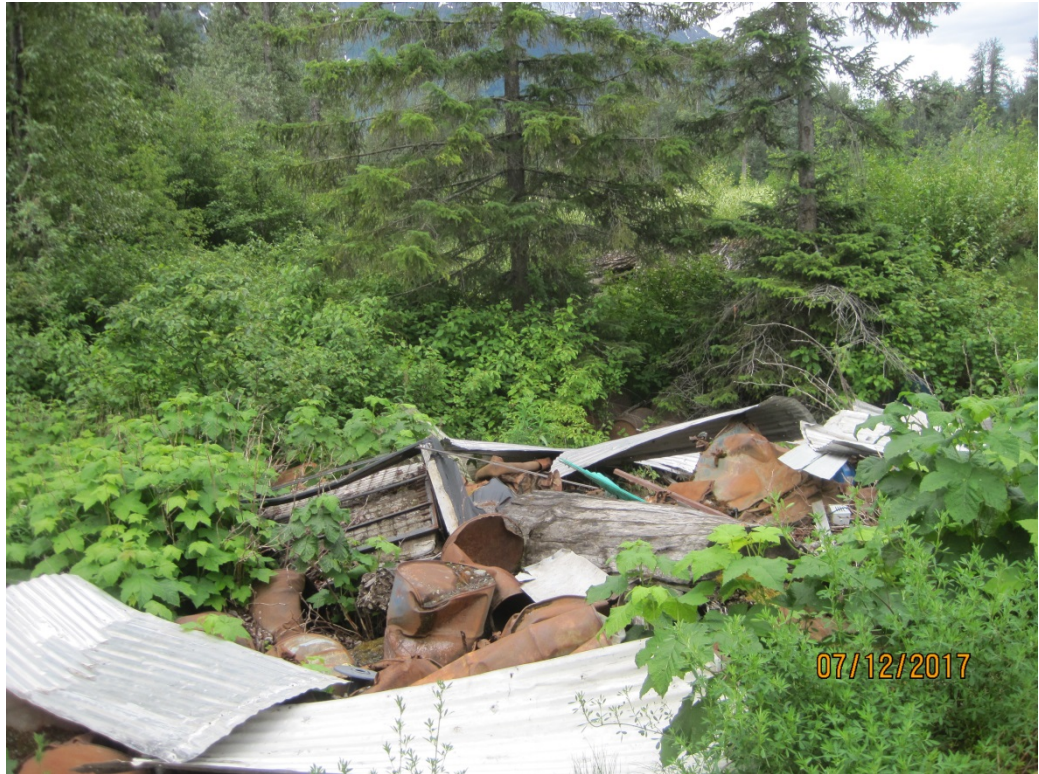
Requirement Description:	Environmental Management Act, Environmental Management Act 6 (3): Subject to subsection (5), a person must not introduce or cause or allow to be introduced into the environment, waste produced by a prescribed activity or operation.
Details/Findings:	During the onsite inspection of the Tulsequah Chief Mine site (Site) on July 12, 2017, Ministry of Environment and Climate Change Strategy (ENV) Officer Neil Bailey observed refuse including scrap metal, used oil containers, wood waste, white goods (freezers and stoves) and paint cans introduced into the environment at the barge landing area (see Photo 1). This introduction of refuse in the environment is considered "municipal solid waste management", a prescribed activity under Section 2(1) and Schedule 1(2) of the Waste Discharge Regulation. This discharge of waste into the environment is not authorized by permit 105719, or any other authorization.

Photo 1
Metal, stoves, freezers and oil containers disposed of at the barge landing site.

Compliance:	Out
Actions to be taken:	Cease the unauthorized discharge of refuse.
Requirement Description:	Environmental Management Act, Hazardous Waste Regulation (63/88) (EMA) 2 (5): This regulation, except sections 17.1 and 46 (1), does not apply in relation to hazardous waste that is produced or accumulated in a quantity of less than 5 kilograms or 5 litres in a 30 day period.
Details/Findings:	The Site has been in care and maintenance since shutting down the Interim Acid Water Treatment Plant (IAWTP) on June 22, 2012. As no personnel were present on Site and no activities are currently occurring, there is less than 5 Litres of hazardous waste (waste oil) accumulating in a 30 day periods at present. Therefore, only sections 17.1 and 46(1) of the Hazardous Waste Regulation apply (see Photo 2).
Compliance:	Not Applicable
Actions to be taken:	It is recommended that hazardous wastes are stored using best management practices such being covered, stored in secondary containment, labelled and in closed containers.

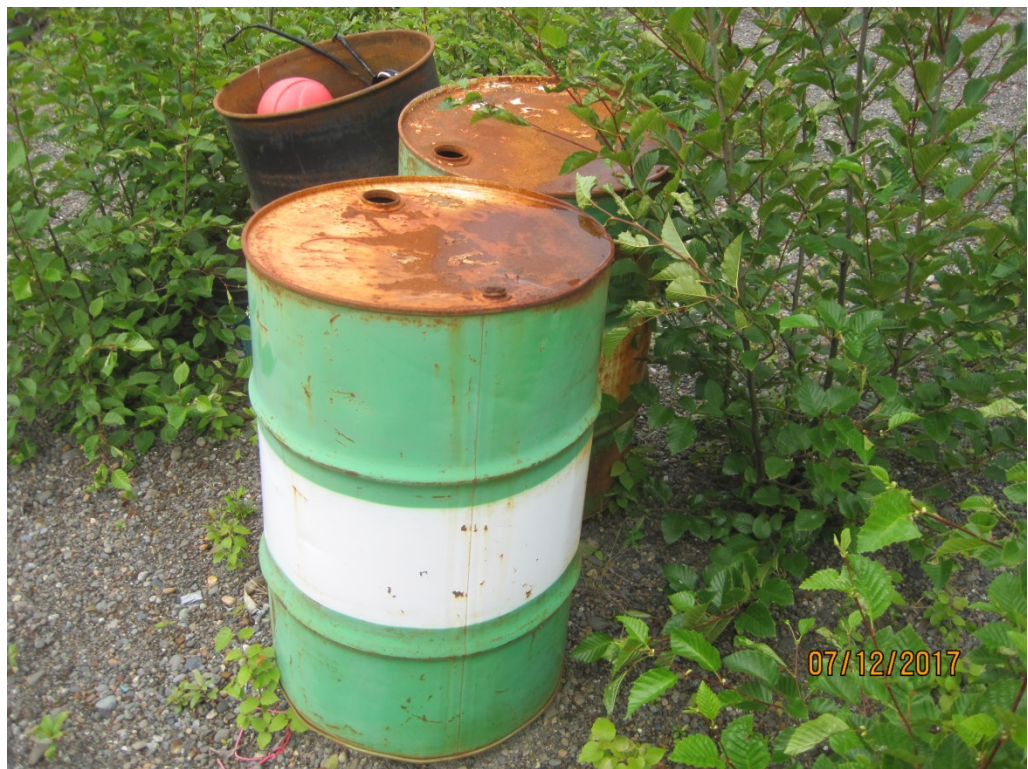
- The buildings on site showed signs of vandalism (break-ins);
- Suspected waste oil was observed in open, unlabeled containers at the barge landing (see Photo 2);

Photo 2
Unlabelled, open waste oil containers at the barge landing area.

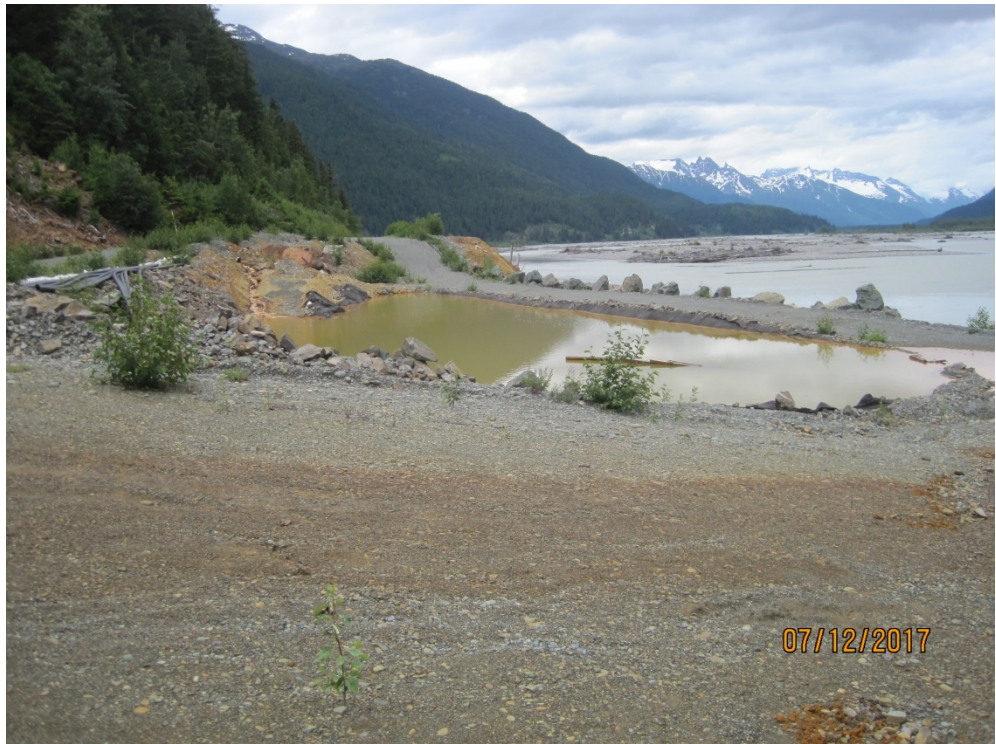
Photo 3
Exfiltration pond.

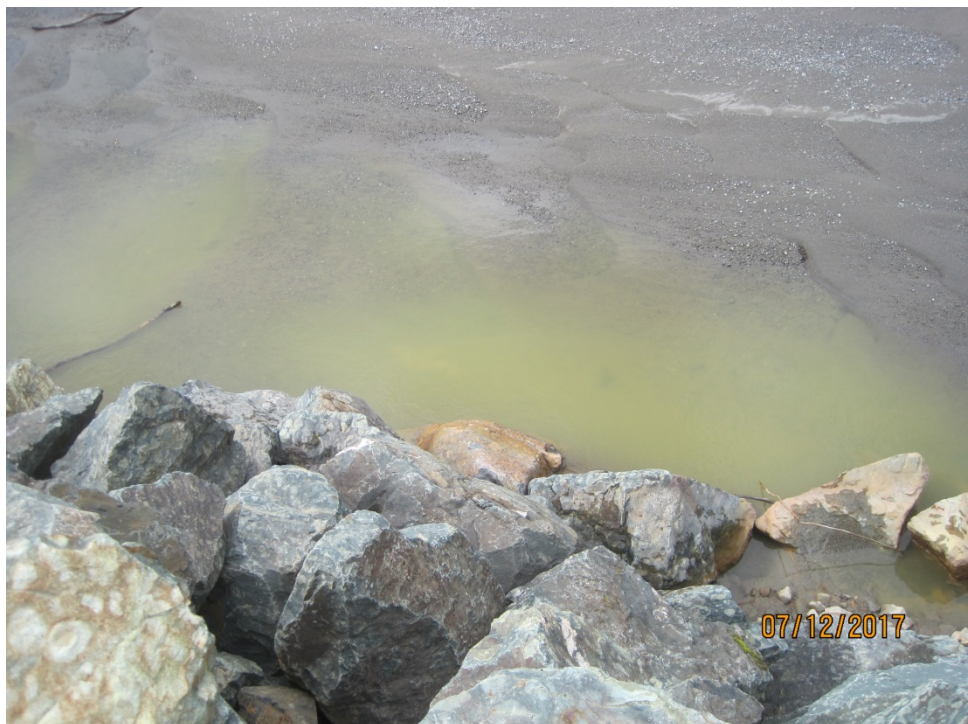
- The Portal Creek Diversion was broken in places and has been crushed by rock above the 5200 portal;
- The 5200 level exfiltration pond was overflowing to the Tulsequah River at the time of this inspection.

Photo 4
Mixing of the exfiltration pond effluent in the Tulsequah River.

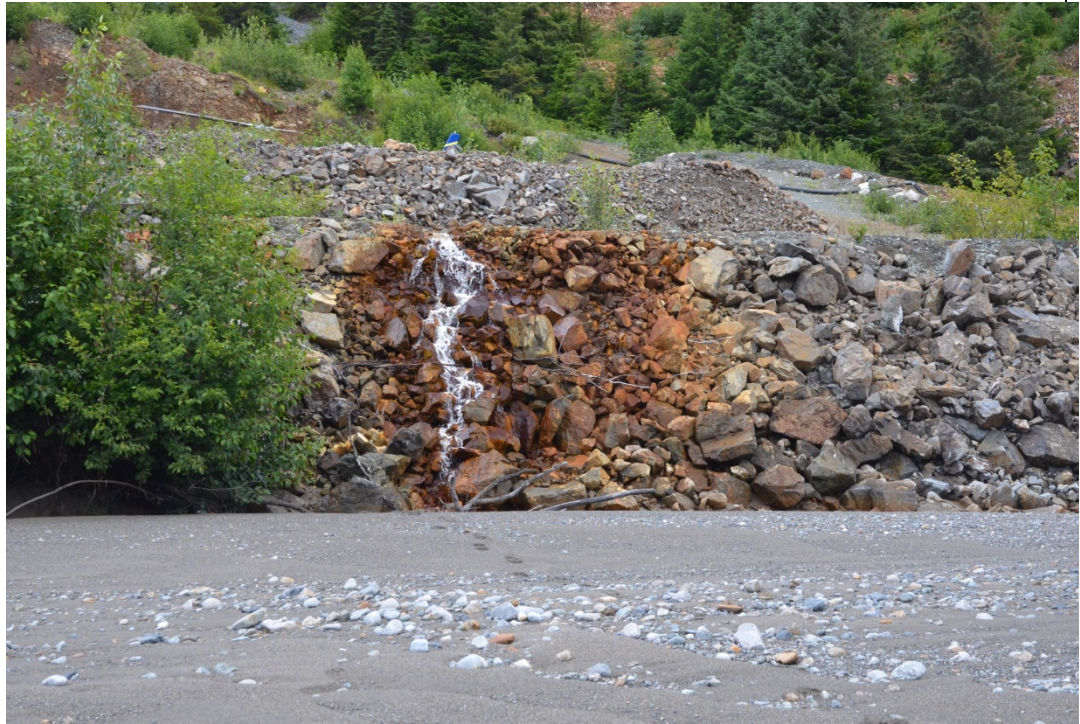
Details/Findings:	The authorized works described in section 1.1.5 of the Permit include a water collection and conveyance system, pumps, an acid water treatment plant, a discharge line and outfall. Officer Bailey observed effluent flowing from the 5200 and 5400 level portals to the 5200 level exfiltration pond, overflowing from the exfiltration pond to the Tulsequah River foreshore - bypassing the Interim Acid Water Treatment Plant (see Photo 5). This is a prohibited bypass of the authorized works (IAWTP) where the Permittee failed to obtain the approval of the Director in writing. The pH of the discharge was measured at 3.58. The exfiltration pond was overflowing to the Tulsequah River at the time of this inspection, constituting a bypass of the approved works and therefore an unauthorized discharge. Samples were taken of this unauthorized discharge, and the effluent was found to be acutely toxic with a 96 hr LC50 (Rainbow trout) <6.25 v/v. The effluent was also found to be acutely toxic to Cerio daphnia (see Photos 2, 4, & 5). It should be noted that the additional bypass provisions included in section 3.6.1 of the Permit would not apply to this prohibited bypass of the IAWTP. Section 3.6.1 of the Permit applies to neutral pH water bypassing the IAWTP and diverted to Portal Creek.

Photo 5
Effluent overflowing from the exfiltration pond.

Compliance:	Out
Actions to be taken:	The Permittee will remain in non-compliance with Permit 105719 until such a time as the unauthorized bypass of the Interim Acid Water Treatment Plant is ceased, and all effluent is discharged in accordance with the Permit.
Requirement Description:	Maintenance of Works and Emergency Procedures 2.3: The authorized works must be inspected regularly and maintained in good working order. In the event of an emergency or condition beyond the control of the Permittee which prevents effective operation of the authorized works or leads to an unauthorized discharge, the Permittee must take appropriate remedial action and notify the Director immediately. The Director may reduce or suspend operations to protect the environment until the authorized works have been restored, and/or corrective steps taken to prevent unauthorized discharges.
Details/Findings:	The authorized works described in section 1.1.5 of the Permit include a water collection and conveyance system, pumps, an acid water treatment plant, a discharge line and outfall. During the inspection on July 12, 2017, Officer Bailey observed the Portal Creek Diversion broken in places and has been crushed by rock above the 5200 portal, and the Portal Creek Diversion ditch outlined in the February 8, 2016 Compliance Plan is not being maintained. As a result, clean water is mixing with acid mine drainage and then flows through the waste rock piles to the 5200 level exfiltration pond (see Photos 6, 7, 8 & 9). The Permittee has failed to maintain the authorized works in good working order.

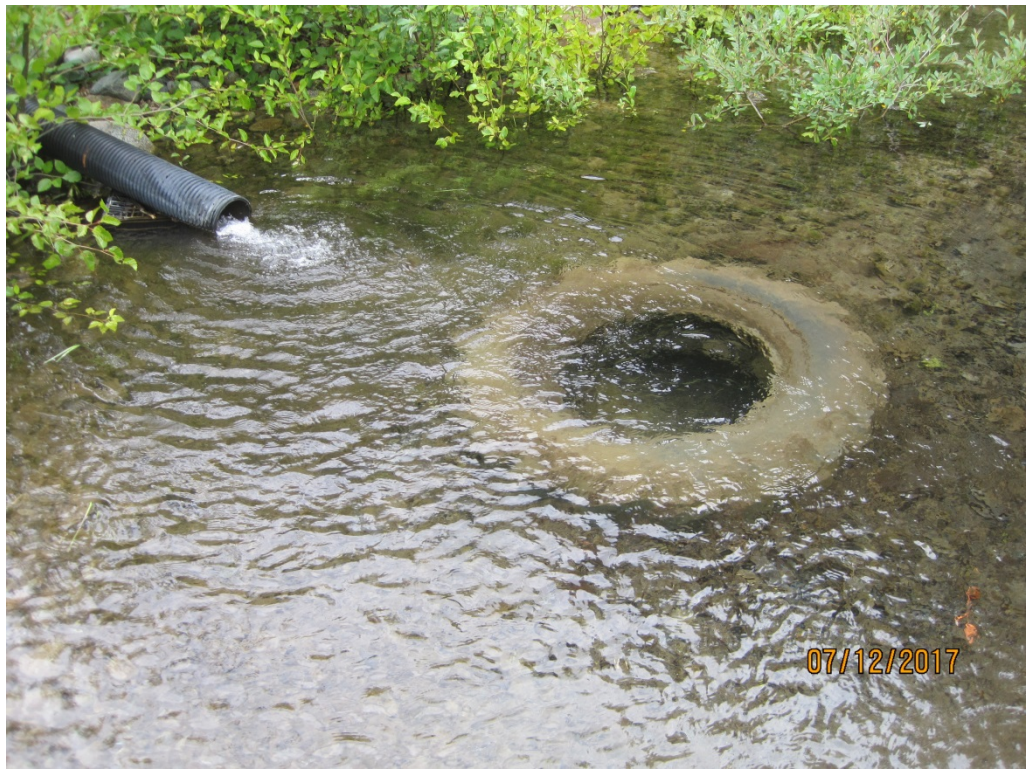
Photo 6
Neutral mine water discharge from 5400 Adit to Portal Creek.

Compliance:	Out
Actions to be taken:	Ensure that the authorized works are inspected regularly and are maintained in good working order.
Requirement Description:	Construction of Treatment Plant Sludge Storage Pond 2.5: The treatment plant sludge pond shall be designed, constructed, maintained and modified (as necessary) by a qualified professional who is knowledgeable in mine water treatment plant sludge management. The works shall be located at least one metre above the high water table, 30 m from the nearest water body and constructed in a manner that prevents the escape of sludge.
Details/Findings:	The treatment plant sludge pond was observed to be more than 30 m from the nearest water body and was bermed to prevent the escape of sludge.
Compliance:	In
Actions to be taken:	No action required.
Requirement Description:	Neutral pH Water Diversion from the Underground 3.6.1 3.6.1: Uncontaminated groundwater from underground drill holes with characteristics better than or equal to that specified in section 1.1.3, may bypass the treatment plant and be diverted to Portal Creek.

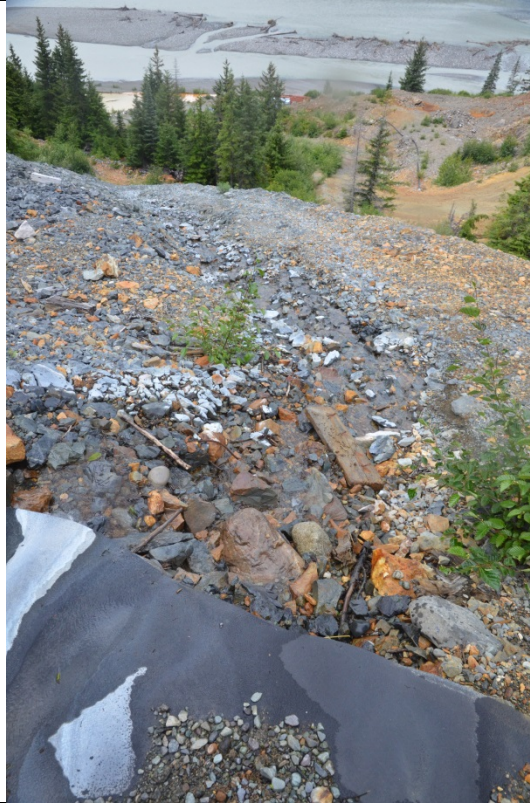
Photo 7
 Portal Creek water flowing over the spillway, through waste rock to the exfiltration pond.

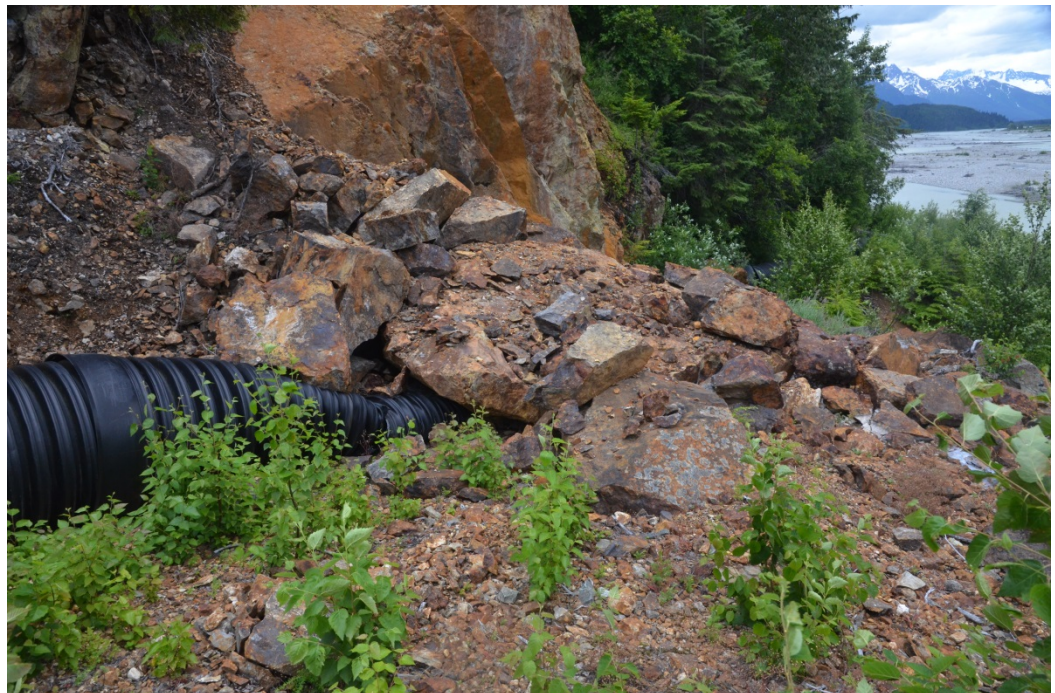
Photo 8
 Portal Creek Diversion is blocked, and not functioning.

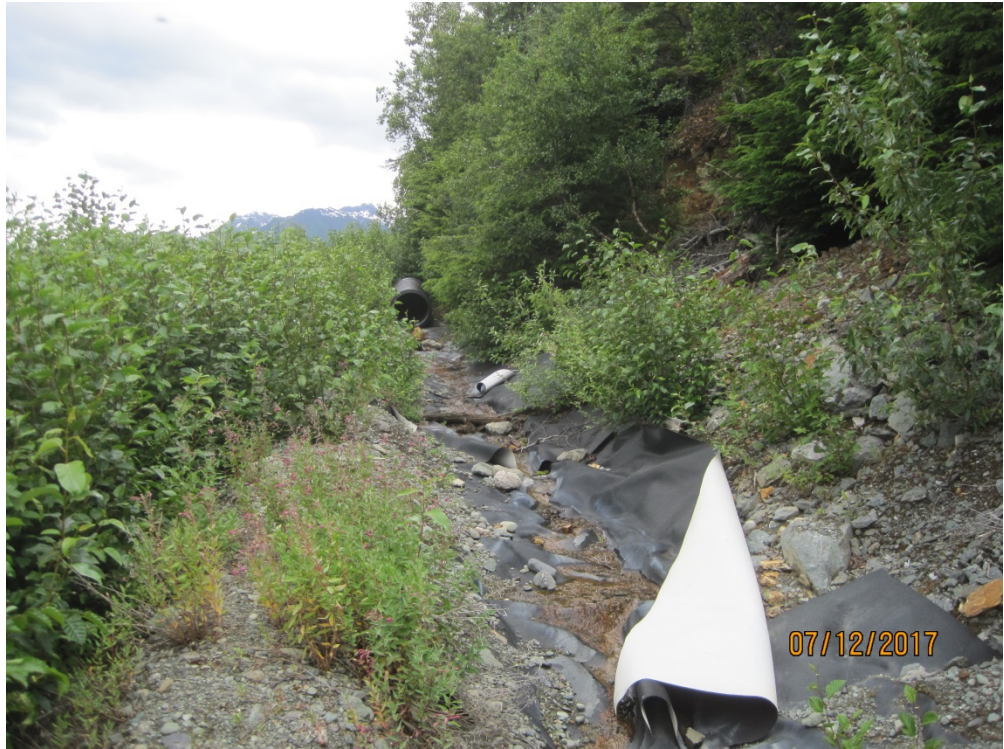
Photo 9
There is very little flow exiting the Portal Creek Diversion.

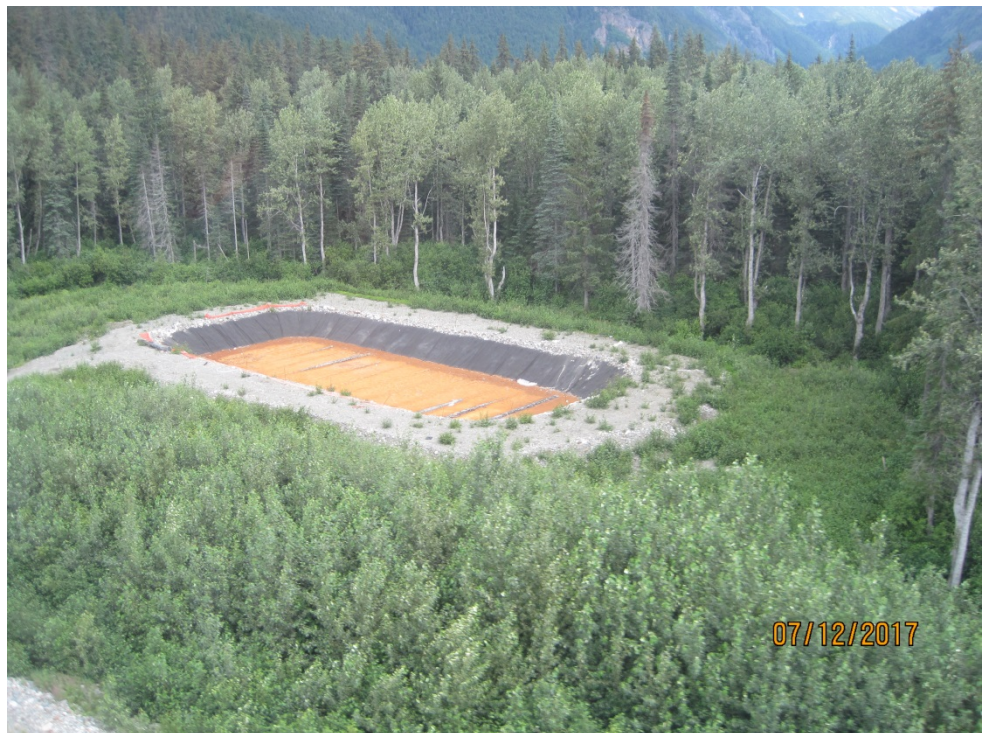
- There was a small sludge storage pond installed northwest of the IAWTP, which was located less than 30 m from the Tulsequah River and is not part of the approved works;

Photo 10
Sludge storage pond near the airstrip.
