*Project number: 4435-029*  
*Document number: R3663*  
*Version: 3*  
*Date: February 21, 2014*

## **MILE 122.7 DERAILMENT – COAL RECOVERY PLAN FOR SILVER CREEK, BURNABY LAKE AND BRUNETTE RIVER**

# ENVIRONMENTAL MANAGEMENT PLAN – SILVER CREEK AND BURNABY LAKE COAL RECOVERY PROGRAM

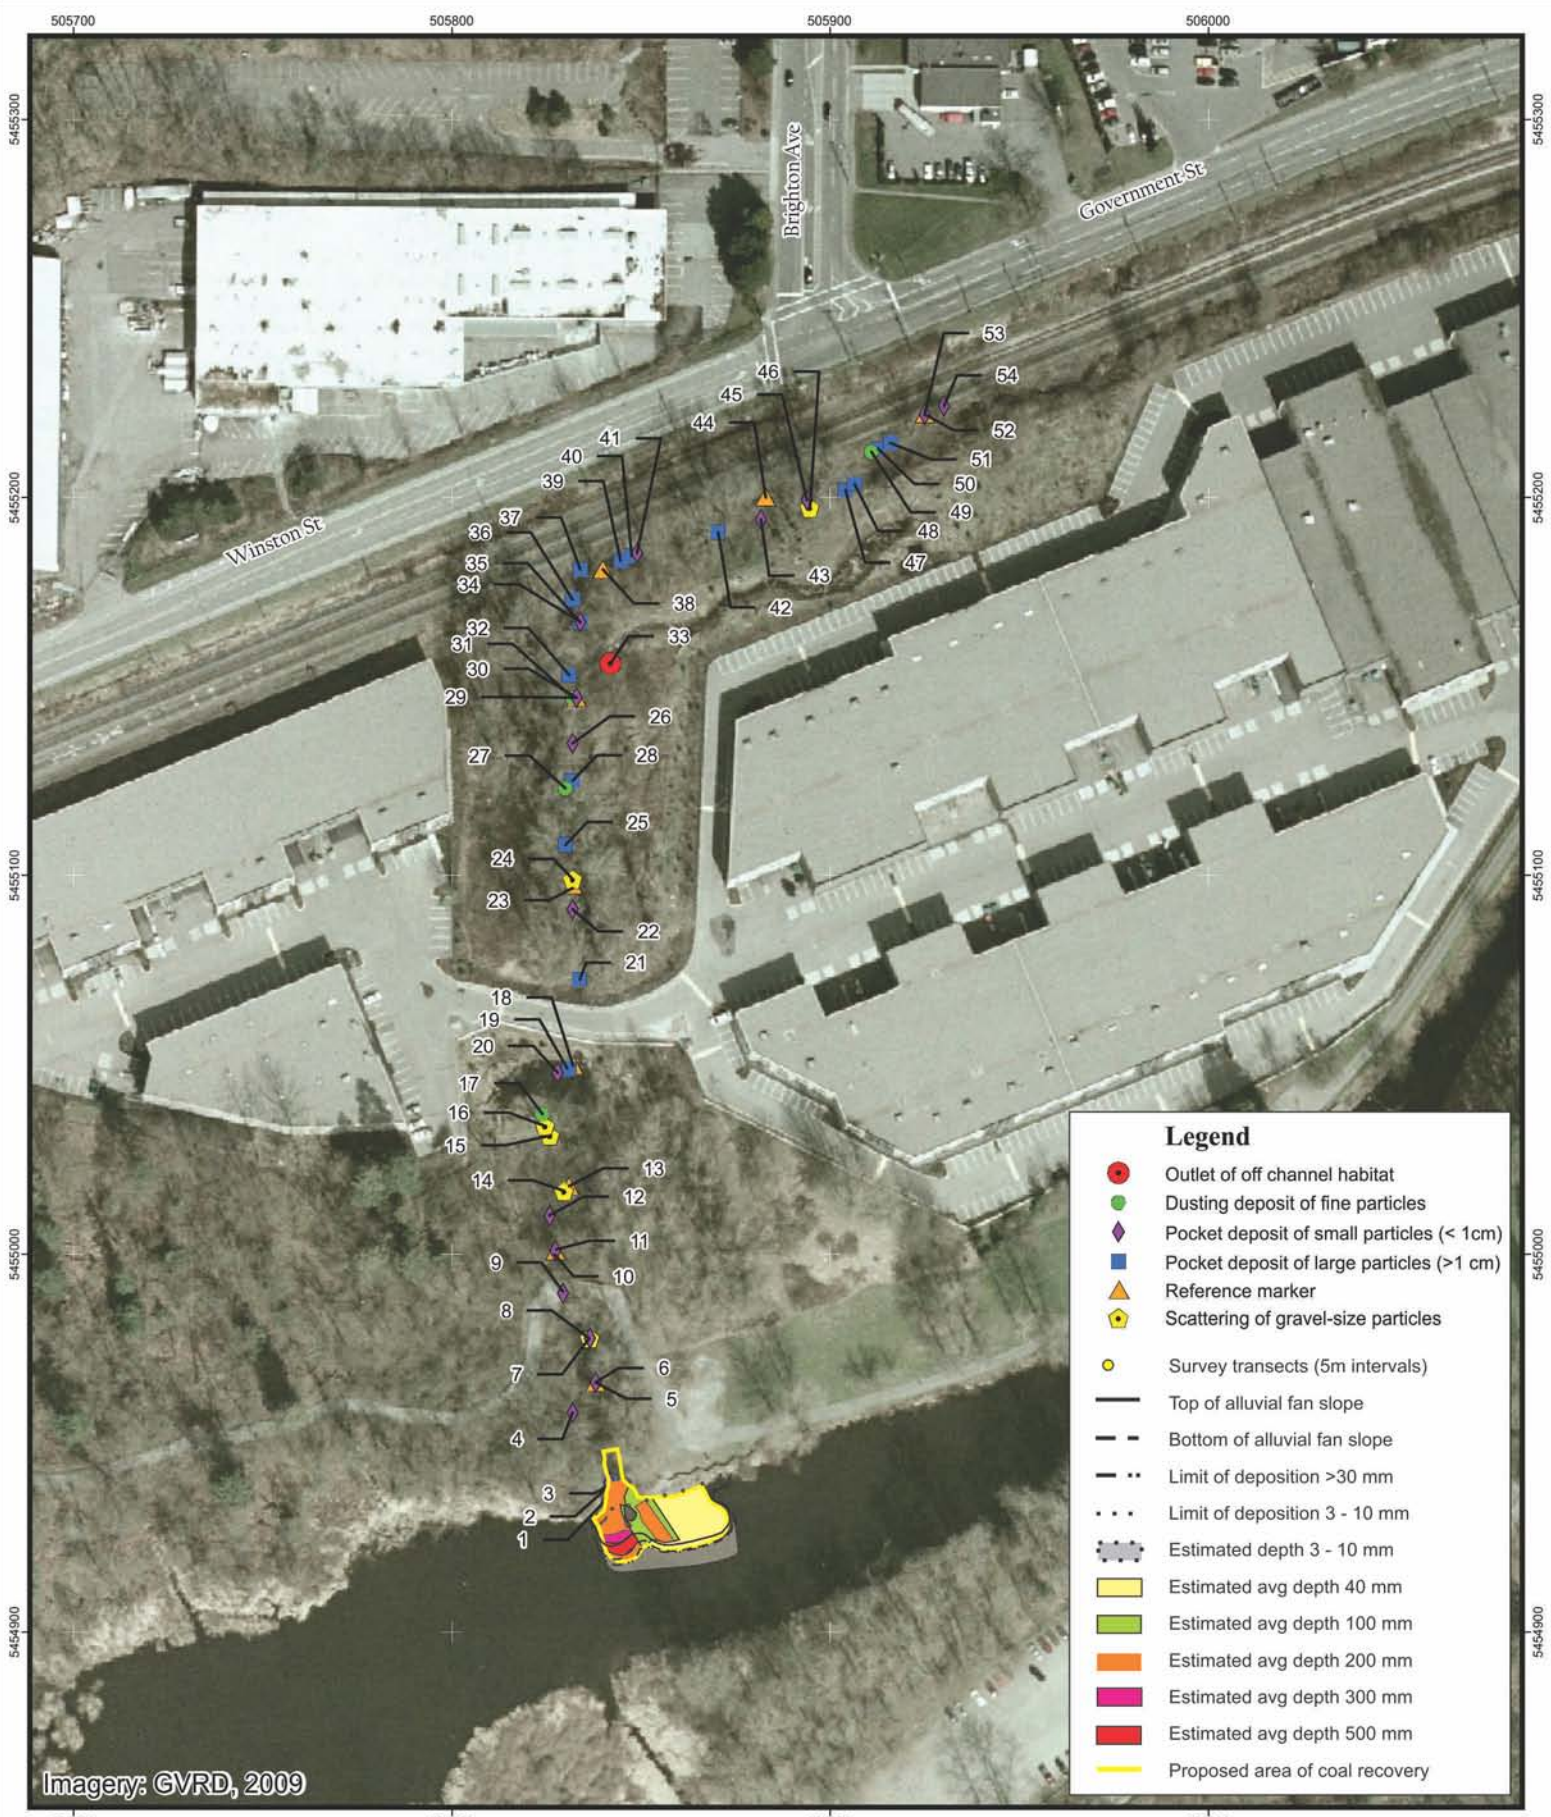
The Burnaby Lake deposition assessment identified an estimated 76 m<sup>3</sup> of coal deposited on the alluvial fan of Silver Creek at the confluence with Burnaby Lake. The deposition was characterized by three (3) general categories;

Coarse gravel size particles were generally confined to the western (upstream) end of the fan where one channel of Silver Creek enters Burnaby Lake on the west side of a vegetated bar. Mixed fines and small gravel were generally confined to the secondary channel on the east side of the vegetated bar, as well as within Silver Creek just upstream of the alluvial fan. The depth of coal deposition varied across the alluvial fan, with the thickest deposits observed at the outer edge of the fan along the flow path of main channel around the vegetated bar. In addition a thin layer of fine deposition (3 – 10 mm deep) was observed off shore from the alluvial fan. A dusting of deposition also extended downstream of the alluvial on the north side Burnaby Lake outlet channel towards Cariboo Dam but was only 1 mm deep (Triton, 2014b; Figure 1-3).

Recommendations for these deposition areas include leaving the material in place (e.g., for thin off shore layers of deposition), removal by hand near sensitive habitats (e.g., turtle basking platforms) and removal with equipment (e.g., vac truck).

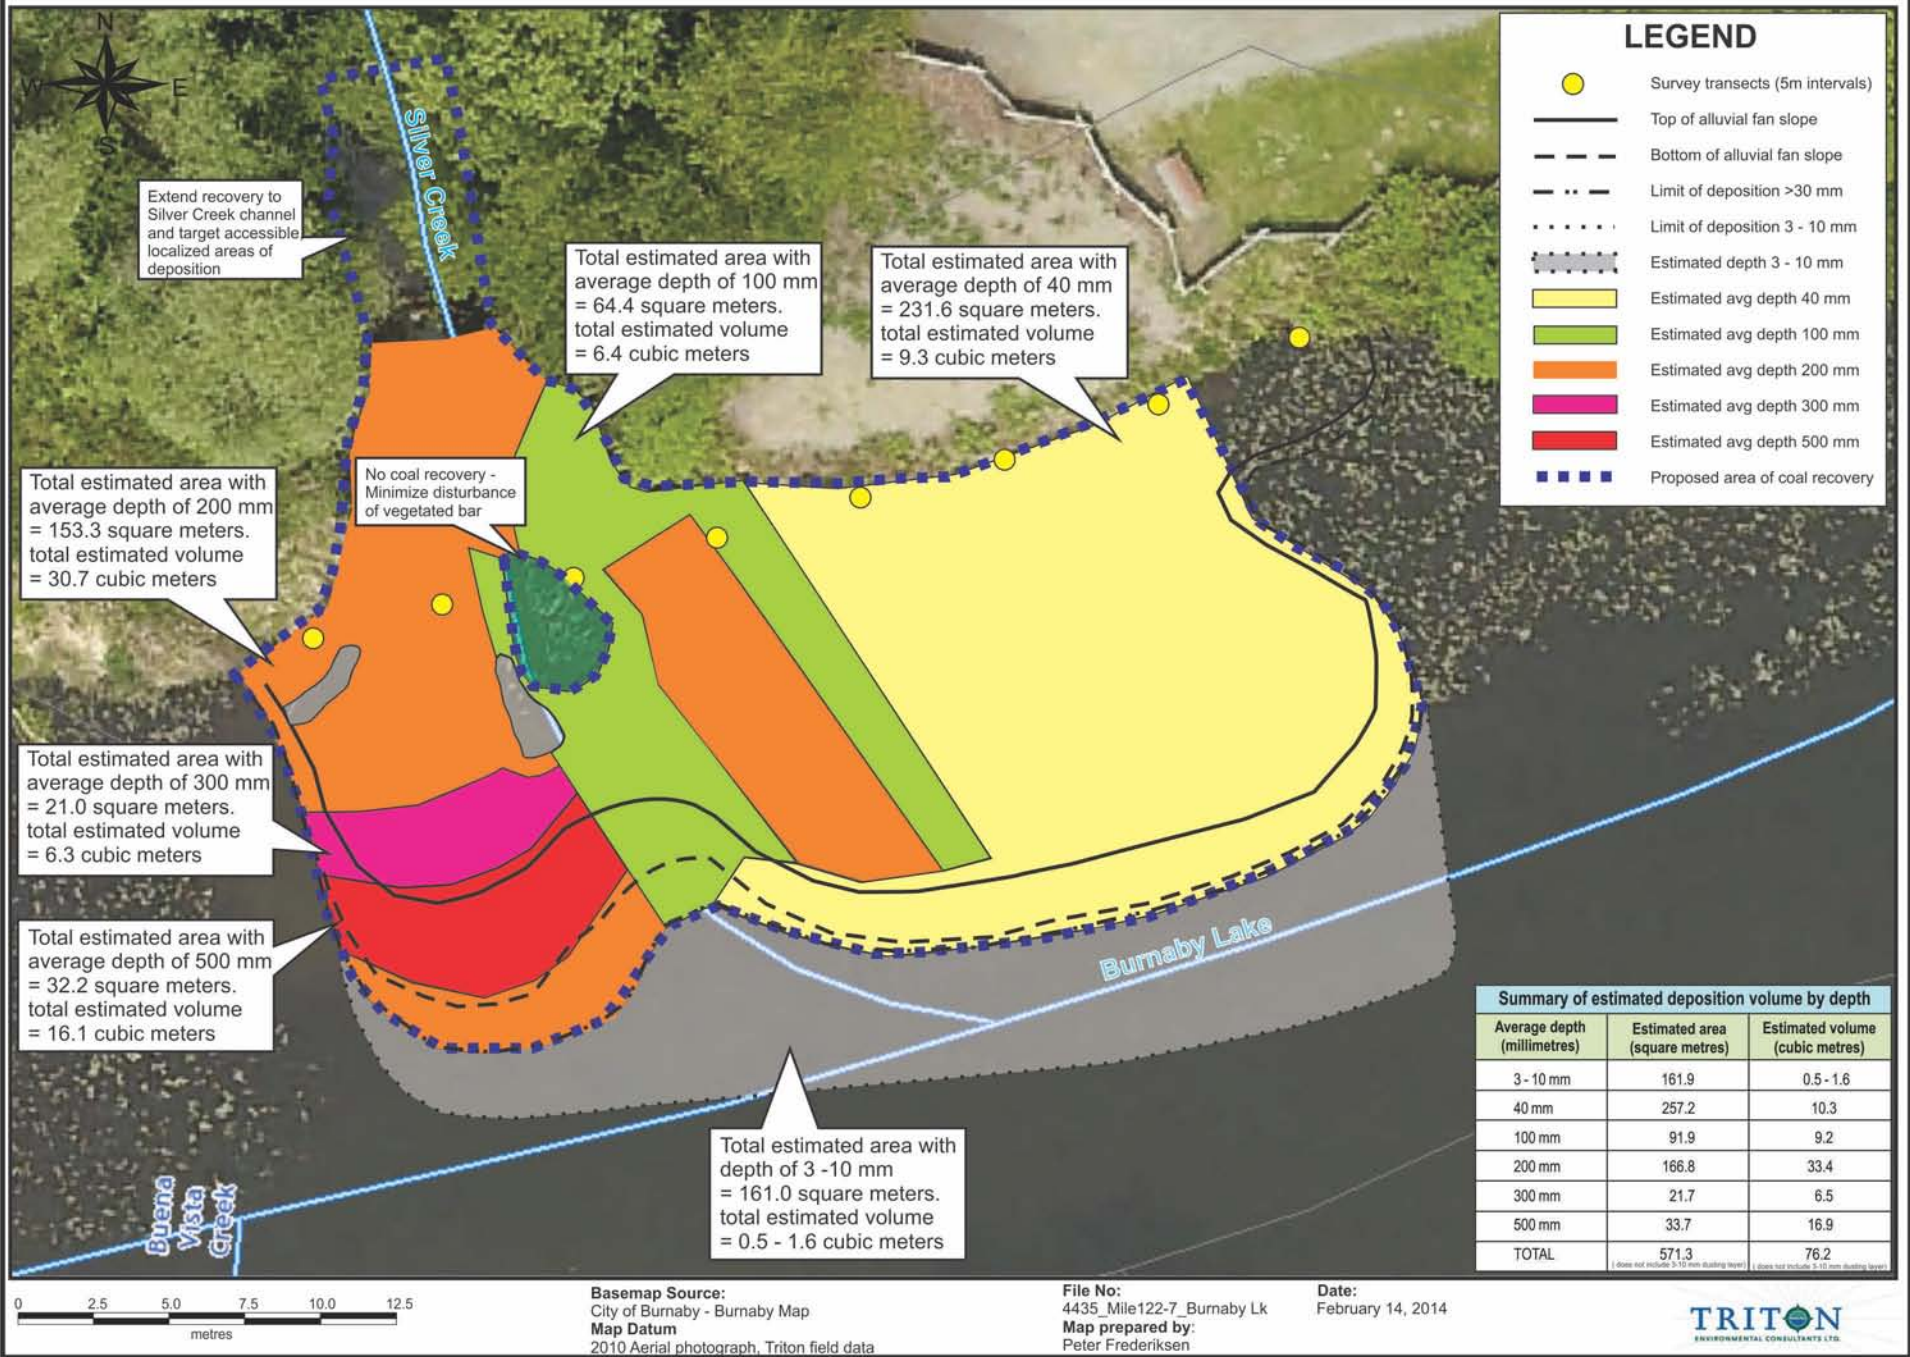
Figure 1-3. Proposed area of coal recovery in Burnaby Lake

The Burnaby Lake coal deposition assessment identified approximately 76 m<sup>3</sup> of recoverable coal at the alluvial fan near the confluence of Silver Creek.

Work to remove coal deposits in this area downstream of the Burnaby Lake Park footbridge over Silver Creek will be undertaken using primarily mechanical removal (i.e. vac truck suction dredging), but will be supported by hand recovery. Extensive plans have been developed to isolate the work area, and salvage aquatic organisms. The work area will be isolated with a silt curtain to contain disturbance in the water column. A 6" electric pump will be installed near the footbridge to divert at least a portion of flow from Silver Creek around the work area, and multiple techniques of aquatic life salvages will be used to remove fish, amphibians and turtles from the work area. Other measures to further partition the work area, and to contain or isolate daily work areas will also be considered and implemented when feasible (e.g silt fencing or geotextile barriers)

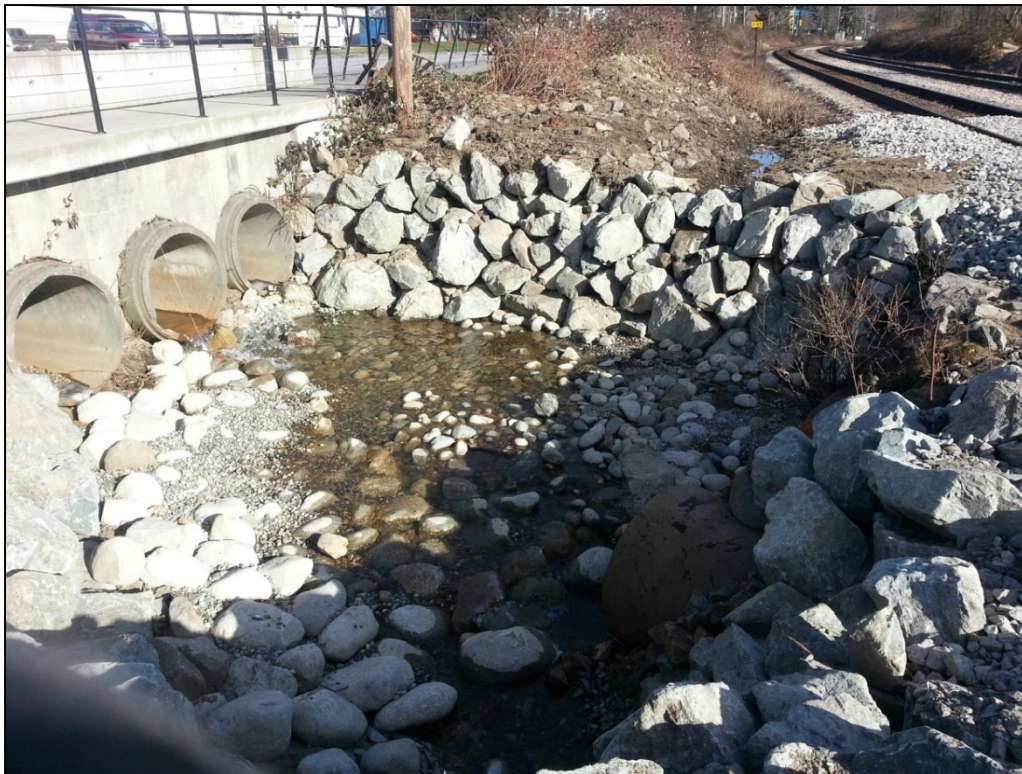
Silver Creek is a non-gazetted stream entering the railway ROW via three (3) municipal storm water pipes (Photo 1). Field surveys conducted in January 2014 indicated an average channel width of 4.06 m and an average wetted width of 3.22 m. Mean water depth at the time of survey ranged from 0.05 m to 0.26 m. Riffle and glide habitat units were common and the survey crew noted few pools with residual depths >0.3 m. The substrate was dominated by small cobble (SC) and large gravel (LG), with areas of extensive sand deposition along with exposed clay seams. Available cover was categorized as low (L) to moderate (M), and was provided mainly by undercut bank (U) and accumulations of large and small woody debris (LWD and SWD), with some overstream vegetation (OV) (Photo 2).

**Photo 1. City of Burnaby storm sewer outfall upstream of the railway ROW**

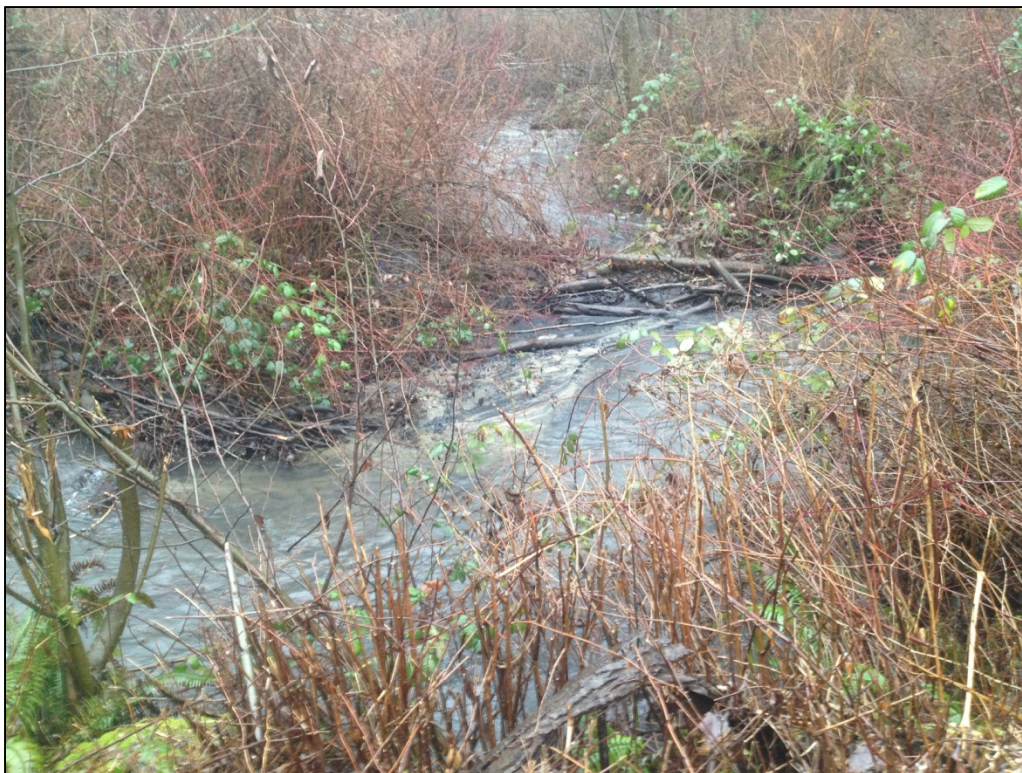
**Photo 2. Silver Creek downstream view**

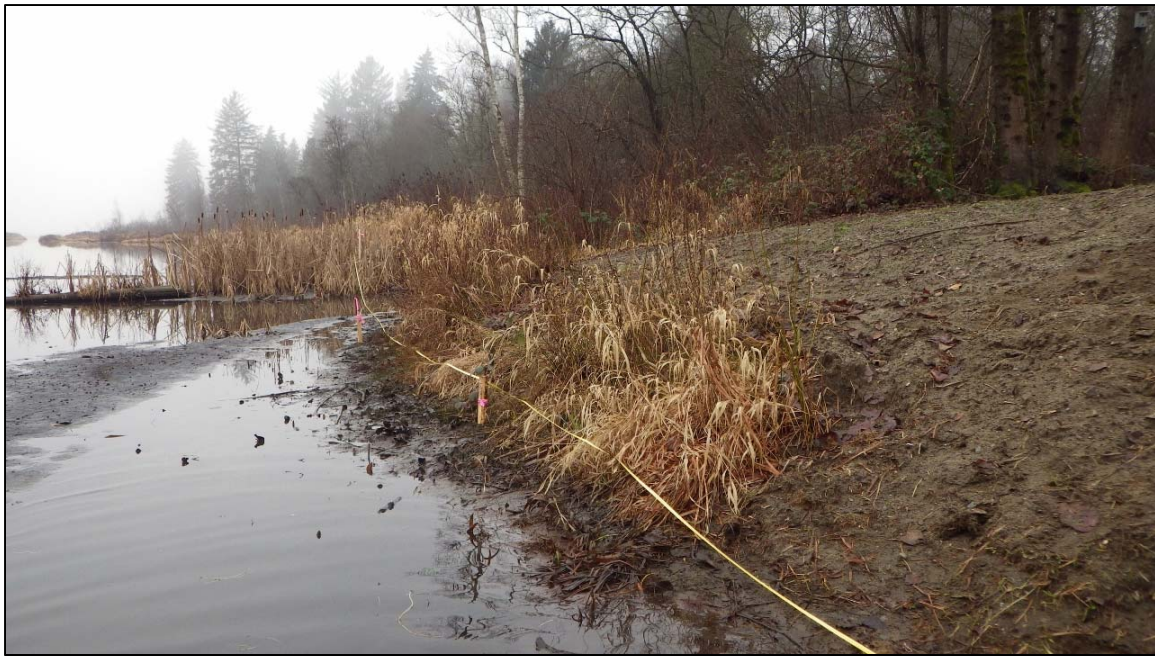
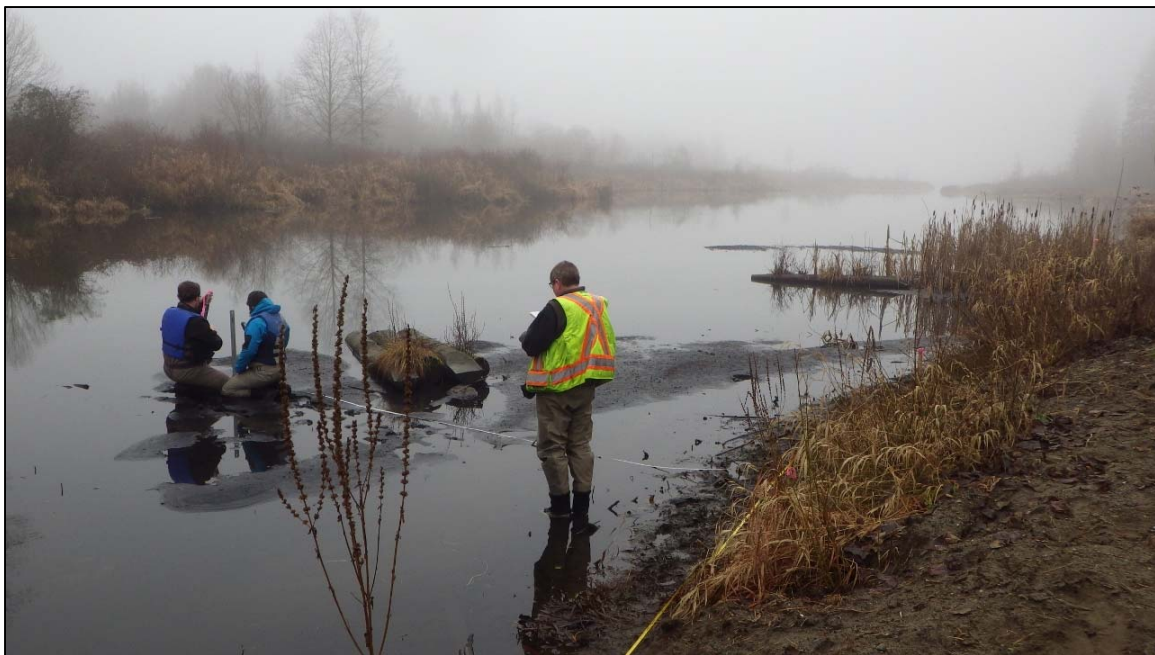
Western painted turtle overwintering habitat is located near the coal recovery area at the Silver Creek and Burnaby Lake confluence. A nesting beach is located upslope of the coal recovery area and will be used on a limited basis for accessing the coal deposit (Photos 3 and 4).

Photo 3: Turtle nesting beach and immediately adjacent offshore habitat

Photo 4: Turtle nesting beach and immediately adjacent offshore habitat

- If the nesting substrate is deemed to be unsuitable for turtles (e.g., due to inadvertent mixing of organic material from coal recovery operations or raking), the substrate will be replaced with a suitable mixture of sand and other material as specified by MFLNRO
- Pedestrian exclusion fencing will be re-constructed to pre-existing condition and any damaged signage will be replaced
- As part of coal recovery program the two (2) turtle basking platforms will need to be removed from the project area to facilitate turtle salvage and removal of coal from under the platforms.
- Prior to being repositioned the basking platforms will be pressure washed to remove residual coal and any staining
