Re: Non-compliance Advisory Letter, Permit 15087, Mount Polley Mine, Air

On April 12, 2017, Ministry of Environment, Environmental Protection Division staff conducted an inspection of your facility, Mount Polley Mining Corporation located at Mount Polley Mine with authorization number 15087 under the *Environmental Management Act*. Ministry staff were accompanied on site by Doug Ablett, Mount Polley Mining Corporation.

Ministry of Environment - Photo Record Sheet

PA15087	Mount Polley Mining Corporation
April 12, 2017	Mount Polley Mine

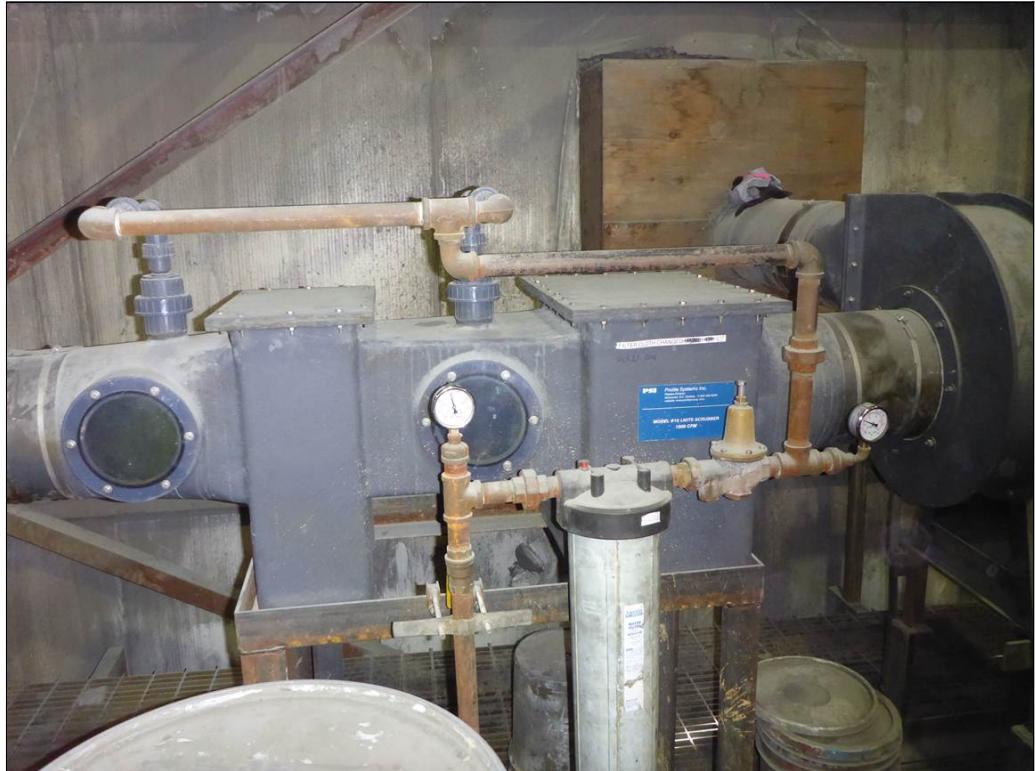
Details/Findings:	All authorized works listed were in place and operational at the time of inspection. The Assay Lab discharges through the acid gas scrubber. The remaining two wet scrubbers treat the discharges specified in sections 1.2 (Reagent Mixing and Storage Tank Vents) (see Figure 1) and 1.3 (Crusher and Screening Plant). Each authorized discharge should have a list of the authorized works associated with that specific discharge, listed in the appropriate section of the permit. This should be addressed as part of the next permit amendment.
Compliance:	In
Actions to be taken:	Ensure a list of authorized works specific to each section are included for each authorized discharge, as part of the next permit amendment.
Requirement Description:	2. GENERAL REQUIREMENTS, 2.2 Maintenance of Works and Emergency Procedures 2.2: The Permittee shall inspect the pollution control works regularly and maintain them in good working order. In the event of an emergency or condition beyond the control of the Permittee which prevents continuing operation of the approved method of pollution control, the Permittee shall notify the Regional Waste Manager or an Officer designated by the Regional Waste Manager: (a) by telephone if the condition occurs between the hours of 08:00 and 16:30, Monday to Friday on normal working days; and, (b) by facsimile transmission (398-4296) if the condition occurs at any other time. All such reports must be received within 24 hours of detection of the occurrence. In addition, emergencies involving spills to the environment (as defined in the Spill reporting Regulation), or spills to the effluent treatment facilities that have the potential to impair the treatment process, shall be reported immediately to the Provincial Emergency Program (1-800-663-3456).

Figure 1. Wet scrubber treating emissions from the Reagent Mixing and Storage Tank Vents.

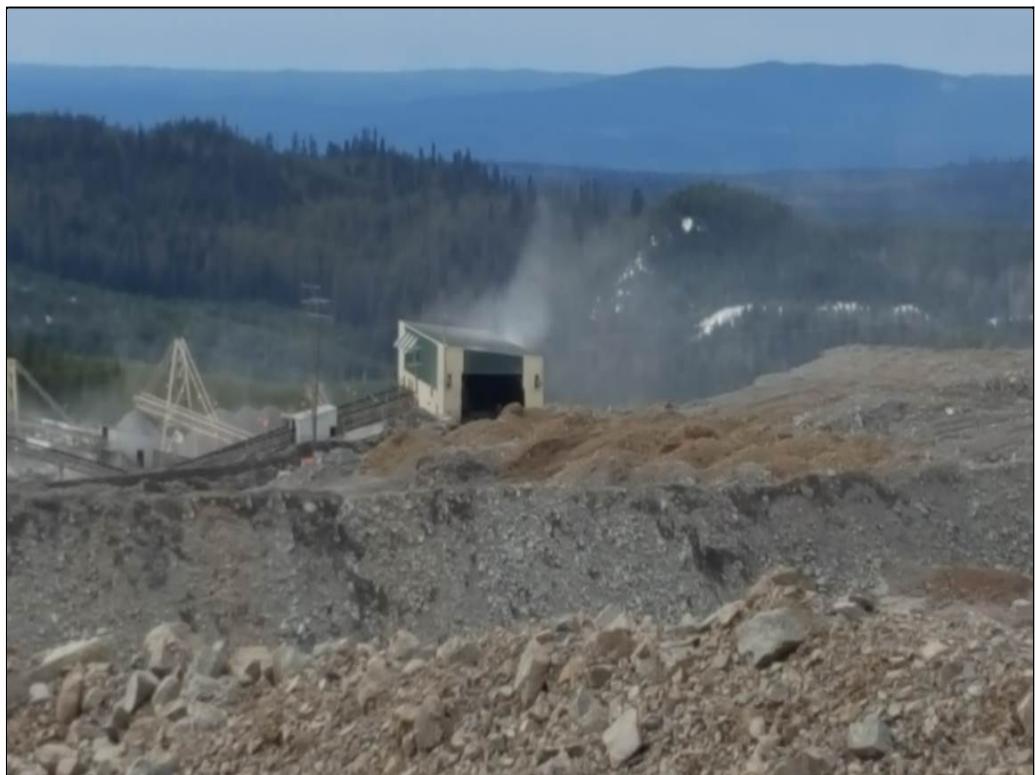
Figure 2. Fugitive dust emitting from the Crusher and Screening Plant discharge.

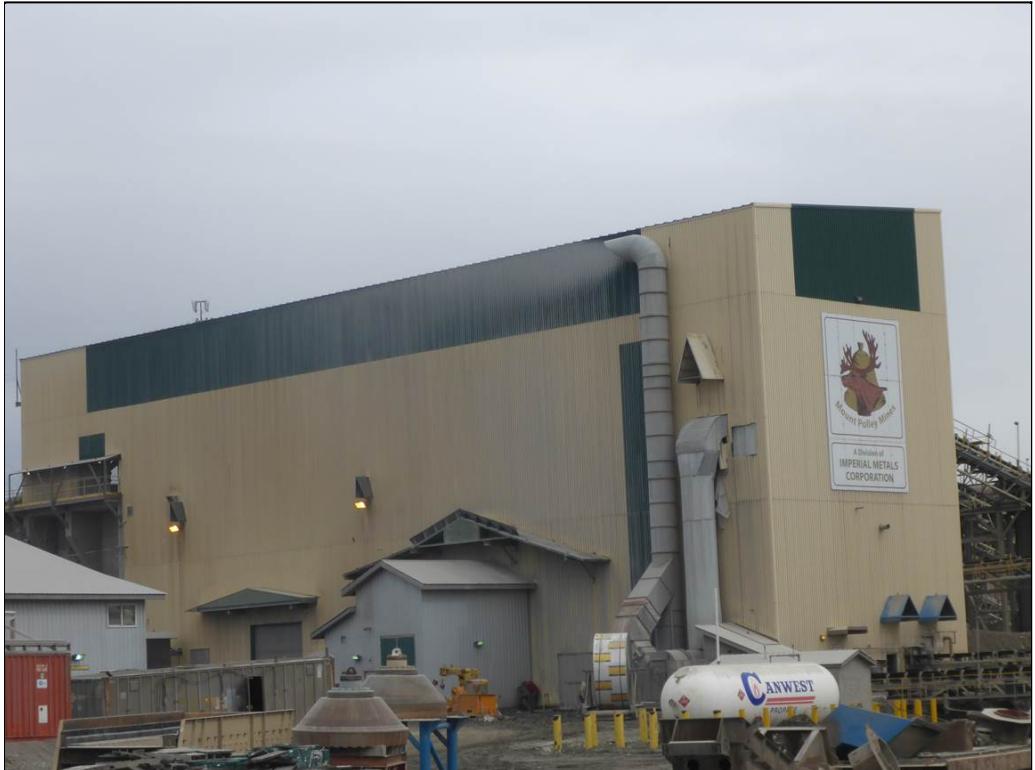
Details/Findings:	During the discussions with the operator, it was mentioned that during the winter, the water in the wet scrubber is prone to freezing. With no water in the system, wet scrubber can no longer treat the discharge. When the water freezes, the operator confirmed that the discharge continues, without treatment. Such an occurrence would be considered a condition beyond the control of the Permittee which prevents continuing operation of the approved method of pollution control. Despite this, the Ministry has not received notification of any of these events.
Compliance:	Not Determined

Figure 3. Discharge from the Crusher and Screening Plant. According to staff, in winter the wet scrubber is prone to freezing, resulting in an untreated discharge. Note the staining on the building, caused by the discharge.

Actions to be taken:	<p>In the event of a condition beyond the control of the Permittee which prevents continuing operation of the approved method of pollution control, (e.g. water in the wet scrubber freezes) the Permittee must notify the Director.</p> <p>Provide confirmation of the dates, since 1 October 2016, that the wet scrubber on the Crusher and Screening Plant was not in operation due to freezing temperatures, and whether the discharge continued at that time.</p> <p>Provide an action plan, including timeline, detailing what steps will be taken to address the issue of operating the wet scrubber at low temperatures. This action plan should include any changes to the current standard operating procedure regarding notification to the Director in the event of a condition beyond the control of the Permittee which prevents continuing operation of the approved method of pollution control, and any proposed modifications to site infrastructure to address the issue of the wet scrubber freezing.</p>

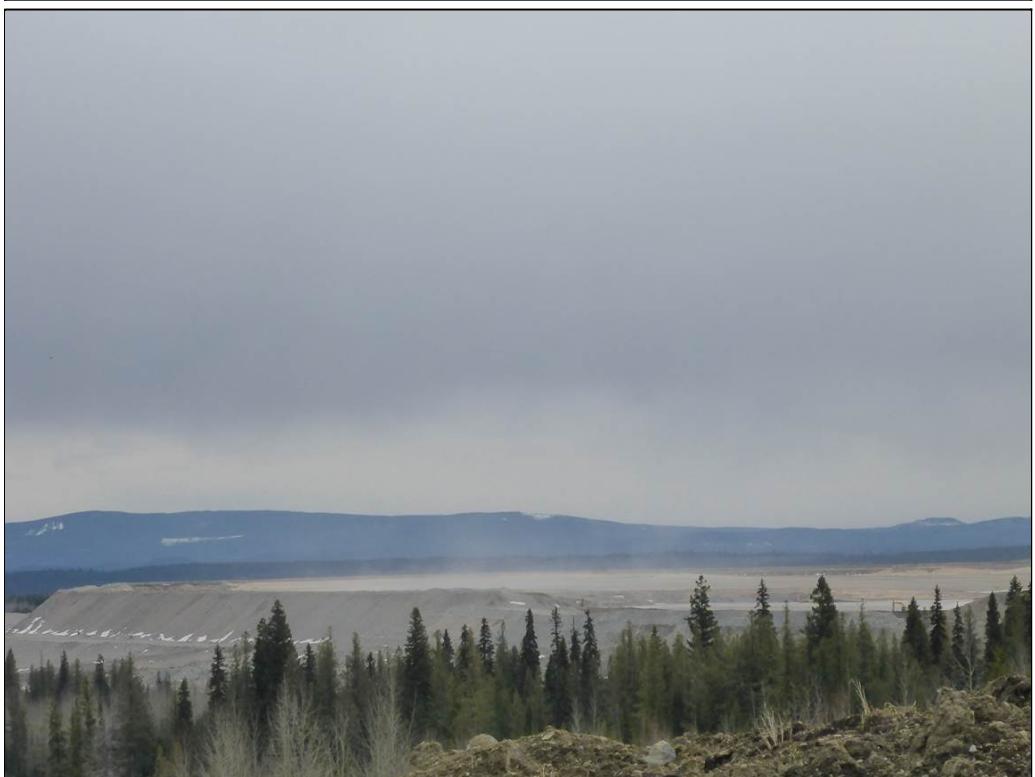
Compliance:	<p>In</p>
Actions to be taken:	
Requirement Description:	<p>2. GENERAL REQUIREMENTS, 2.5 Fugitive Dust Control</p> <p>2.5: The Permittee shall suppress fugitive dust created within the operation area. Any measured dustfall data shall be compared to the Ministry Objective value of 2.9 mg/dm²/d. If measured ambient air quality compares unfavourably to the Objective value, the Regional Waste Manager will evaluate the sensitivity of the receiving environment, the contribution of the Permittee's dustfall sources to the measured ambient values, plus any other pertinent information and may, at his discretion, require the Permittee to implement additional control measures on fugitive dust sources.</p>
Details/Findings:	<p>During the inspection, some dust was observed emitting from the Crusher and Screening Plant stack (see Figure 2).</p> <p>Some fugitive dust generation was observed on the Tailings Storage Facility (TSF) (see Figure 4). During the site inspection, Colleen reported that the sprinklers would be recovered from the TSF this year, citing limited effectiveness and safety issues, with the area influenced by the sprinklers becoming over saturated. Such steps will require the Fugitive Dust Control Plan to be updated to reflect changes in practices.</p>

Figure 4. Wind blown fugitive dust generation on the TSF.
