B.C. DAM SAFETY PROGRAM ANNUAL REPORT 2020/2021

EXECUTIVE SUMMARY

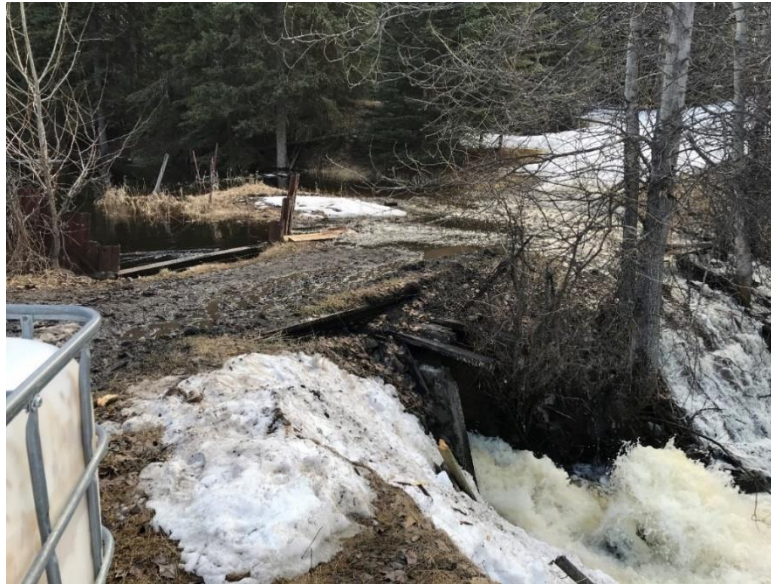
2. Dam Name: Spokin Lake Dam
DFile: D810450-00
Date: April 23, 2020
Classification: Low
Location: Northeast of 150 Mile House

On April 23rd, 2020, FLNR staff discovered Spokin Lake Dam was overtopping at the peak of freshet, starting the erosion of the downstream slope of the dam (Photo1). The unauthorized dam has an undersized outlet inadequate to pass inflows which cause flooding. It causes the reservoir to back up and floods upstream residential areas and the Spokin Lake Road at 11km. FLNR notified and worked on a plan with the dam owner to decommission the dam. An Order was issued on November 25th, which the dam owner promptly complied with, resulting in the decommissioning of the dam on February 24th, 2021.

Photo 1: Overtopping and erosion of downstream face of Spokin Lake Dam

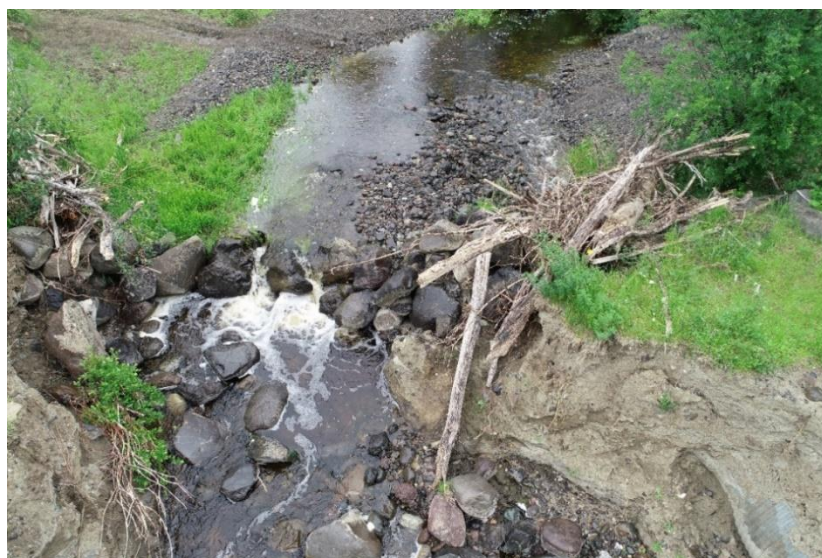
3. Dam Name: Valley Pond (Lower) Dam
DFile: D810559-00
Date: June 23, 2020
Classification: Low
Location: Near 150 Mile House

On June 23rd, 2020, on a works assessment regarding land transfer to the new owner from the former owner, FLNR staff discovered Valley Pond (Lower) Dam already breached (Photo 2). FLNR is coordinating efforts between the two parties ensuring that the dam is either decommissioned or rehabilitated in compliance with the Regulation and the choice of either one will depend on the needs of the new owner.

Photo 2: Valley Pond (Upper) Dam breach

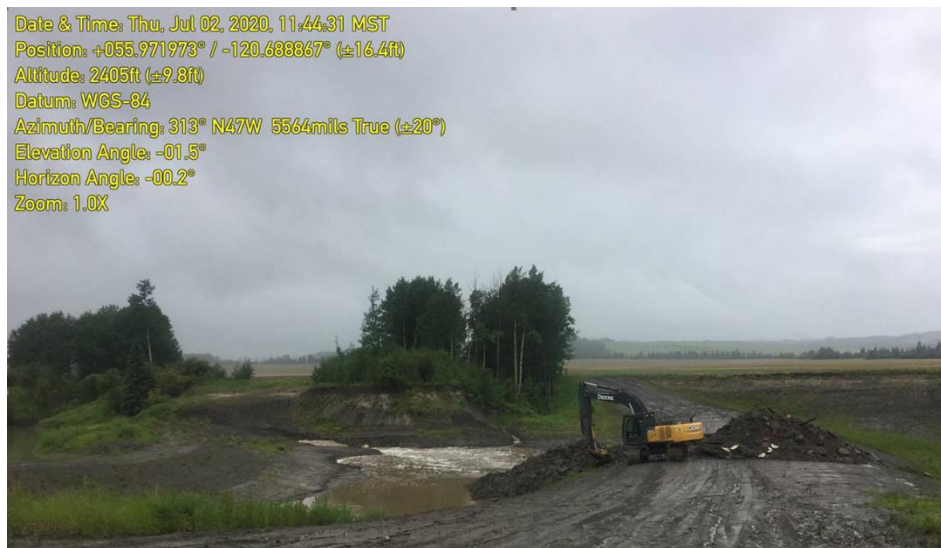
4. Dam Name: Unauthorized dams on tributary to Kiskatinaw River
DFile: None
Date: July 2, 2020
Classification: Probably Significant
Location: Southwest of Pine Valley, northeastern B.C.

On July 2nd, 2020, FLNR staff reported the failure of two unauthorized earthen dams associated with adjacent ponds on a tributary to the Kiskatinaw River (Photo 3). The lower pond was dammed and there was no spillway nor outlet supporting it. The lower pond dam was breached and at the time of the initial report the owner mobilized an excavator to control the erosion of the breach. The upper pond flowed into the lower pond through an outlet channel which was also slowly eroding. Current satellite imagery shows the dams have been removed but the bed of the lower pond has been raised yet still allowing drainage from the upper pond area. There are issues associated with unlicensed use of water and unauthorized construction of works especially dams that FLNR is currently resolving legally with the dam owner.

Photo 3: Unauthorized dams associated with storage ponds southwest of Pine Valley

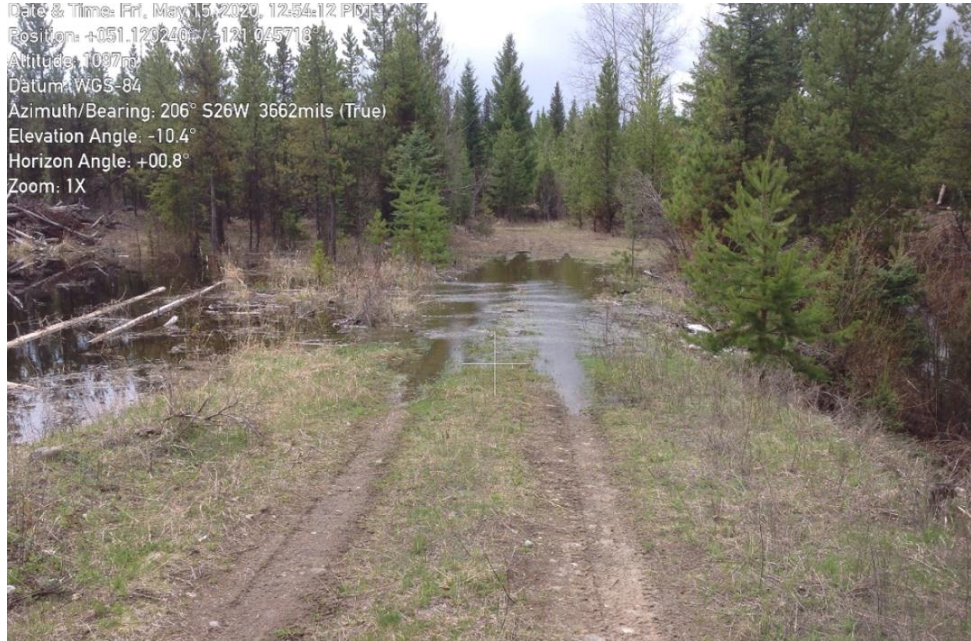
1. Dam Name: Goldie Lake Dam
DFile: D110229-00
Date: May 15, 2020
Classification: Low
Location: East of Clinton

On May 15, 2020, FLNR staff discovered Goldie Lake Dam was overtopping because of the 900mm culvert spillway under the road accessing recreational land on the other side of the lake was blocked with debris (Photo 4). The dam owner, upon being notified by FLNR to activate the dam emergency plan, removed the debris with equipment to allow flood water pass through the spillway to reduce the water level. The owner was also required to monitor the condition of the dam. FLNR staff have since been to the site to confirm the work has been completed, water level receding, and the spillway performing as it should.

Photo 4: Overtopping of Goldie Lake Dam (looking south south-west from right bank)

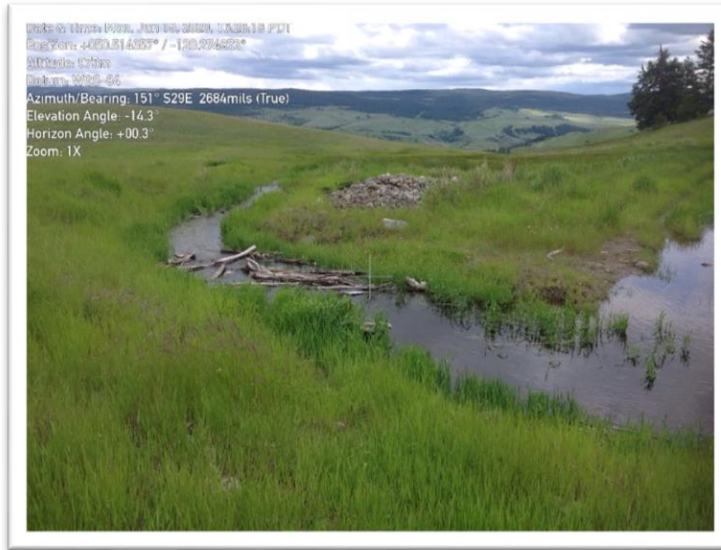
2. Dam Name: Ussher Creek Dam
DFile: D120298-00
Date: June 15, 2020
Classification: Significant
Location: Southeast of Kamloops

On June 15, 2020, Ministry of Transportation and Infrastructure (MOTI) staff notified FLNR that Chilliheetza Pond had exceeded its capacity overtopping Ussher Creek Dam (Photo 5). The resulting excessive flows downstream impacted the ditches and undersized culverts of Hwy 5A below, near Shumway Lake. On a visit to the dam, FLNR staff discovered the cause of the overtopping: the dam did not have a lower level outlet, showed excessive seepage below the dam, and had debris blocking the spillway. The dam owner was contacted to clear the spillway of the debris, monitor the condition of the dam, retain a qualified engineer to assess the dam, and keep FLNR informed of any development. It was evident that the dam owner had not maintained the flows into the reservoir nor the dam. Because of the lack of full channel flow in recent years and continued property development downstream of the dam, no action was taken during the time for dam remediation. The owner only monitored the condition of the dam and continued surveillance of Hwy 5A to ensure the travelling public was not put at risk. FLNR followed up with an order for the owner to drain the reservoir and assemble a plan to either repair or replace the dam. The current water licence held by

Photo 5: Debris in the spillway and high-water level at the Ussher Creek Dam (looking southeast)

the owner does not permit the total diversion of water from Ussher Creek to the reservoir. FLNR had also ordered the installation of a proper and adjustable diversion structure.

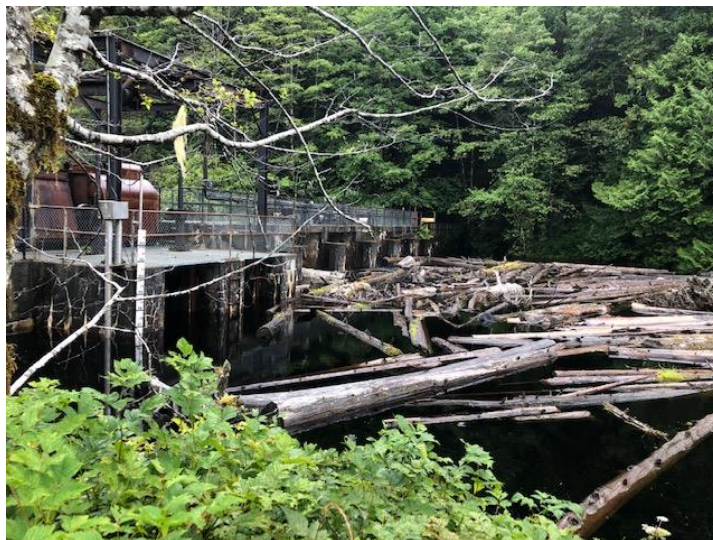
- Dam Name: Kloiya Dam
DFile: D630007-00
Date: August 15, 2020
Classification: Significant
Location: East of Port Edward

On August 15, 2020, rainfall from a large localized storm increased the reservoir level of Kloiya Dam causing large flows through the spillway of the dam breaking the log boom holding a lot of debris (Photo 6). The dam owner advised FLNR that the debris would be removed from the spillway, the spillway inspected, and the log boom repaired; these were all completed when the reservoir level fell after the storm to its normal level. The gates were also inspected.

Photo 6: Log Debris from broken boom at Kloiya Dam

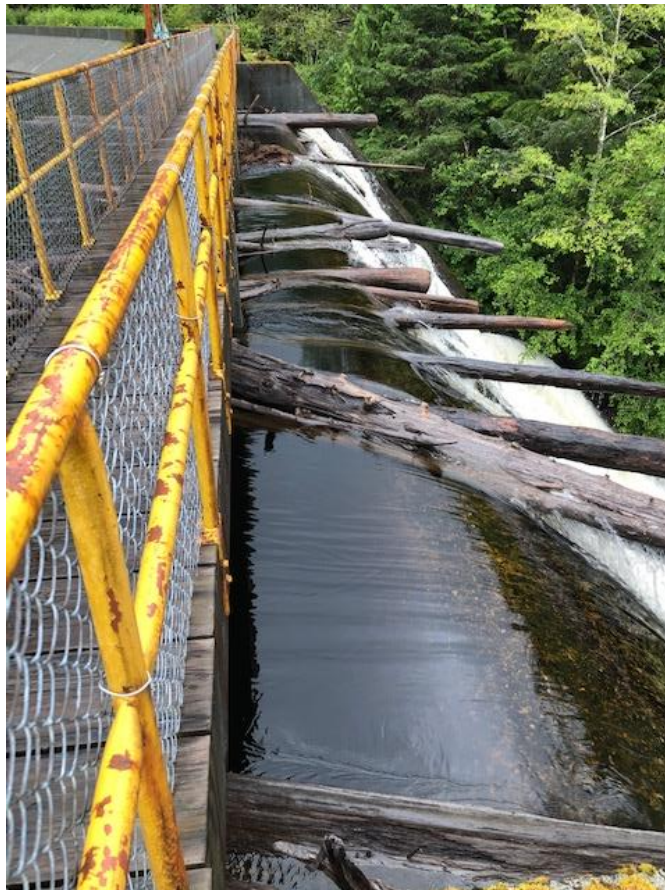
- 4. Dam Name: Diana Lake Dam
- DFile: D630002-01
- Date: August 15, 2020
- Classification: High
- Location: East of Port Edward

On August 15, 2020, the same storm impacting Kloiya Dam also impacted Diana Lake Dam raising the reservoir level resulting in large flows bringing log debris onto the spillway (Photo 7). Similarly, the dam owner hired a contractor to remove the debris from the spillway and reset the log boom when it was safe. After the storm, the owner drew down the reservoir to inspect the spillway and the dam including the gates.

Photo 7: Log debris on the spillway of the Diana Lake Dam

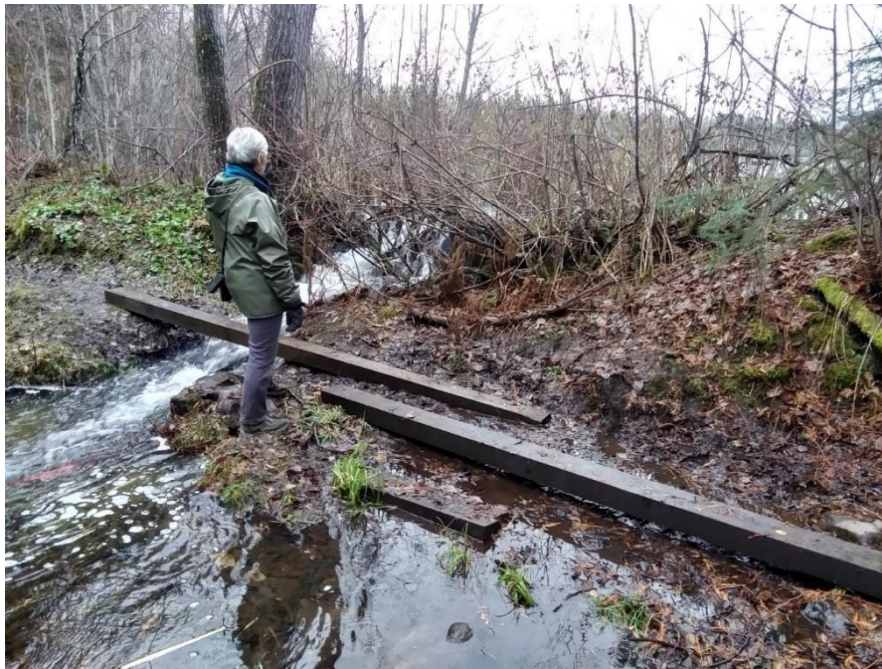
- 5. Dam Name: Ross Lake Dam
- DFile: D620240-00
- Date: November 13, 2020
- Classification: High
- Location: Southwest of New Hazelton

On November 13, 2020, FLNR was made aware of an unauthorized 65m long dam on the northern end of the Ross Lake Park. On November 16 and 18, the dam owner and FLNR staff discovered Ross Lake Dam had overtopped and a stable breach had formed spilling water into a channel outlet (Photo 8) which flowed in the direction of the Bulkley River. At the time, no sign of active erosion of fill material was visible and the dam allowed 1.5m depth of live storage of water. Concerned that an uncontrolled breach could destroy railway infrastructure below, FLNR ordered the dam owner on November 20 to breach the dam to prevent any water storage and then retain a qualified professional to assess the structure. FLNR is working with the dam owner to either rehabilitate or decommission the dam depending on the interests of the dam owner and Canadian National Railway.

Photo 8: Upstream view of breached dam looking south to Ross Lake

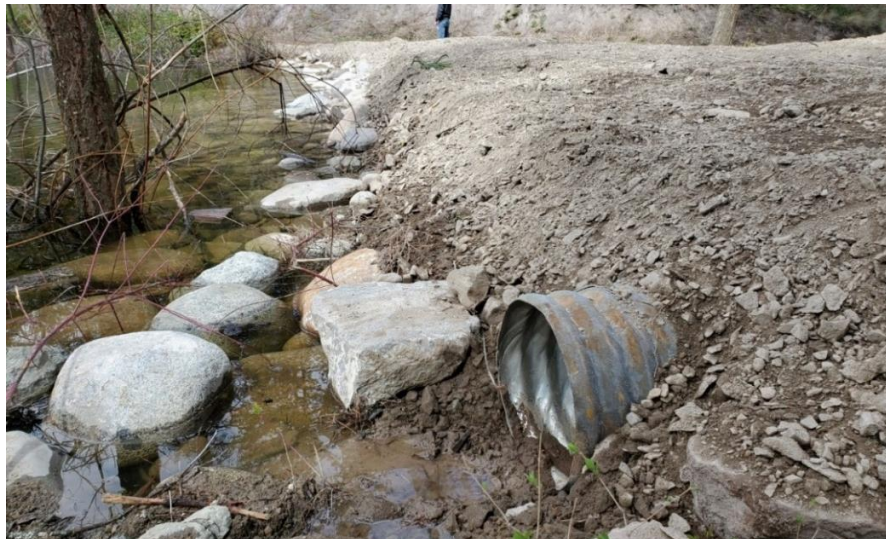
1. Dam Name: Unauthorized dam on lake west of Okanagan Lake
DFile: None
Date: April 6, 2020
Classification: Significant
Location: Vicinity of Turtle Road in Okanagan Falls

On April 6, 2020, FLNR staff discovered a dam was constructed on an unnamed lake near Okanagan Falls (Photo 9). On April 23rd, a DSO further found the dam to have 0.8m of material added, raising the dam crest to 6m in height to accommodate a corrugated metal pipe 40cm in diameter as a spillway. Freeboard on the lake was 0.5m and seepage at the downstream toe of the dam was at 1 to 2 litres per minute. The DSO determined that the dam was regulated under the Dam Safety Regulation. After contacting the owner the next day about the dam, FLNR learned that the owner thought he was authorized to construct the dam from the water licences he was issued. None of the licences authorized the construction of the dam at this location. Uncontrolled release of water from this lake would create a debris flow that would destroy private and public roads downstream of the dam causing significant damage. The dam owner was directed to remove the dam, or if the dam was to be kept, to have it rehabilitated to meet the requirements of the Regulation.

Photo 9: Unauthorized regulated dam with recently added culvert spillway of unnamed lake northwest of Okanagan Falls.

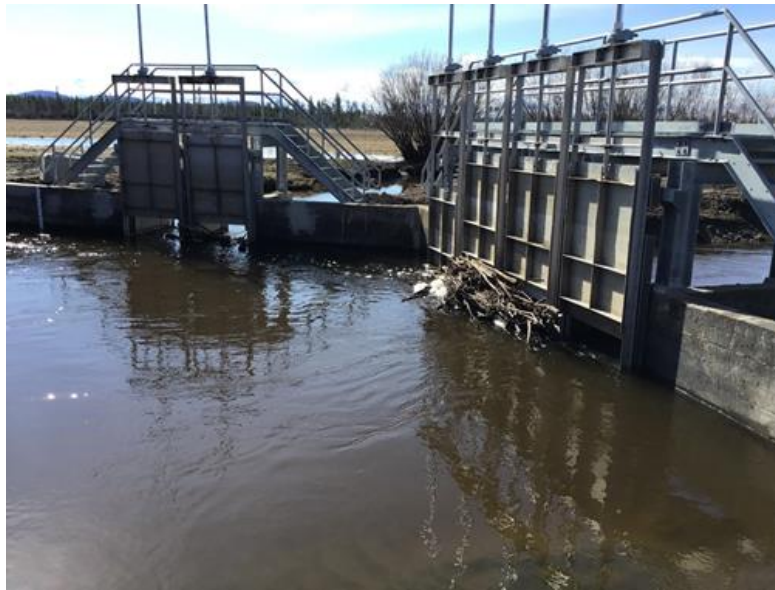
2. Dam Name: Anahim Creek Diversion Dam
DFile: D810584-00
Date: April 30, 2020

On April 30, 2020 during an aerial rapid dam assessment, FLNR staff noted Anahim Creek Diversion Dam was performing as designed but discovered other problems with the dam that needed to be rectified. Specifically, debris plugged the gate (Photo 10), scouring the left and right abutments, concrete catwalk supports excessively damaged, the stair foundation settled, gate slides misaligned, and the lock block reinforcement wall had fallen into the creek. FLNR has directed the dam owner to retain a qualified engineer to review the dam and other structures and plan the repair of the facilities.

Photo 10: Debris plugging the opening preventing closure of the slide gate of the Anahim Creek Diversion Dam

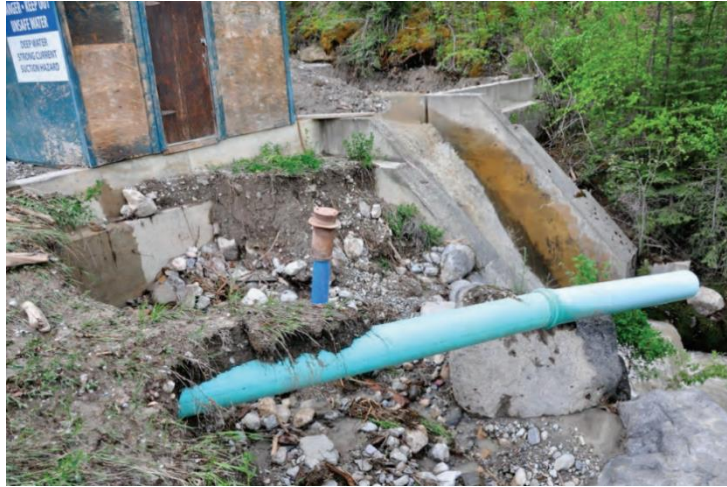
3. Dam Name: Cold Spring Creek Dam
DFile: D330122-00
Date: May 31, 2020
Classification: Significant
Location: Vicinity of Fairmont Hotsprings

On May 31st, 2020, 33mm of rainfall in the area around Fairmont Hotsprings followed by two days of extremely hot weather resulted in substantial snow melt in the upper elevations. This triggered several debris flows that flooded areas of the town including Cold Spring channel and Cold Spring Creek Dam. In addition to the debris filling the headpond behind the dam, it overtopped the dam, eroding the abutments on the downstream face (Photo 11). The Regional District of the East Kootenay (RDEK) have dredged the reservoir of the dam to remove debris as part of an extensive effort to repair the damage caused by the debris flood. FLNR was informed by the RDEK that the repairs to the dam, however, was not completed by the dam owner. FLNR staff had confirmed with the owner on June 17th that the dam had been rehabilitated. They also informed the dam owner on the need to contact FLNR when a hazardous incident occurs at the dam. RDEK had commissioned

Photo 11: Downstream face of the Cold Spring Creek dam showing path of water to right side of spillway and resulting scour (Credit: Northwest Hydraulics Consultants)

several studies which recommended that the dam and reservoir be upgraded to also contain debris and improve routing of water flow, should a similar event recur on the Cold Spring Creek.

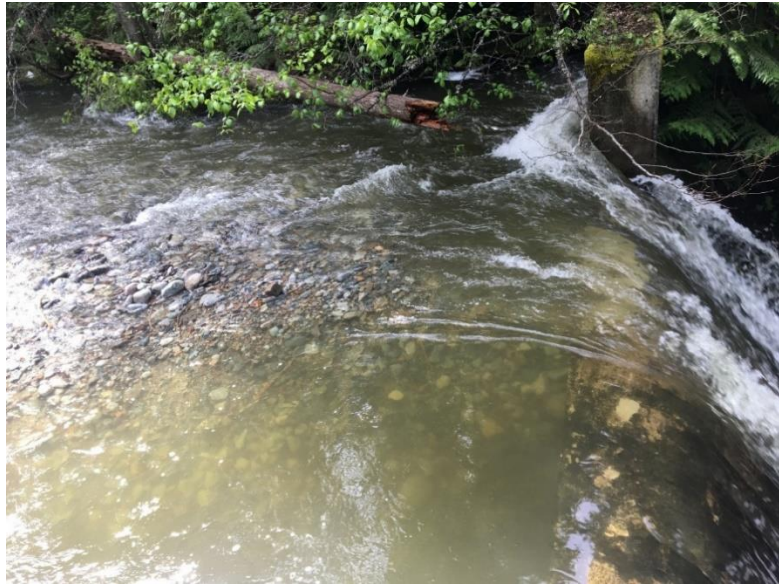
4. Dam Name: Rover Creek Dam
DFile: D350152-00
Date: June 2, 2020
Classification: Significant
Location: West of South Slocan

On June 2nd, 2020 during freshet, FLNR staff was notified by dam owner staff that sediment was filling the reservoir of Rover Creek Dam to the height of the spillway sill (Photo 12) because of increased inflows. In monitoring the condition of the dam, they were advised to contact FLNR if there were changes that require attention. They had indicated that the new sediment load would be dredged after the freshet.

Photo 12: The sediment load has reached the spillway sill of the Rover Creek Dam

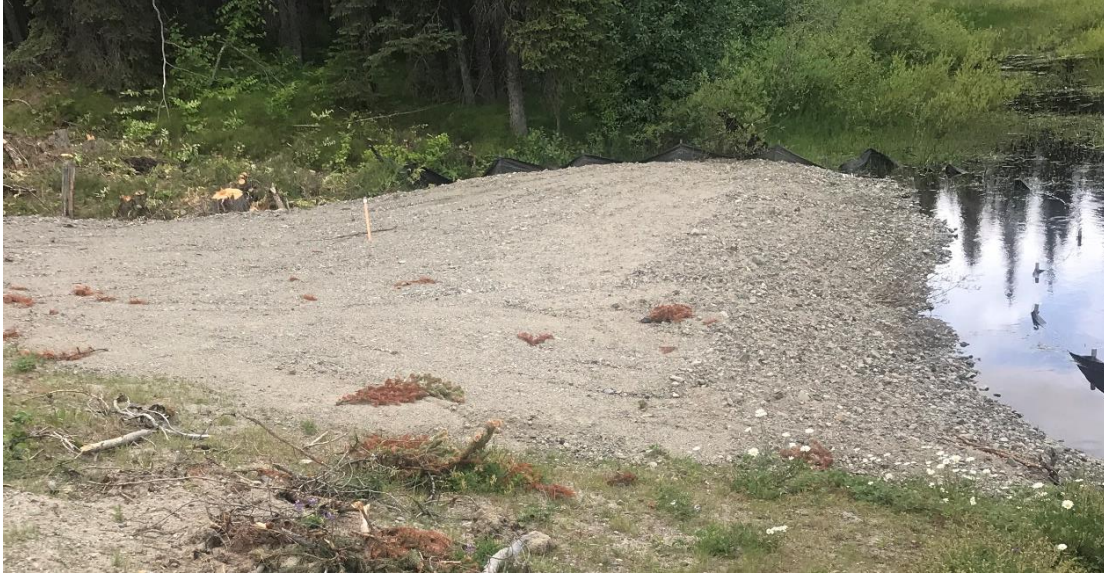
5. Dam Name: Headwaters #1 Dam
DFile: D220003-00
Date: June 3, 2020
Classification: Very High
Location: West of Peachland

On June 3rd, 2020 after regular surveillance, dam owner staff contacted FLNR about a seepage boil discovered at the toe of Headwaters #1 Dam. Such boils emerge typically due to preferential water flow and movement of soil particles through earthen dams towards the downstream toe and, if not remediated, can eventually lead to internal piping failure. FLNR staff advised the dam owner to provide updates on the progress of the work to mitigate piping. The dam owner had retained an engineering consultant to investigate and recommend appropriate measures to repair the problem and to keep FLNR informed of the work. In addition to receiving an engineering report documenting the work that was completed, FLNR staff have visited the site on July 24th to review and confirm the placement of a sand/gravel filter over the boil and continued surveillance (Photo 13).

Photo 13: Repaired boil at Headwaters #1 Dam. Photo taken on July 24, 2020.

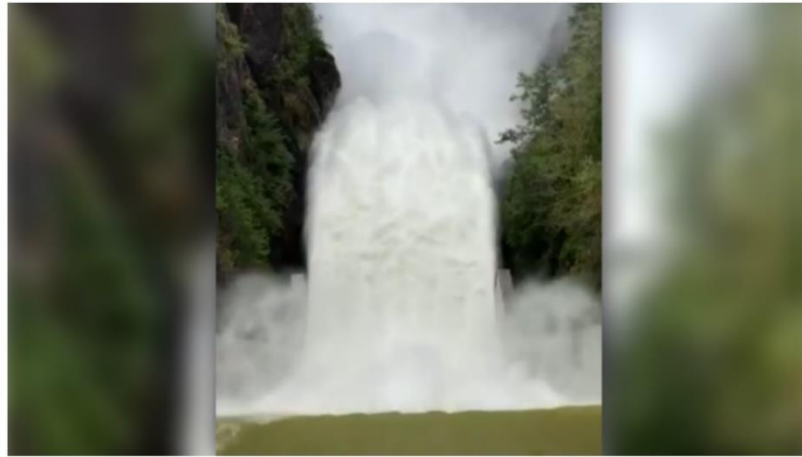
On October 1, 2020, the radial drum gate of Cleveland Dam unexpectedly open spilling water during maintenance work on sensors that control the drum gate (Photo 14). This sudden uncontrolled release of water into the Capilano River resulted in the deaths of two people and injury to several other people who were recreating near the river. FLNR staff have met Metro Vancouver dam safety staff and completed a site visit to review and work with Metro Vancouver to determine the cause of the dam incident. An investigation by Metro Vancouver revealed that faulty instrumentation programming controlling the movement of the gate by dam maintenance staff created conditions

leading to an unscheduled release of water. Staff responsible for the incident had their employment subsequently terminated. Other investigations conducted by the RCMP, BC Coroner's Service, and WorkSafe BC are currently underway. The BC Dam Safety Program will be closely reviewing any recommendations regarding public safety around dams resulting from these assessments to help improve public safety.

Photo 14: Uncontrolled release of water from the Cleveland Dam, October 1, 2020
(Credit: Twitter/Christine Tam)

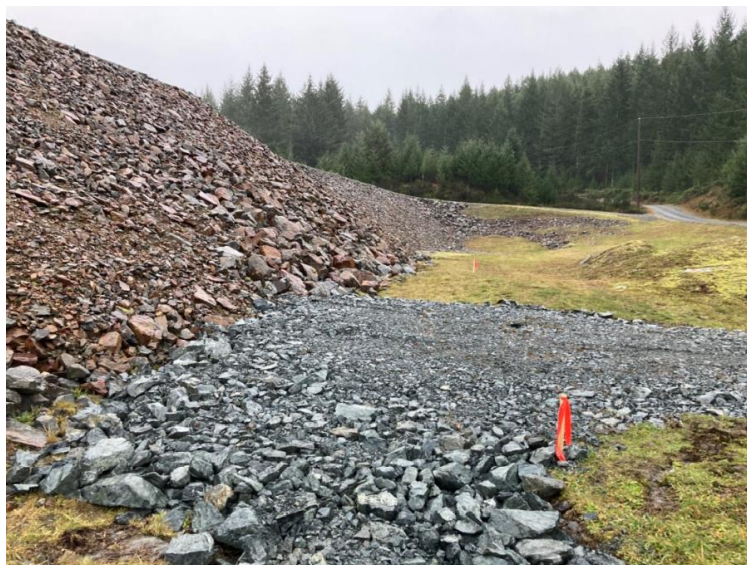
6. Dam Name: Sooke Lake Dam
DFile: D730006-01
Date: December 10, 2020
Classification: Extreme
Location: West of Langford

On December 10, 2020, Sooke Lake Dam owner staff, conducting maintenance work stripping the ground to bedrock at the toe of the dam, discovered seepage collecting in the created depression (Photo 15) over time. A consultant engineer determined that the source of the seepage was not from the dam but from the rockfill also located at the toe of the dam but higher up relative to the depression location.

Photo 15: Filled depression at toe of Sooke Lake Dam where seepage collected
