DETECTION OF SEPTIC TANK LEACHATE INFLOWS  
FROM SHORELINE DEVELOPMENT - OSOYOOS LAKE

P.F. Epp  
Waste Management Program  
Okanagan Sub-Region

Penticton, B.C.  
April 1985

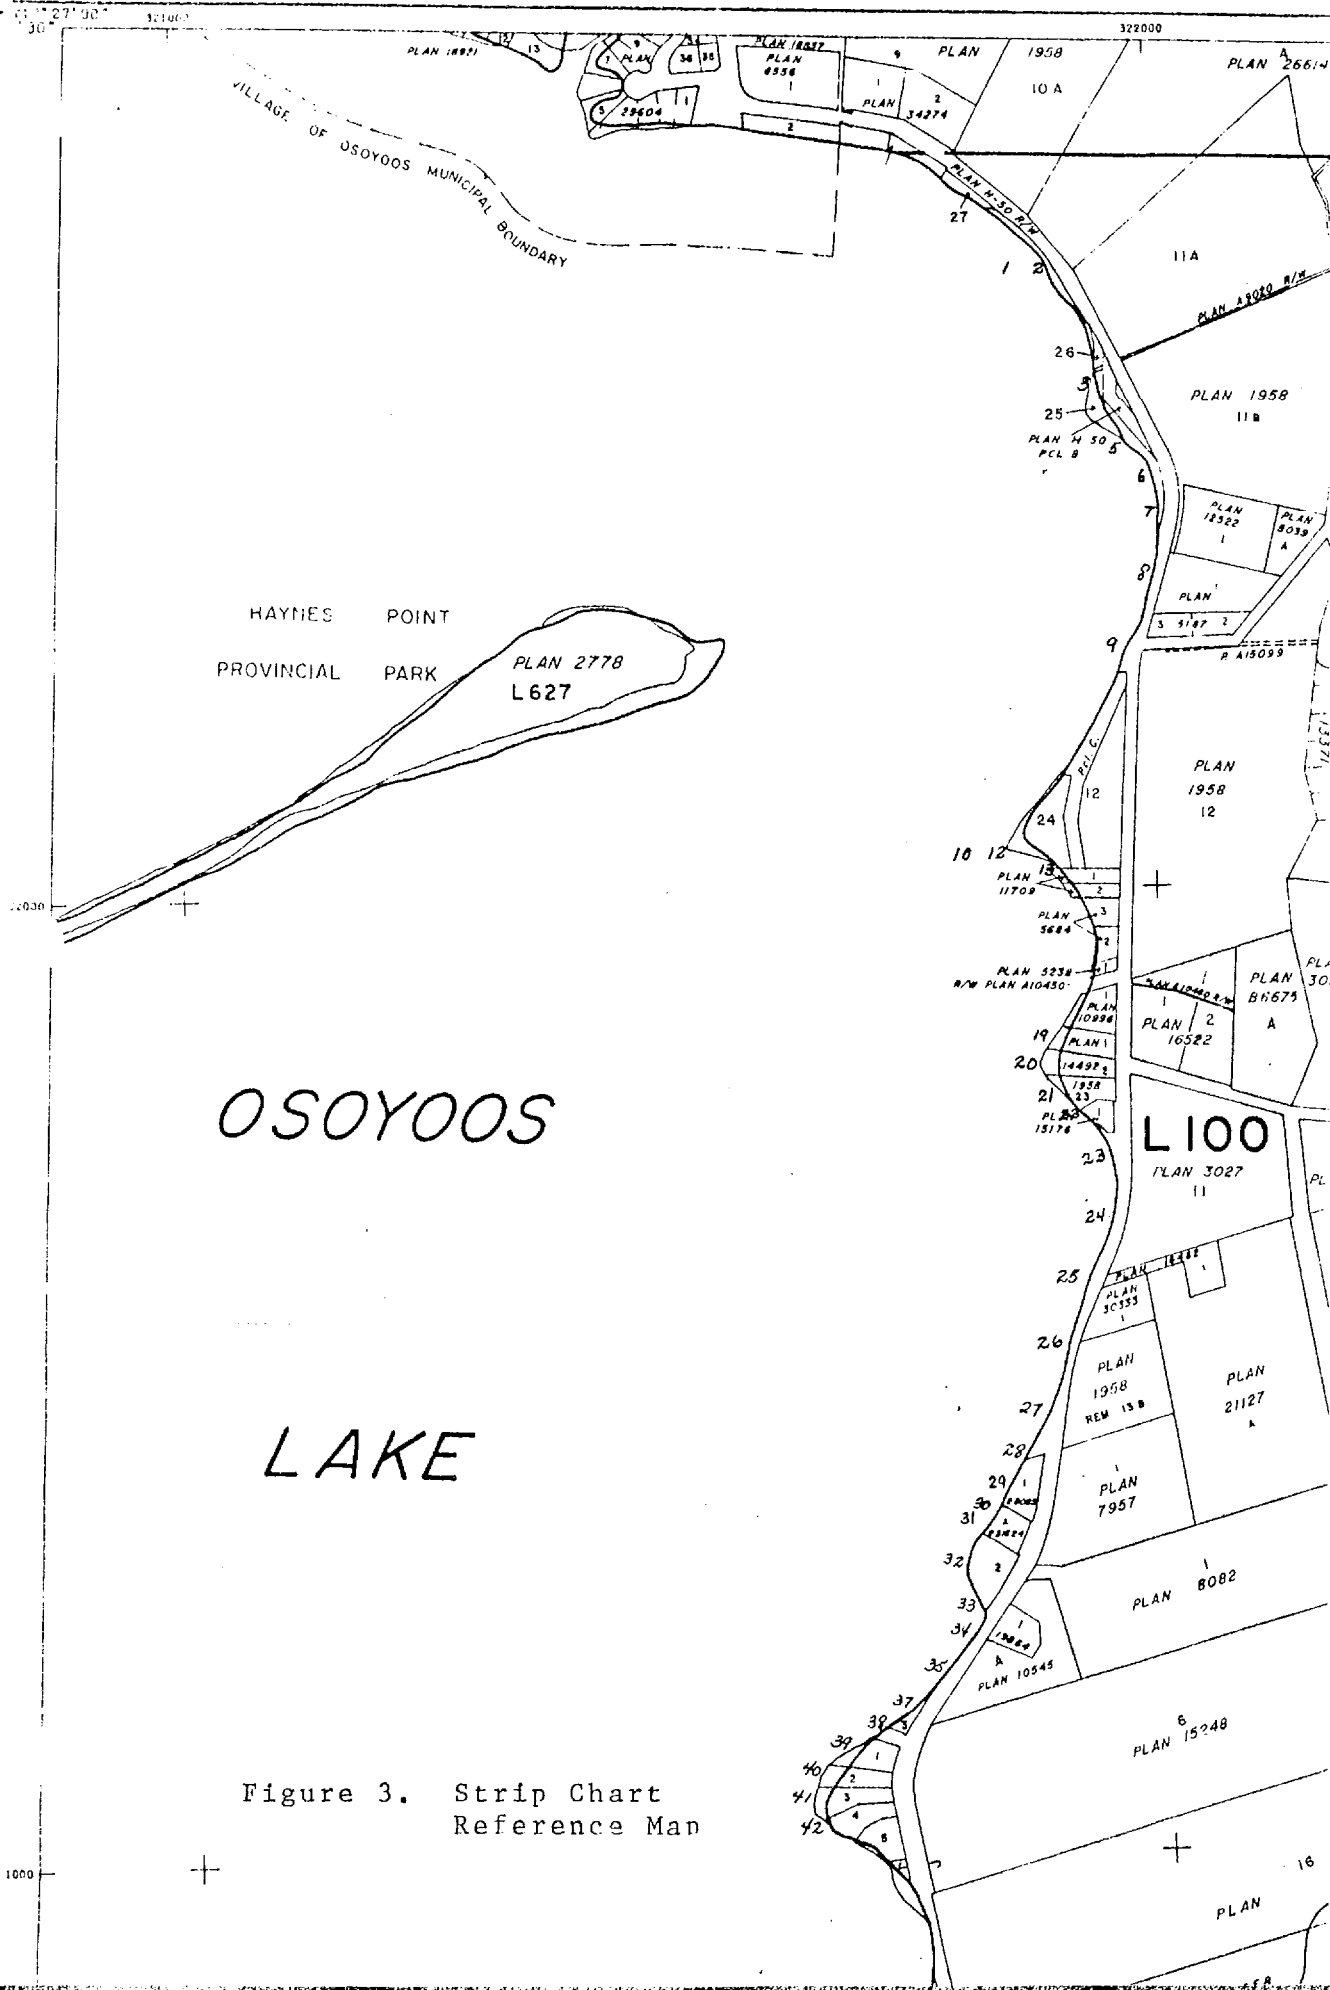
Figure 3. Strip Chart Reference Map

The initial background reading on the strip chart was 20 plus or minus 2 at approximately 100 m offshore at Lot A, Plan 26614, (point 1, Figure 3). The 0.2% urine solution had a reading of 29 plus or minus 2 and the 0.4% urine solution had a reading of 40 plus or minus 3.

The background adjustment was apparently bumped while maneuvering around the second dock at Lot 25, Plan 1958 (point 5, Figure 3). This was confirmed when the readings did not

return to background levels along the subsequent undeveloped shoreline (points 7, 8, 9, Figure 3). A new background was then established off the point on Lot 24, Plan 1958 (point 10, Figure 3). This second background reading was set at 16. Apparent fluctuation is plus or minus 4. Background lake water was sampled about 100 m off shore at this point.

1. near Plan A9020 R/W (point 3, Figure 3). Campground. Reading was 10 above average background. Water sampled.
2. Lot 23, Plan 1958 (past point 21, Figure 3). House. Reading was 8 above average background.
3. Lot 11, Plan 3027 (point 23, Figure 3). Campground. Reading was 8 above average background.
4. Lot 13B, Plan 1958 (point 27, Figure 3). Campground. Reading was 10 above average background. Water sampled.
5. Lot 1, Plan 8023 (point 29, Figure 3). Campground. Reading was 10 above average background. Water sampled.
6. Lot A, Plan 31524 (point 31, Figure 3). Campground, boat house, Reading was 8 above average background. Water sampled.

1. Lot A, Plan 26614 (before point 2, Figure 3). House and orchard. Reading was 6 above average background.
2. Lot 11, Plan 3027 (point 24, Figure 3). Campground. Reading was 6 above average background.
3. Lot A, Plan 10545 (point 35, Figure 3). Campground. Reading was 6 above average background. Water sampled.
4. Lot 3, Plan 10545 (point 38, Figure 3). Reading was 6 above background.
5. Lot 1, Plan 15248 (point 39, Figure 3). House. Reading was 6 above background.
6. Lot 3, Plan 15248 (point 41, Figure 3). House. Reading was 6 above background.

Septic tank leachates appear to be entering the lake at several locations along this shoreline. Most of the major plumes occur directly in front of campgrounds. Water sampling indicates noticeable changes in specific conductivity, sulphates and nitrogen (particularly ammonia). Sampling was done in November, approximately 2 months after the end of the camping season. This may account for the minor changes in phosphorus compared to background.

Further work to pinpoint the sources of the leachates may be required. Groundwater sampling in conjunction with groundwater flow determinations are recommended.
