DETECTION OF SEPTIC TANK LEACHATE INFLOWS  
FROM SHORELINE DEVELOPMENT - OSOYOOS LAKE

P.F. Epp  
Waste Management Program  
Okanagan Sub-Region

Penticton, B.C.  
April 1985

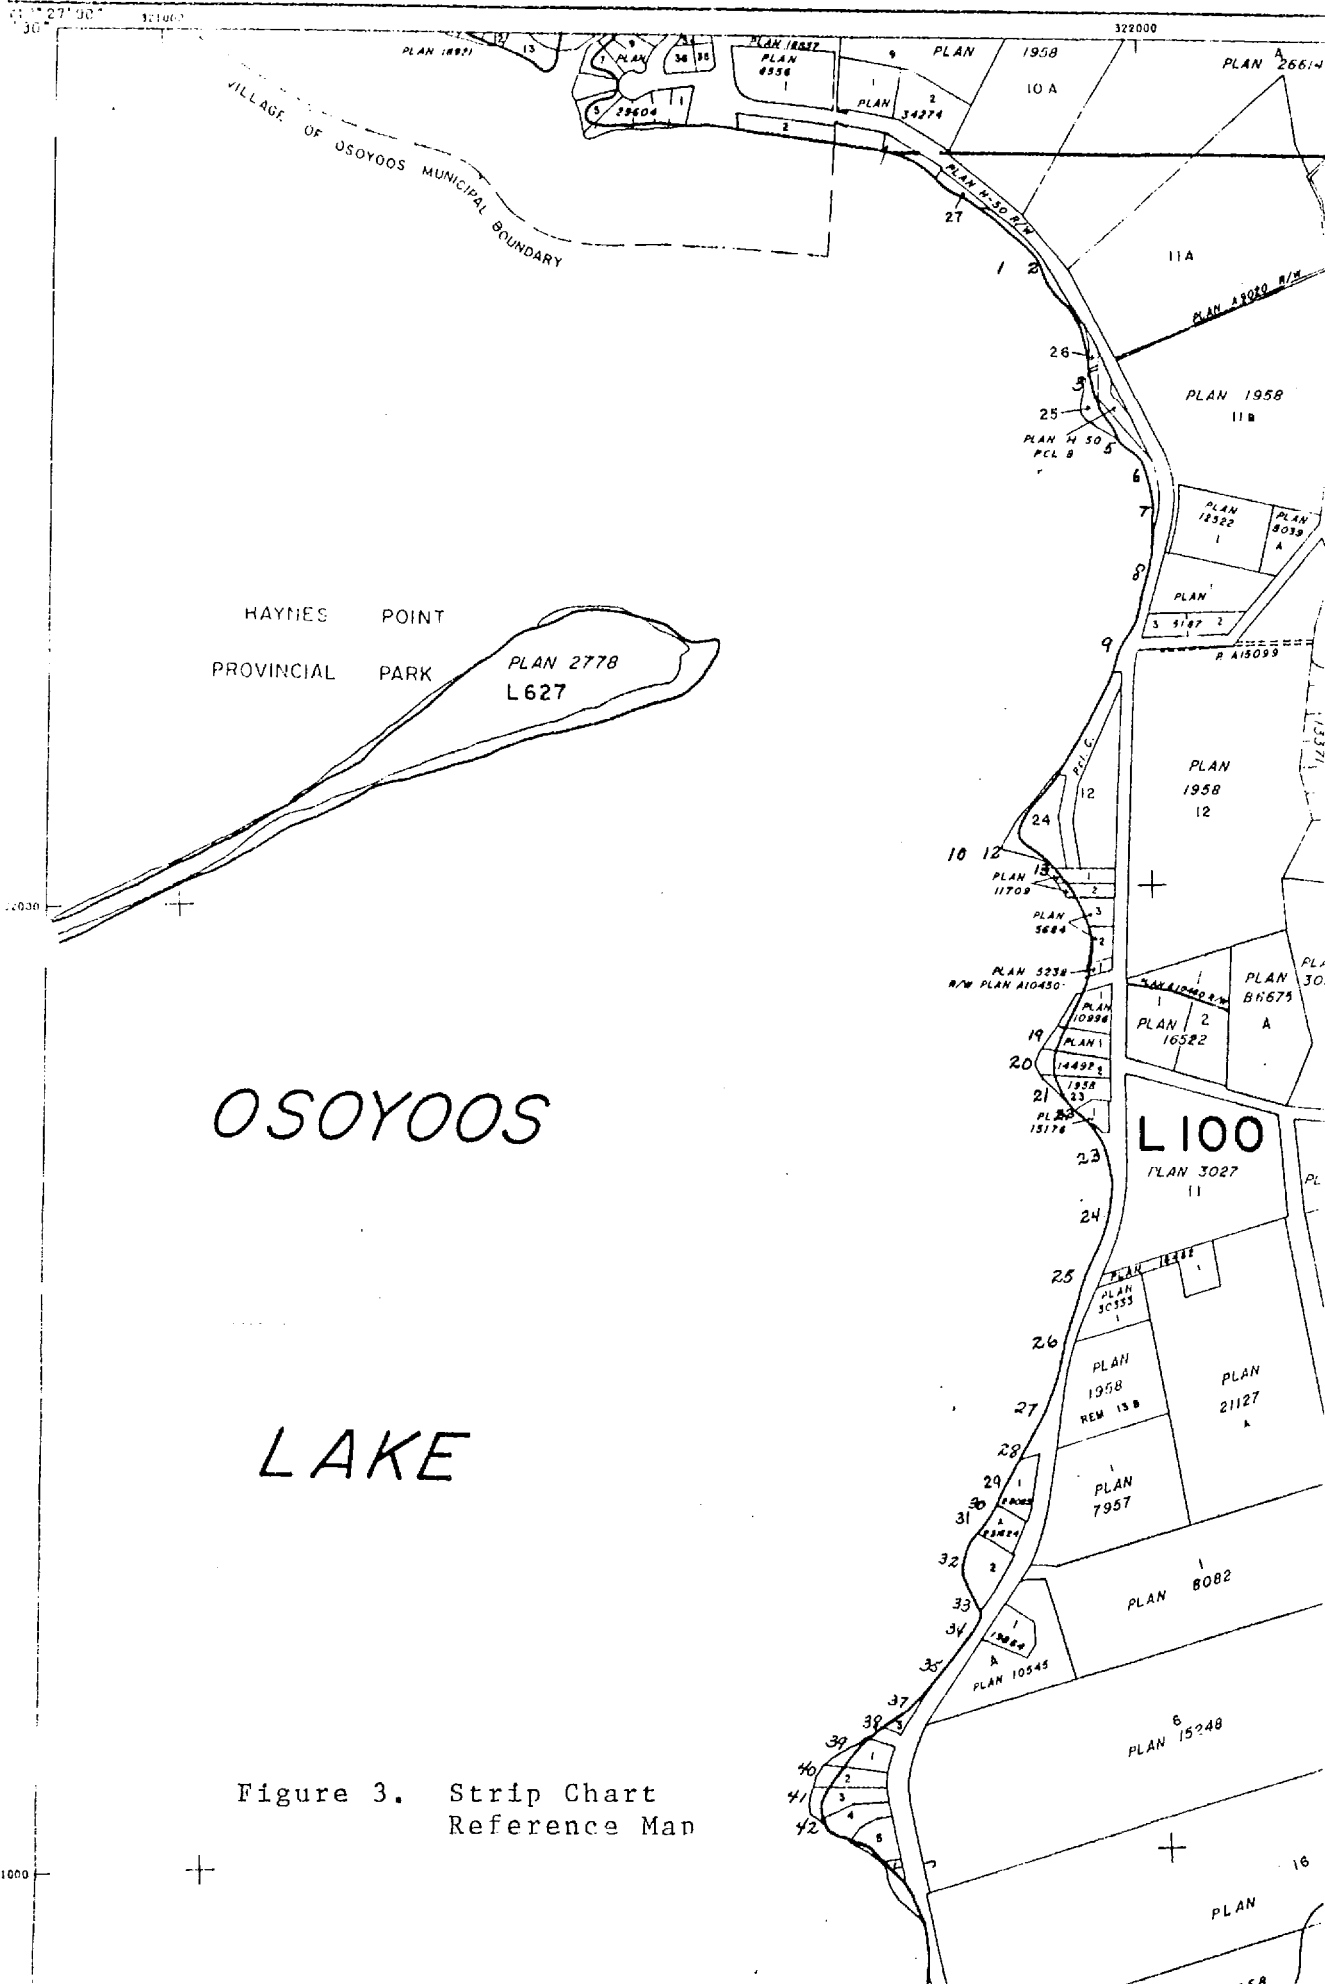
Figure 3. Strip Chart Reference Map

The initial background reading on the strip chart was 20 plus or minus 2 at approximately 100 m offshore at Lot A, Plan 26614, (point 1, Figure 3). The 0.2% urine solution had a reading of 29 plus or minus 2 and the 0.4% urine solution had a reading of 40 plus or minus 3.

The background adjustment was apparently bumped while maneuvering around the second dock at Lot 25, Plan 1958 (point 5, Figure 3). This was confirmed when the readings did not

return to background levels along the subsequent undeveloped shoreline (points 7, 8, 9, Figure 3). A new background was then established off the point on Lot 24, Plan 1958 (point 10, Figure 3). This second background reading was set at 16. Apparent fluctuation is plus or minus 4. Background lake water was sampled about 100 m off shore at this point.

1. near Plan A9020 R/W (point 3, Figure 3). Campground. Reading was 10 above average background. Water sampled.
2. Lot 23, Plan 1958 (past point 21, Figure 3). House. Reading was 8 above average background.
3. Lot 11, Plan 3027 (point 23, Figure 3). Campground. Reading was 8 above average background.
4. Lot 13B, Plan 1958 (point 27, Figure 3). Campground. Reading was 10 above average background. Water sampled.
5. Lot 1, Plan 8023 (point 29, Figure 3). Campground. Reading was 10 above average background. Water sampled.
6. Lot A, Plan 31524 (point 31, Figure 3). Campground, boat house, Reading was 8 above average background. Water sampled.

1. Lot A, Plan 26614 (before point 2, Figure 3). House and orchard. Reading was 6 above average background.
2. Lot 11, Plan 3027 (point 24, Figure 3). Campground. Reading was 6 above average background.
3. Lot A, Plan 10545 (point 35, Figure 3). Campground. Reading was 6 above average background. Water sampled.
4. Lot 3, Plan 10545 (point 38, Figure 3). Reading was 6 above background.
5. Lot 1, Plan 15248 (point 39, Figure 3). House. Reading was 6 above background.
6. Lot 3, Plan 15248 (point 41, Figure 3). House. Reading was 6 above background.

Further work to pinpoint the sources of the leachates may be required. Groundwater sampling in conjunction with groundwater flow determinations are recommended.

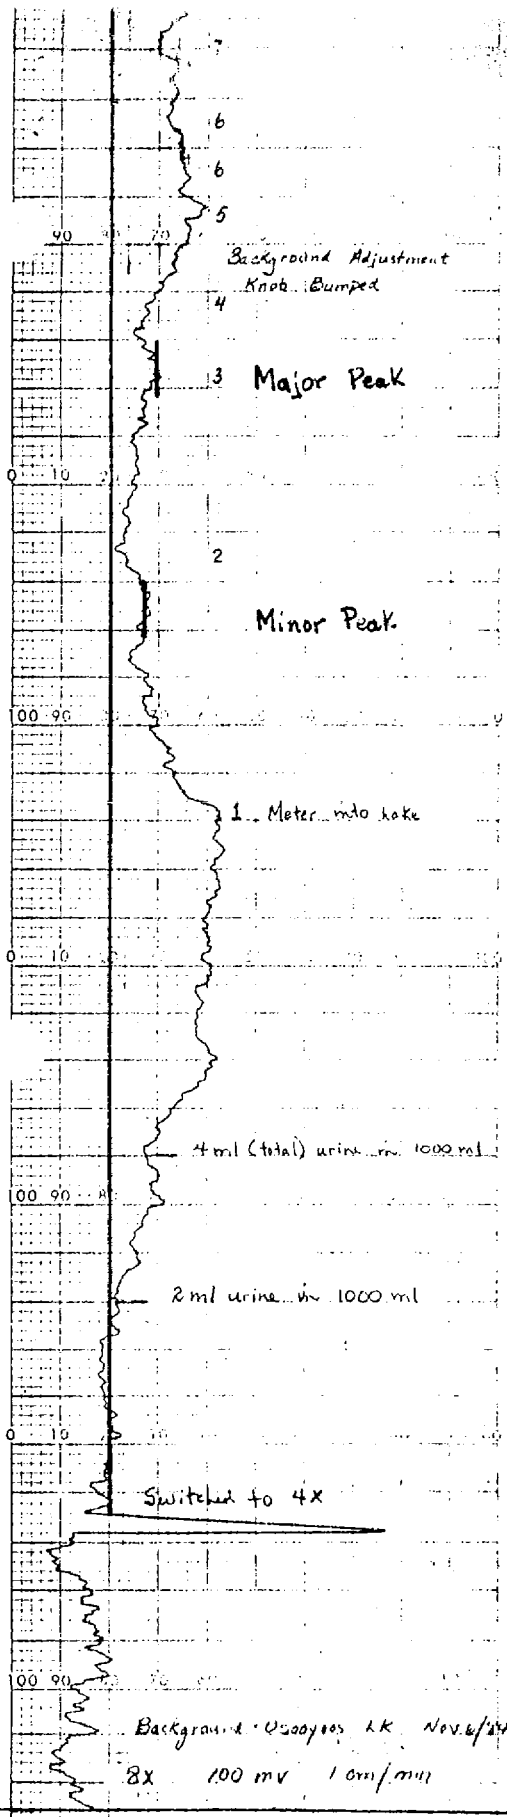
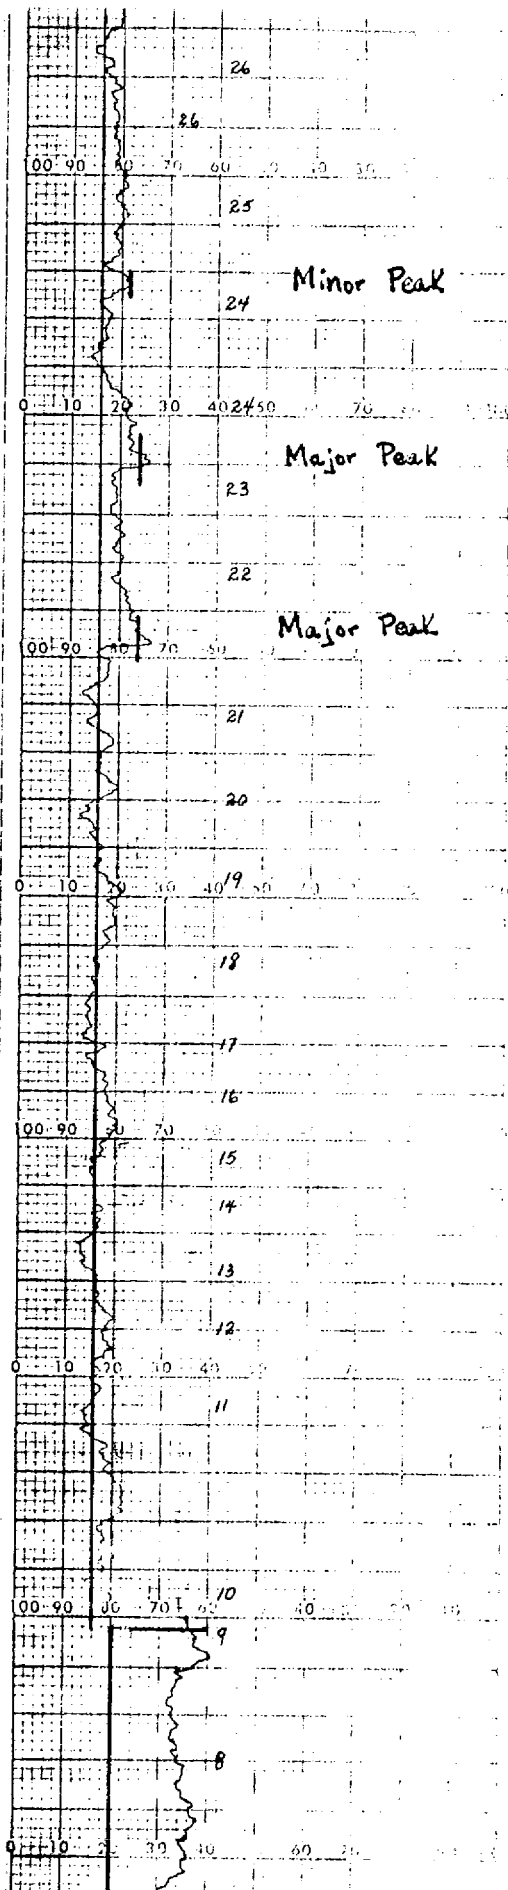
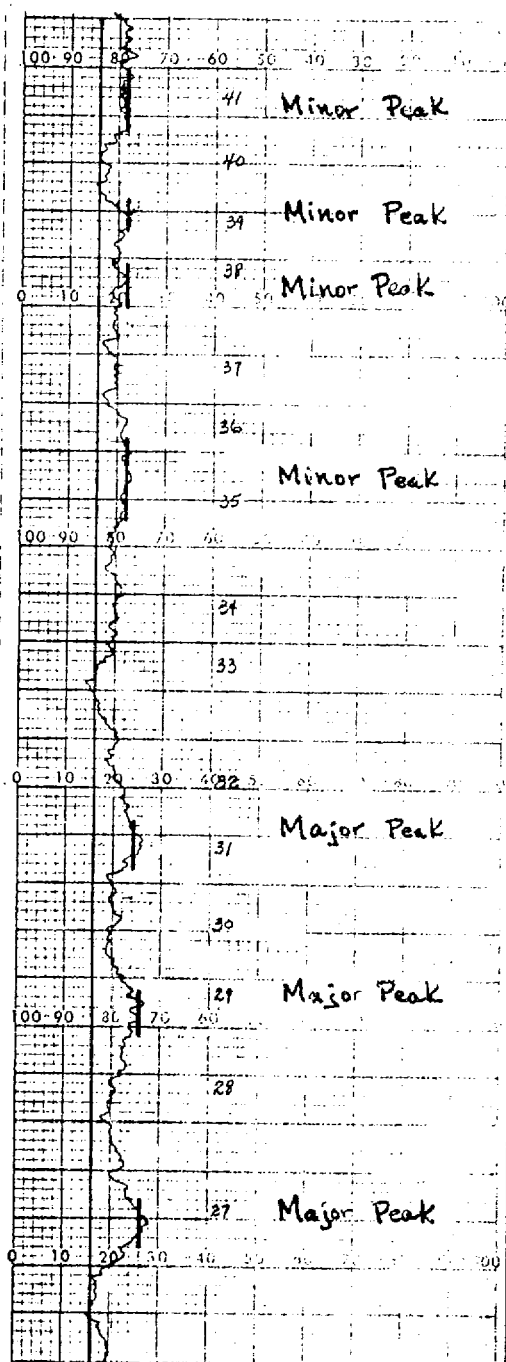
Appendix A

3.1 The complete strip chart record is given in Appendix A. It is important to note the limitations of leachate detector systems when interpreting the results. Some dissolved natural organics will fluoresce at wavelengths similar to those of whiteners and brighteners, thus increasing fluorometer readings or giving positive readings where none should occur. The Model 15 fluorometer has been designed to minimize these effects, but it may not have eliminated them entirely. Air entry into the system, such as when the pump is inadvertently lifted from the water, may also affect results. Entry of lake bottom sediments into the system generally causes a positive response. Known air or sediment responses are marked on the chart. Lake inflows such as springs or streams can dilute water in the area and thus cause negative chart readings.

There is also some fluctuation in the background and standards response records which is likely inherent in this fluorometer system. It may also be partially due to operation of the equipment at temperatures close to the operating minimum of 2°C. This background fluctuation has the effect of masking or enhancing minor variations, making interpretation of results more difficult.
