Closed-bottom corrugated-steel embedded culverts in British Columbia: overview of twelve sites

Clayton T. Gillies,
Western Division

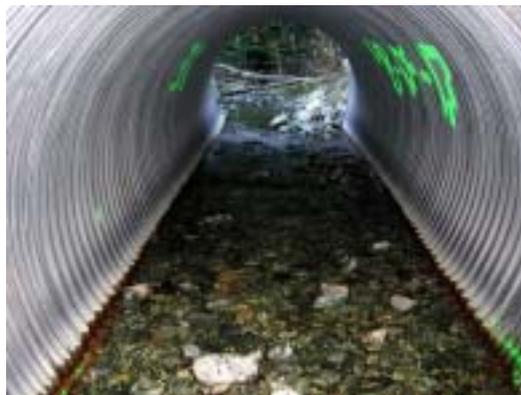
Figure 1a.
Embedded culvert
more than three
years after
installation.

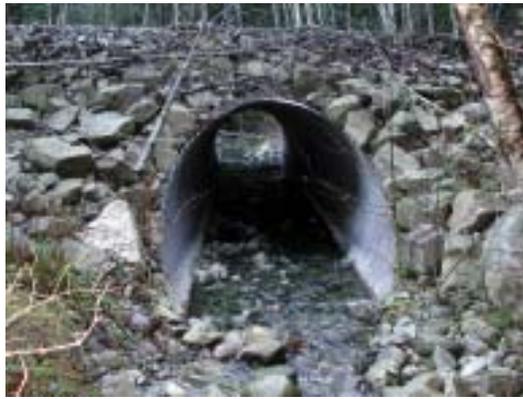
Figure 1b. Inlet of embedded culvert.

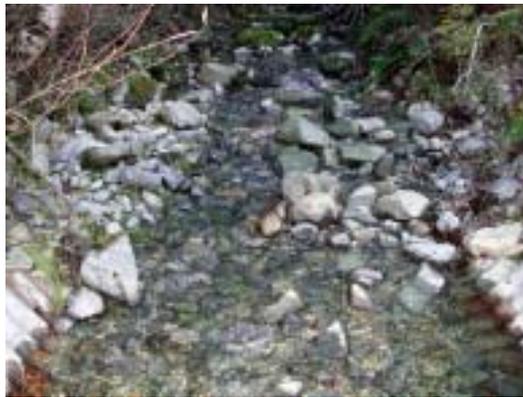
Figure 1c. Culvert inlet showing match to natural stream width and gradient.

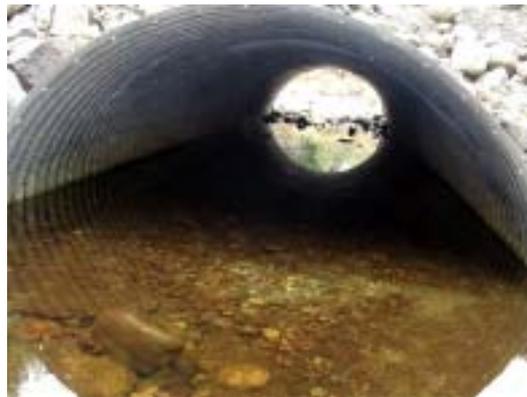
Figure 2a.
Embedded pipe
arch one year after
installation.

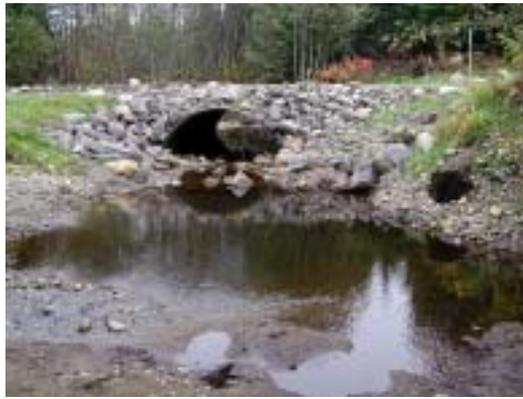
- Only cutthroat trout were noted to be present immediately prior to and during the culvert installation.
- Pools exist at the inlet and outlet of the culvert. The inlet pool is approximately 7 m from the culvert and is 55 cm deep (Figure 2b), and the outlet pool is adjacent to the culvert and is 40 cm deep.

Figure 2b. Culvert inlet showing pool area and shallow fill height above culvert.

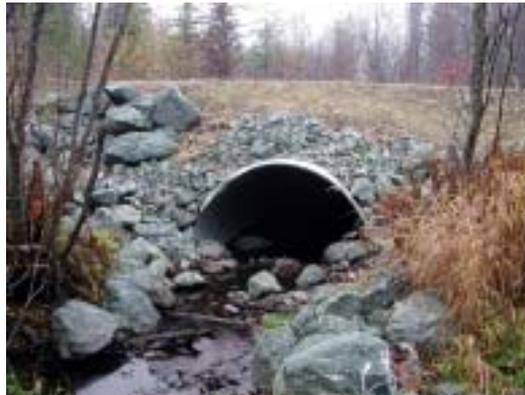
Figure 3a.
Embedded pipe
arch one year after
installation,
showing armoured
streambanks,
height of fill, and
varying sizes of
riprap and
embedding
material.

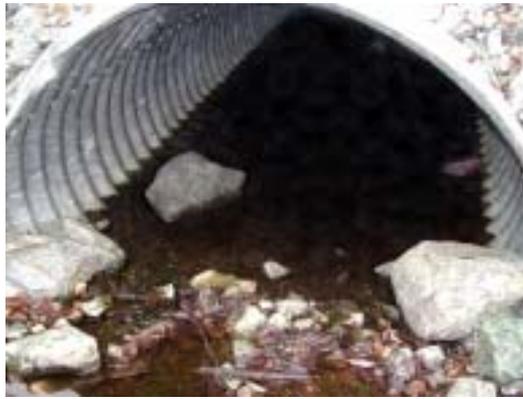
Figure 3b. Outlet of embedded culvert.

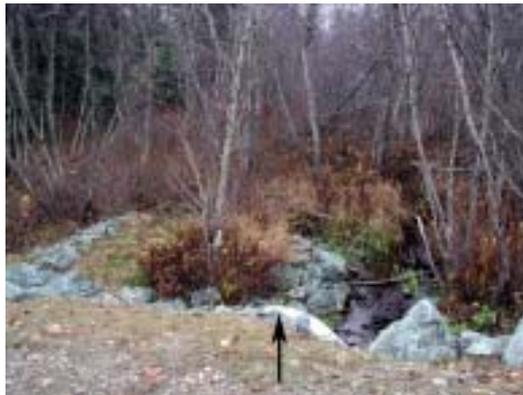
- A rock spur was built of riprap to help prevent road and/or ditch water from entering the stream directly from the ditchline. The spur will also act as a sediment trap, reducing suspended sediment delivery into the stream (Figure 3c).
- Fillslopes and exposed banks were seeded with a reclamation mixture (mainly grasses).

Figure 3c. Looking downstream from culvert outlet showing deciduous forest, and rock spur on left hand side of image (arrow indicates obvert/top of outlet).

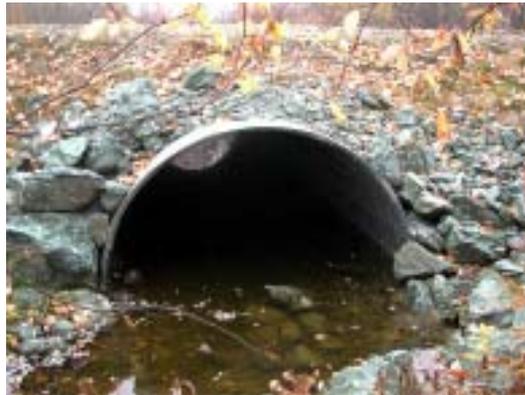
Figure 4a. Outlet of embedded pipe arch one year after installation showing submerged embedding material, height of fill, and riprap armouring.

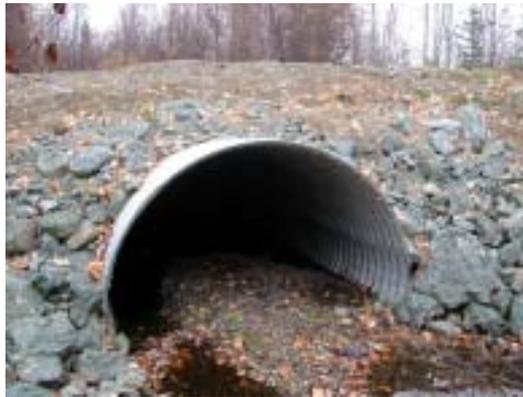
Figure 4b. Inlet of embedded culvert showing leaf litter and gravel material placed within the culvert.

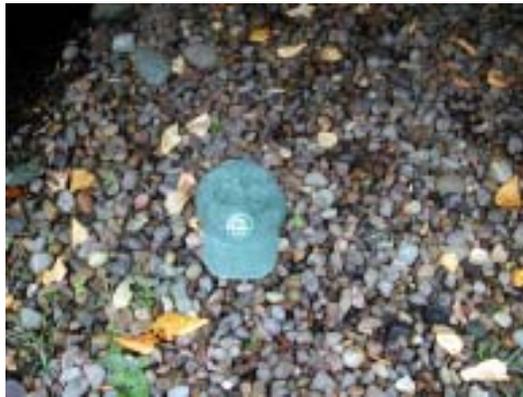
Figure 4c. Gravel material placed within the culvert.

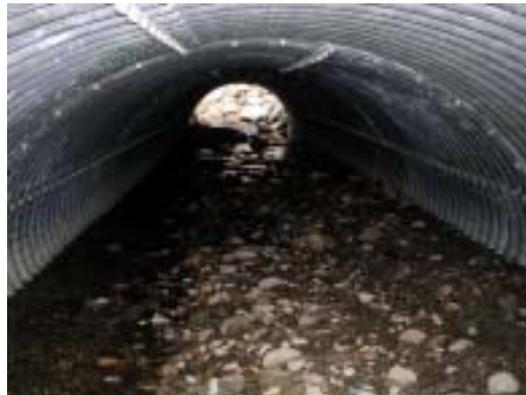
Figure 5a. Culvert three years after installation, showing naturally deposited bedload material.

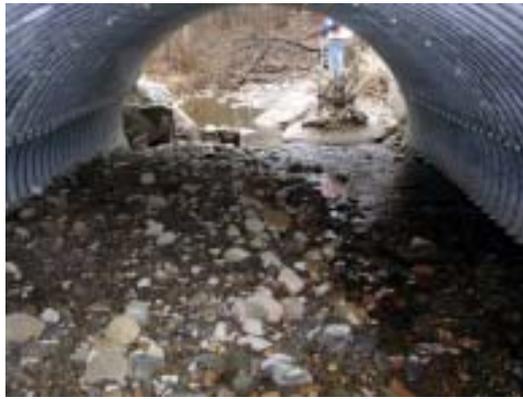
Figure 5b. Looking downstream through the embedded culvert, showing the stream flowing along one side of the culvert at this location.

- The position of the low-flow channel shifts within the culvert due to changes in the streambed caused by high-flow events. At the time of the field visit, the majority of the low-flow channel was located adjacent to one side of the culvert (Figure 5b). Hand-made rock spurs could be used to force the flow away from the edge of the culvert.
- The embedded culvert was delivered pre-assembled. The delivered culvert cost in Table 5 includes the supplier's assembly charge.

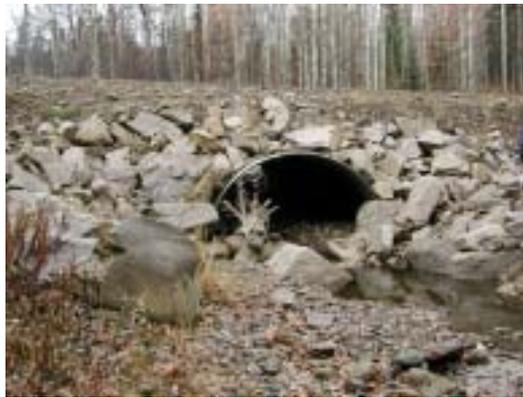
Figure 5c. Outlet of embedded culvert showing height of fill, riprap armouring, and a small root wad deposited during high flows.

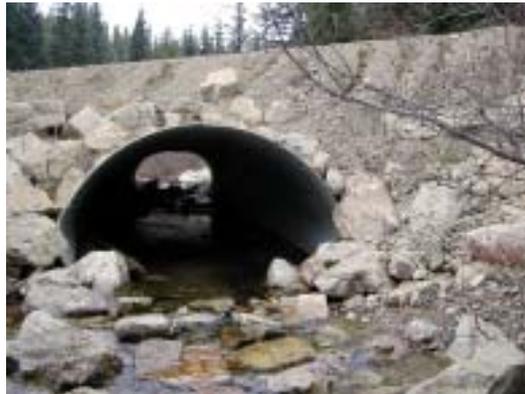
Figure 6a. Outlet of embedded culvert.

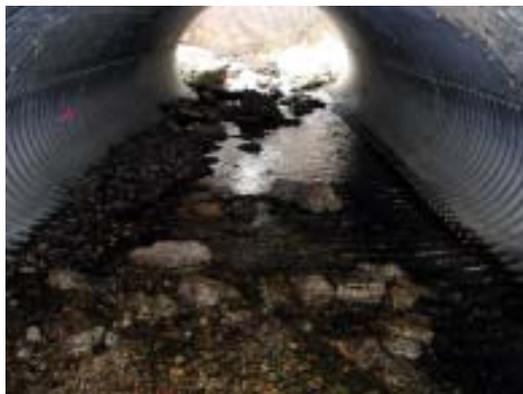
Figure 6c. Embedded culvert showing boulders intermingled with natural deposits of sand and gravel.

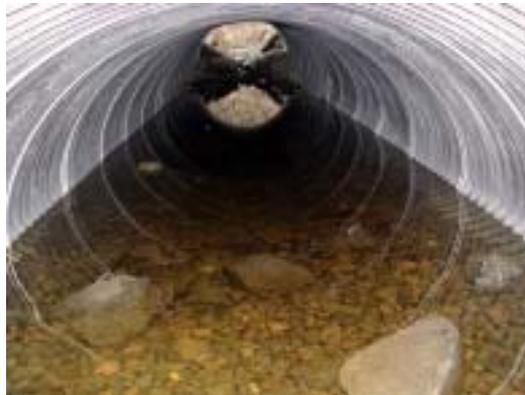
Figure 7a. Looking towards inlet of embedded culvert showing cobbles along surface of simulated streambed and additional embedding material placed near the inlet.

- Construction caused minimal disturbance to the natural streambank immediately upstream and downstream of the installed culvert.
- The additional embedding material near the inlet will migrate during high flow events and blend with the embedding material downstream.

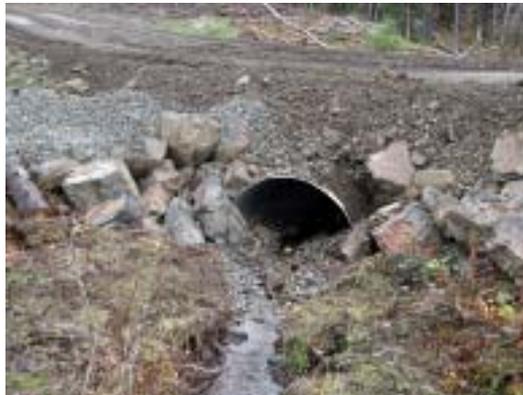
Figure 7c. Inlet of embedded culvert showing riprap armouring, use of drain rock along the ditch and fill slope, and minimal disturbance to natural streambank.

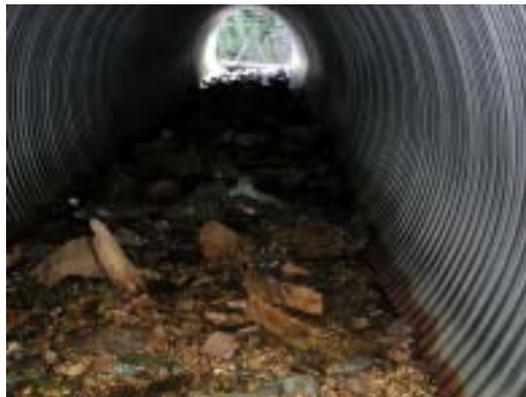
Figure 8a.
Embedded culvert
six years after
installation
showing various
sizes of material
retained within the
culvert.

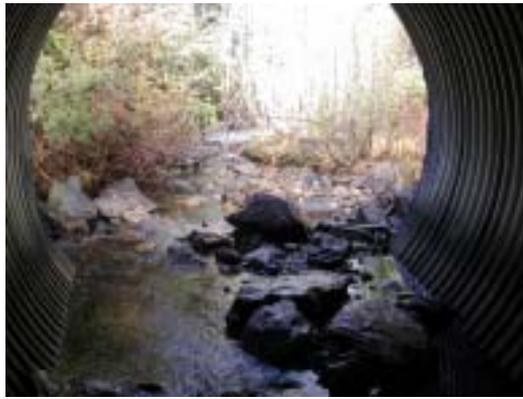
Figure 8b. Outlet of embedded culvert.

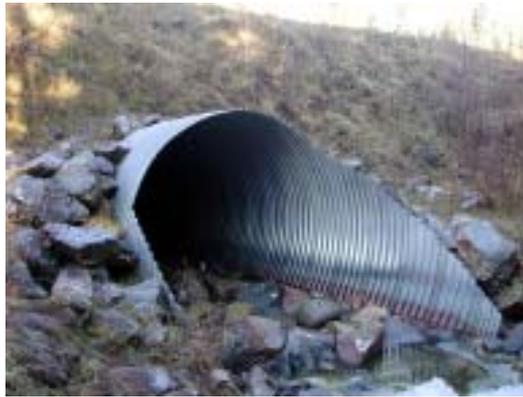
Figure 8c. Inlet of culvert showing step-bevel and high water markings along culvert wall.

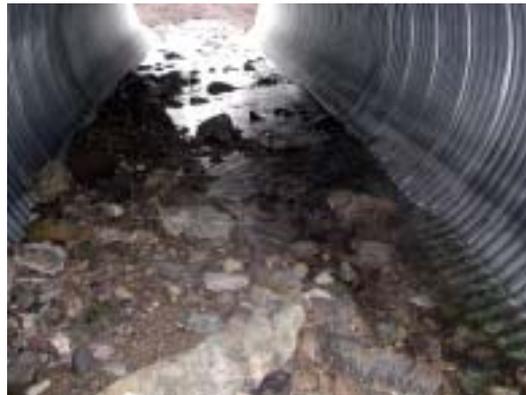
Figure 9a.
Embedded culvert
two years after
installation
showing various
sizes of material
retained within the
culvert.

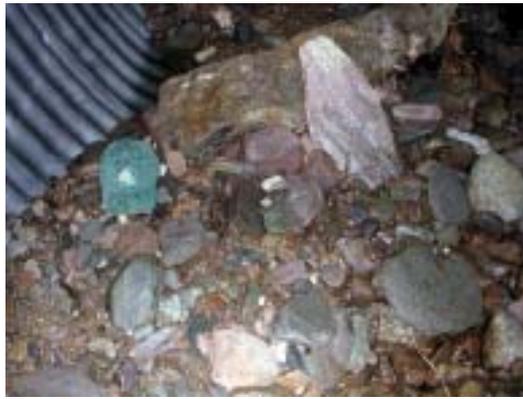
Figure 9b. Various sizes of aggregate within the culvert (hat can be used for scale).

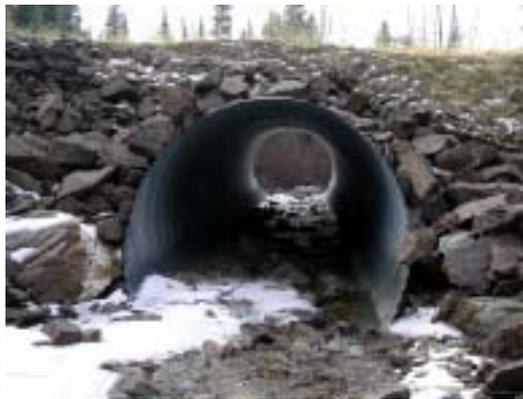
Figure 9c. Inlet of culvert showing riprap armouring and height of fill over the culvert.

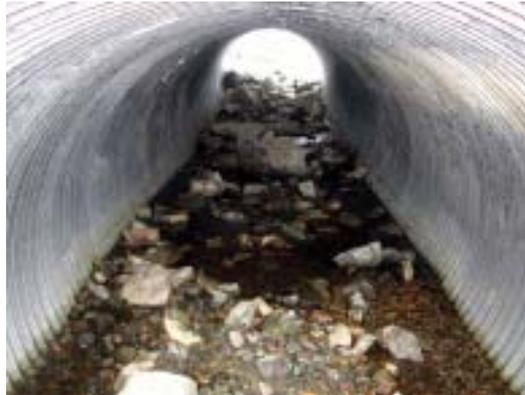
Figure 10a.
Looking towards
the culvert inlet,
showing simulated
streambed one
year after
installation.

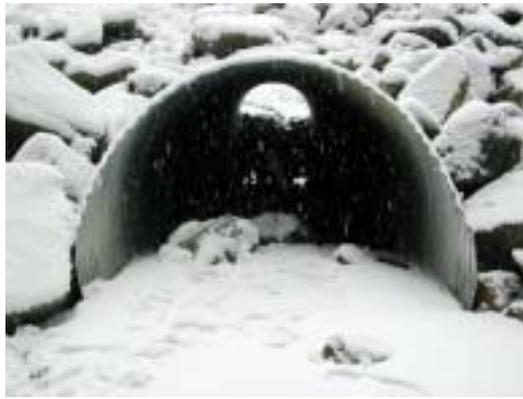
Figure 10b. Looking upstream showing the size of larger material within the culvert and riprap armouring of the fill slope.

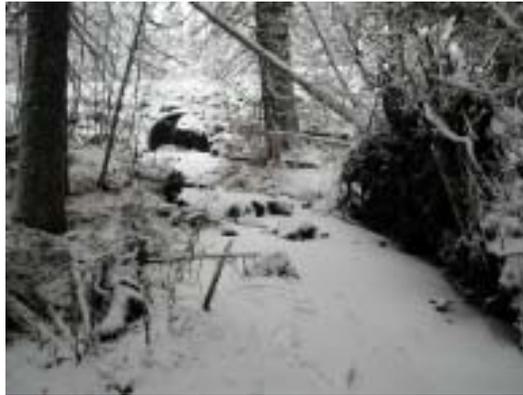
Figure 10c. Looking upstream towards embedded culvert showing stream channel, height of fill above culvert, and road grade.

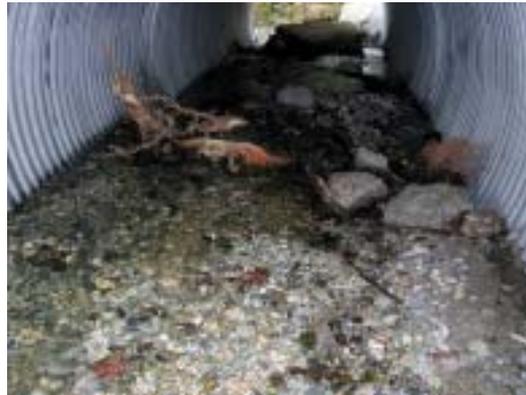
Figure 11a.
Looking towards
outlet of
embedded culvert
two years after
installation. Note
the large woody
debris which has
migrated into the
culvert.

- Cobble-sized material from within the culvert has migrated approximately 9 m downstream in the two years since completion. A “stop-log” and/or weir-log at the outlet (Figure 11b) was completely covered with bedload material during the field visit. The height of material within the culvert completely covered all the baffles.
- Boulders placed along the surface of the simulated streambed, such as the boulder at the inlet of the culvert shown in Figure 11c, should be considered when designing the hydraulic capacity of the culvert.

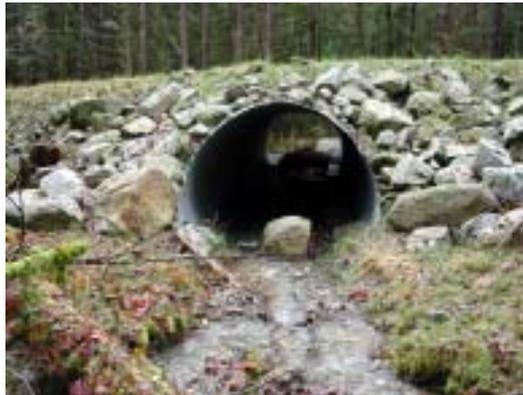
Figure 11c. Inlet of embedded culvert showing width of natural stream and undisturbed stream banks.

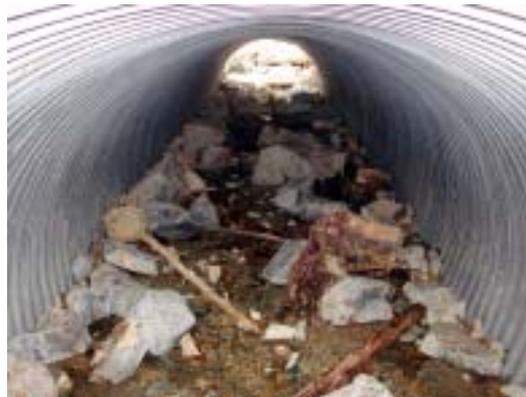
Figure 12a.
Embedded culvert
showing woody
debris and an
abundance of
boulders within the
culvert.

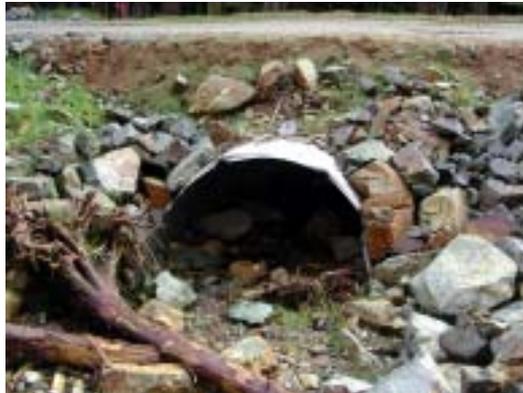
Figure 12c. Inlet of embedded culvert showing height of fill, riprap armouring, and use of woody debris.
