Closed-bottom corrugated-steel embedded culverts in British Columbia: overview of seven sites

Abstract

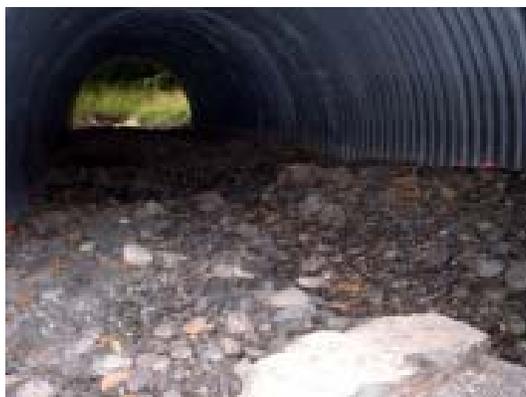
Figure 1a. Looking towards inlet of embedded culvert.

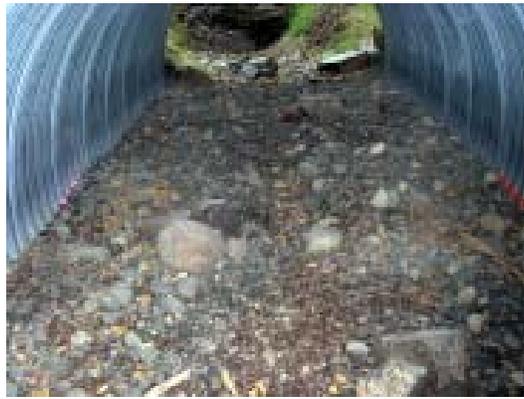
Figure 1b. Looking towards outlet of culvert.

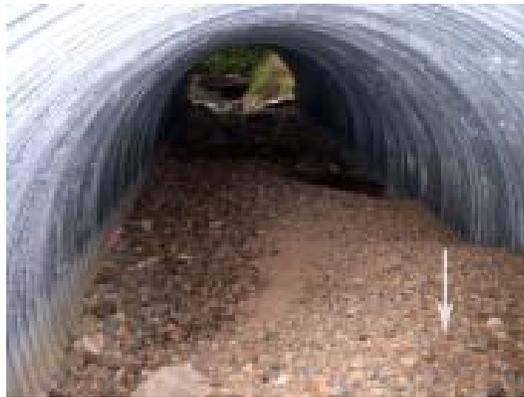
- Infill gravel within the culvert near the inlet has been displaced from one side of the culvert and has deposited along the opposite side (Figure 1c). The stream turns 90 degrees to enter the culvert, which forces flows along the scoured side of the culvert.
- The simulated streambed's distribution and size of material matches well with the natural

Figure 1c. Mound of gravel (white arrow) along one side of the culvert near the inlet.

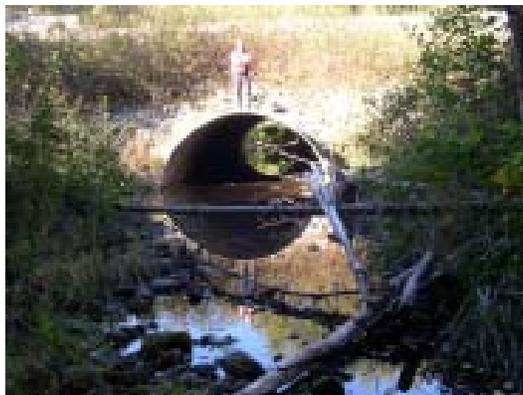
Figure 2a. Embedded culvert showing natural woody debris within stream, and the height of road fill.

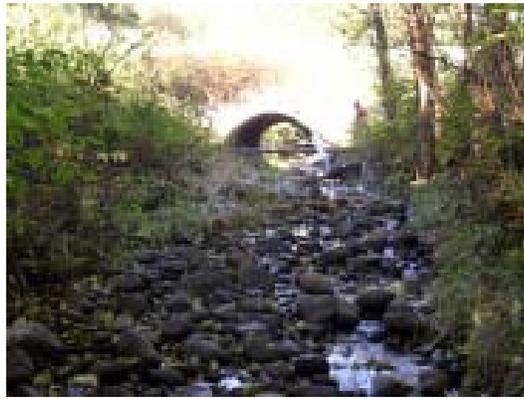
Figure 2b. The natural stream bedload is comprised mainly of cobble size material. Note the alignment of the culvert with the stream.

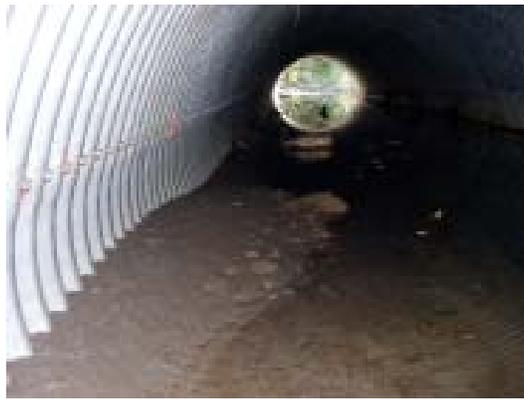
Figure 2c. Embedded culvert showing finer, sandy material deposited along one side of the culvert's inlet. The opposite side is mostly bare.

- Numerous small fish approximately 7 cm in length were observed during the field visit, both outside and within the culvert.
- Fine material has been deposited along one edge of the culvert at the inlet (Figure 2c). The opposite edge has had material displaced, creating a distinct deeper channel through this section. Through the centre and outlet of the culvert, the infill material is at a consistent depth from side to side.
- The simulated streambed's composition visually compares well with the fines component of the natural stream channel, but is lacking the abundant cobble-sized material found in the natural channel.

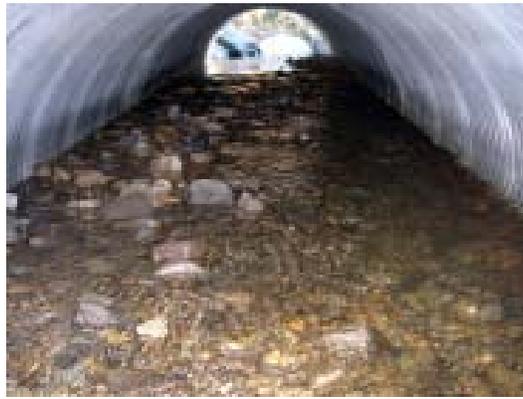
Figure 3a. Looking towards inlet of embedded culvert, showing stream flow and cobble sized material.

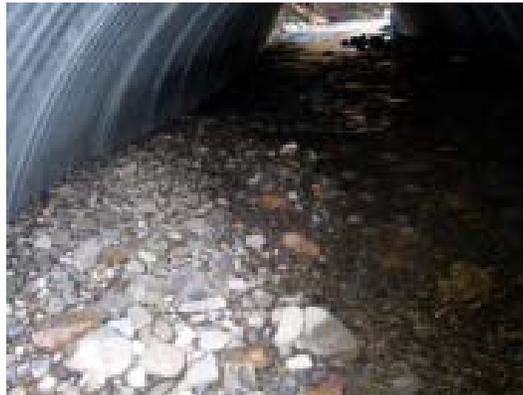
Figure 3b. Inlet of embedded culvert showing uneven depth of aggregate partly due to the stream turning sharply into the culvert.

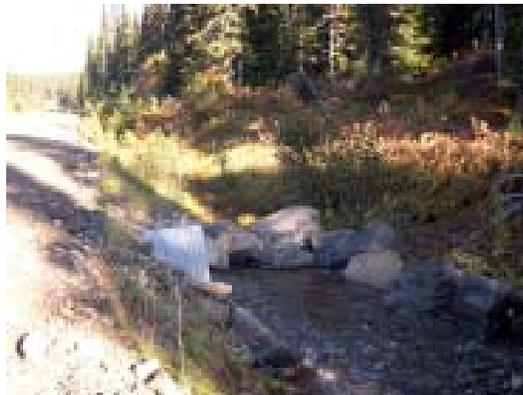
Figure 3c. Inlet of embedded culvert showing stream turning sharply into the culvert.

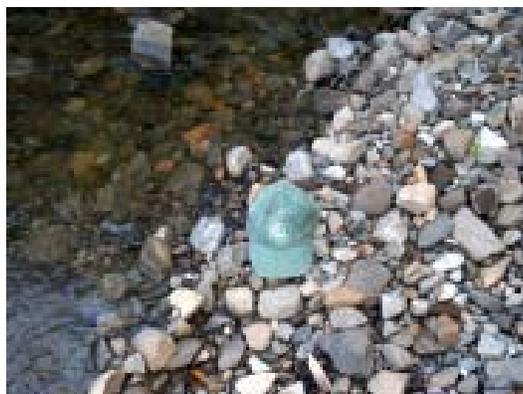
Figure 3d. Natural bedload material downstream of the culvert.

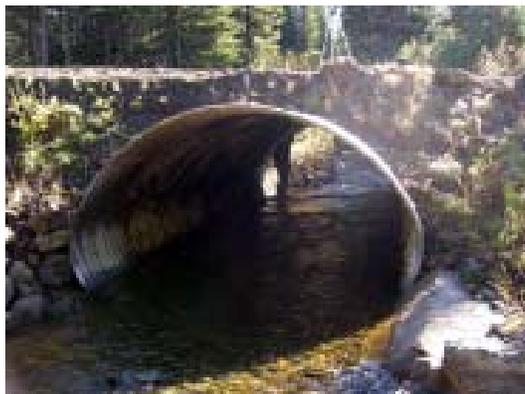
Figure 4a. Looking upstream showing the embedded culvert, stream flow, and one partially exposed baffle.

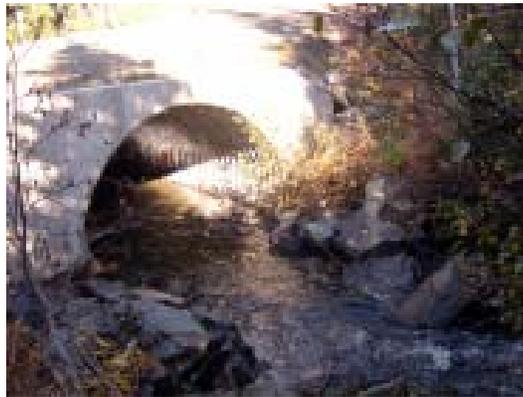
Figure 4b. Inlet of embedded culvert showing concrete headwall and riprap armouring along the stream bank.

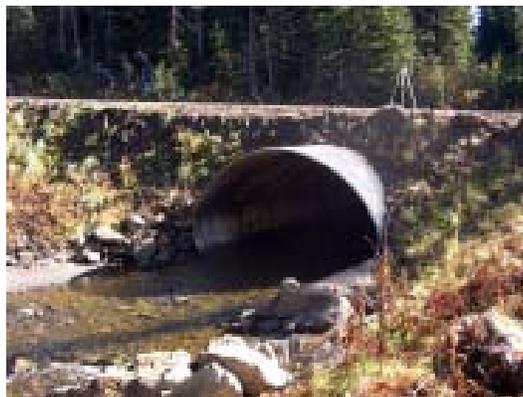
Figure 4c. Outlet of embedded culvert showing riprap armouring on the right, riffle area near the outlet, and shallow road fill above the culvert.

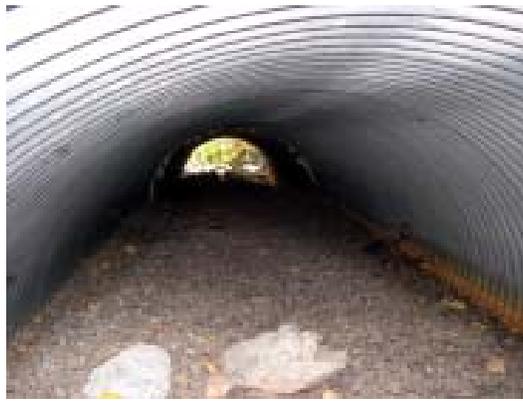
Figure 5a. Looking towards outlet of embedded culvert showing surface cobbles and gravel.

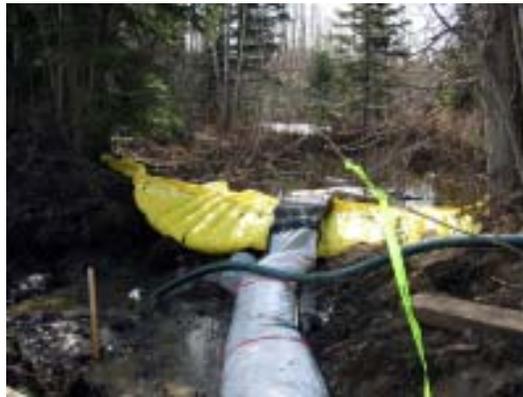
Figure 5b. Water-Gate™ dam with the overflow diverter tunnel (photo courtesy of BCMOF).

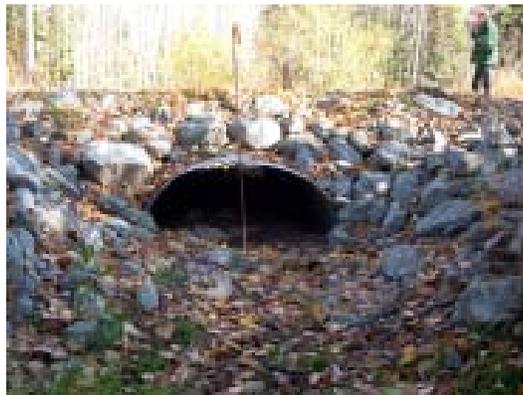
Figure 5c. Inlet of embedded culvert.

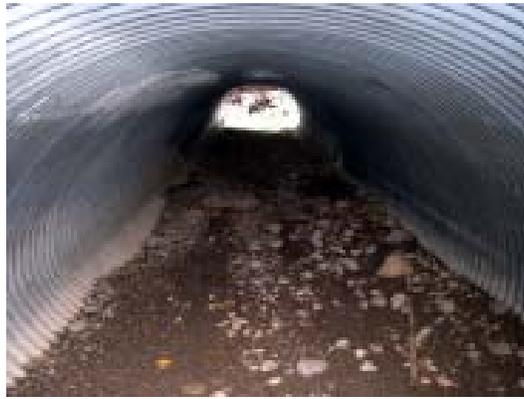
Figure 6a. Looking towards inlet of embedded culvert showing sandy bottom with surface cobbles and gravels.

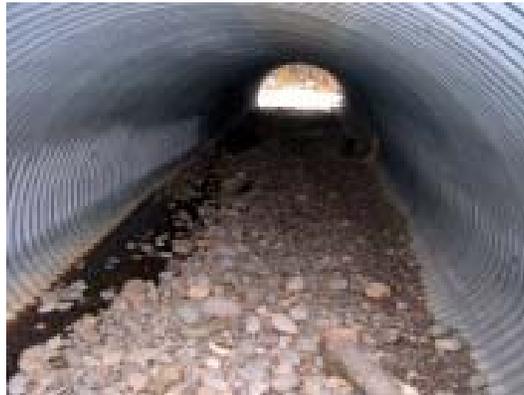
Figure 6b. Looking towards outlet of embedded culvert showing cobble-sized bedload.

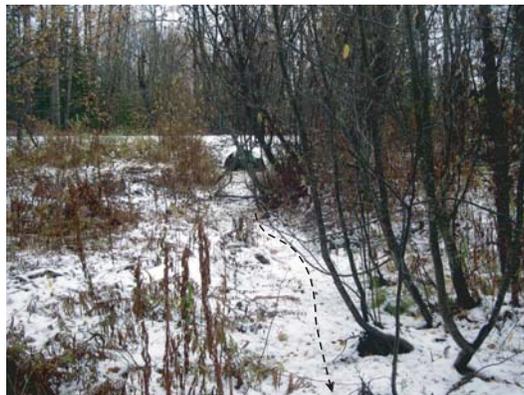
Figure 6c. Looking towards the outlet of the embedded culvert, showing flat terrain and shallow stream banks (dashed line indicates the approximate centre of the stream channel).

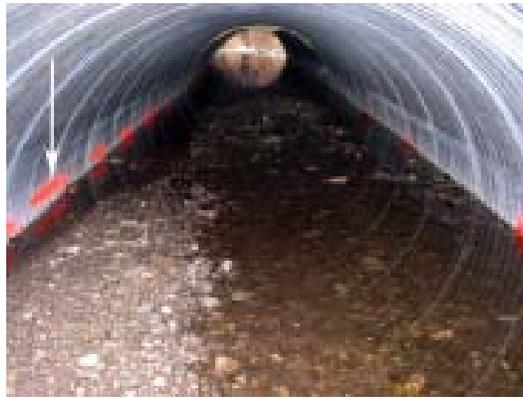
Figure 7a. Looking towards outlet of embedded culvert, showing predominantly gravel substrate. Spray paint lines, as indicated by the arrow, along the culvert's wall indicate target infill depth plus 5 cm.

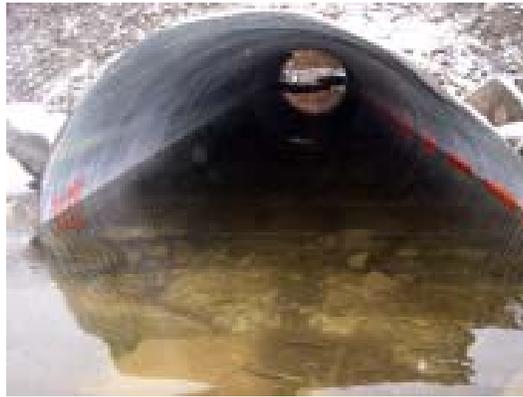
Figure 7b. Outlet of embedded culvert showing water depth during field visit and subsurface material.

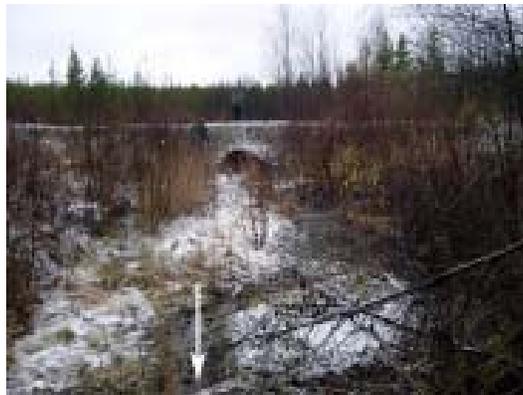
Figure 7c. Looking towards the outlet of the embedded culvert showing flat terrain and shallow stream banks. Arrow indicates centre of braided stream channel through the powerline clearing.
