# SITE C CLEAN ENERGY PROJECT

## Geotechnical Safety Overview Report

February 2021

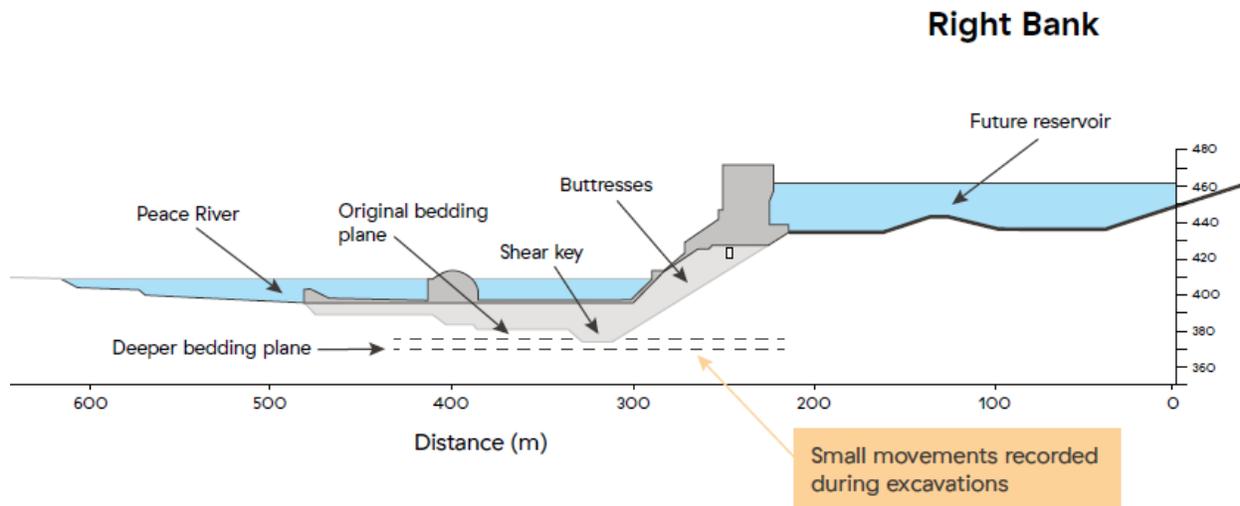
In 2018, during the excavation for the spillway buttress, small movements (millimetres) began to occur on a bedding plane below the bedding plane through which the shear key intersects. These small displacements indicated that the shear strength along bedding planes deeper than

the shear key bedding plane may be lower than what was initially assumed in the design basis. These small displacements, other instrument data, and the results of geological mapping led to a re-assessment of the expected strength of the bedrock at this depth.
