**Squamish River Drainage Basin:
(TFL 38)
Terrain and Slope Stability Mapping
for
Forest Management**

**Prepared for
International Forest Products, Ltd.
by
J.M.Ryder**

June 1995

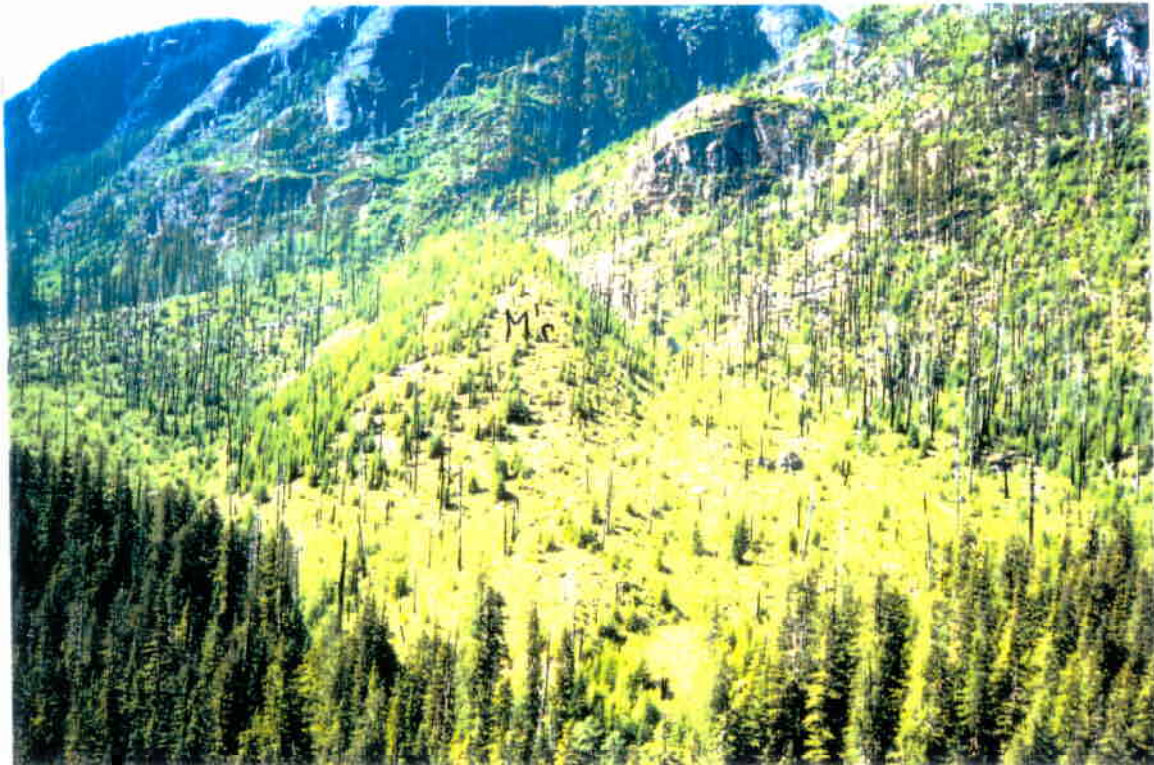
Photo 1: Recessional moraine (M¹) in Sims valley near Sims Elaho confluence
Steep side slopes on such moraines are commonly unstable when undercut by creeks or roads. (Photo: A.Collett)

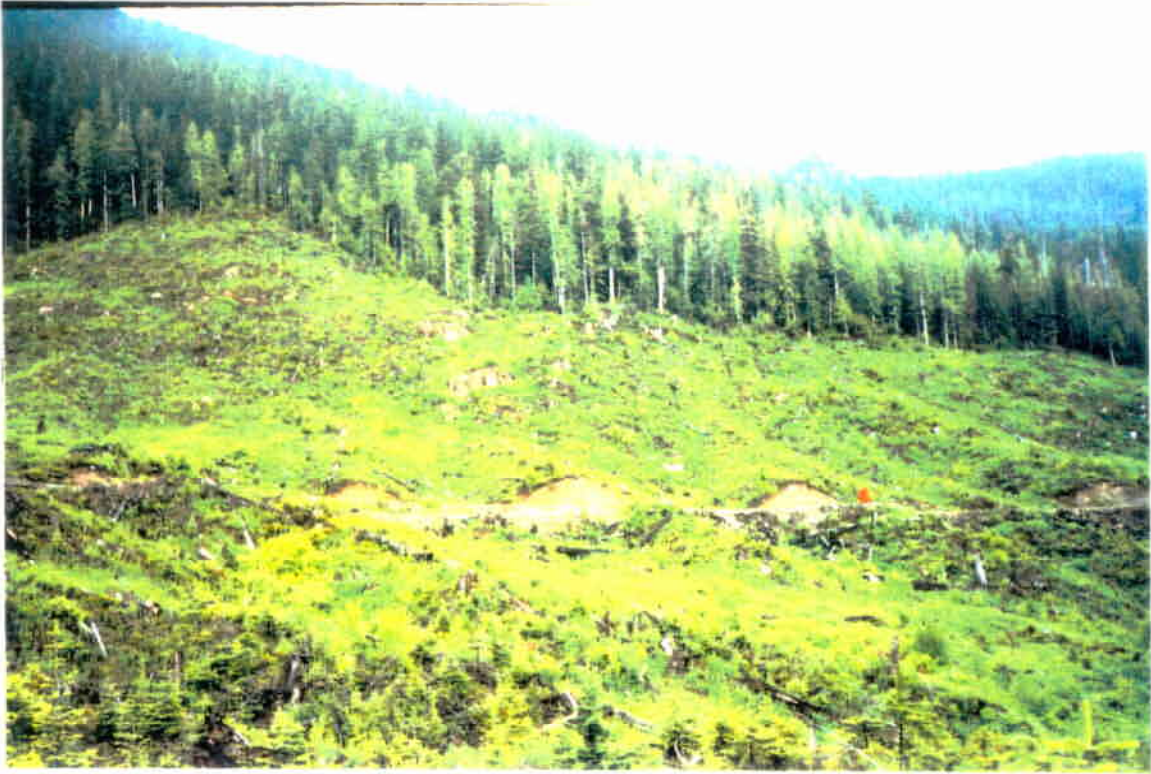
Photo 2: Elaho valley near Jarvis Creek (mile 59, E-main). Typical lower slopes covered by basal till. Note rock outcrops that indicate the variable thickness of the till, and note gullies (between road cuts) that indicate the erodible nature of this material. (Photo: S.Tsang)

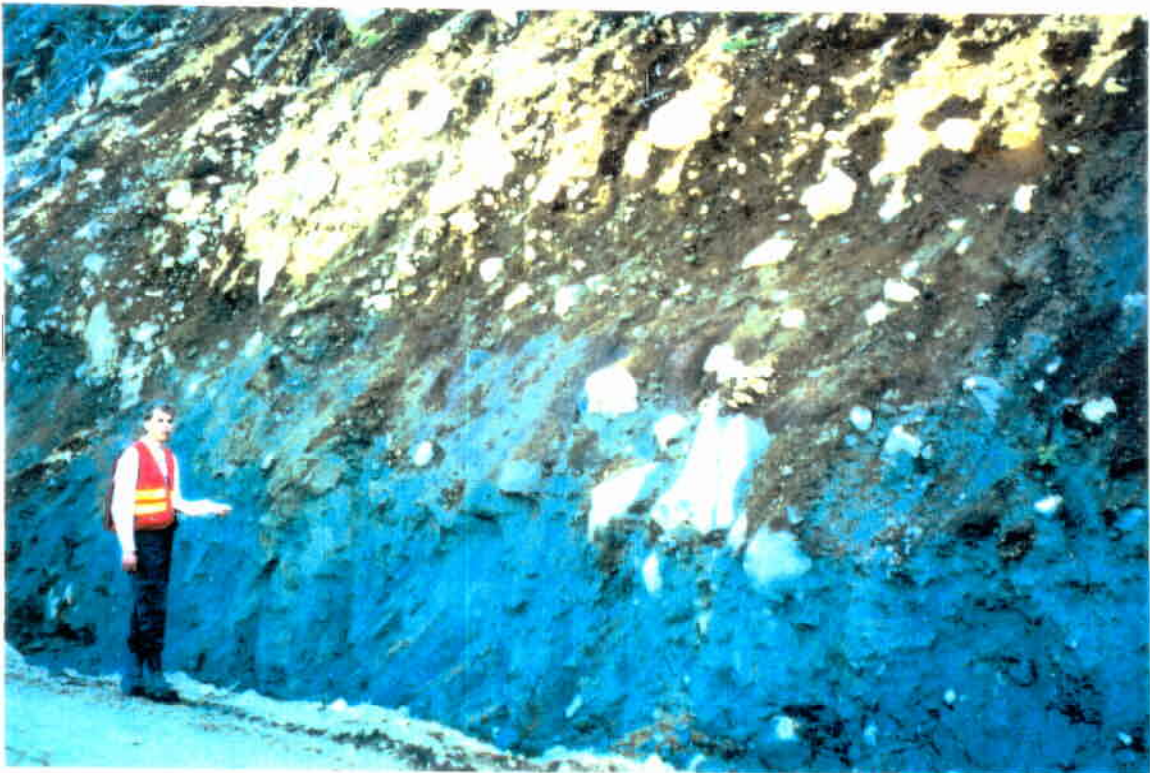
Photo 3: Typical basal till exposed in road cut, Elaho valley. Note blue-grey colour of unweathered till, and subangular clasts (pebbles, cobbles and boulders) set in a fine grained (silty sand) matrix. (Photo: A. Collette)

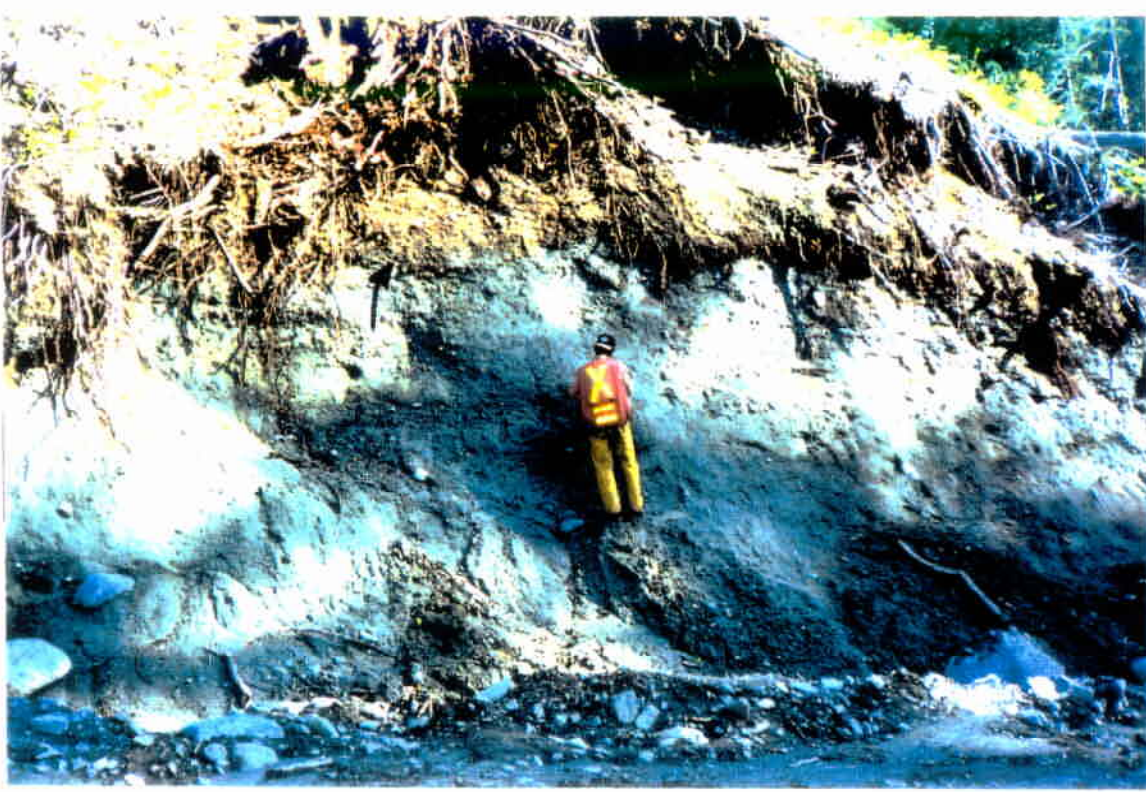
During postglacial time, weathering and soil-forming (pedogenic) processes have transformed the upper 1 to 2 m of the till into relatively loose sandy material with properties that are dissimilar to those of unmodified till (Photo 4). The weathered till is highly permeable, so that water from rain and snowmelt moves rapidly down through the soil until it reaches the upper surface of the unweathered till. A perched water table tends to develop here, and within this saturated zone, water seeps downslope through the lower part of the soil. This process is highly significant because most debris slides are triggered by loss of cohesion related to the high pore water pressure that develops at the base of the soil zone when the water table rises during intense rainstorms (Section 5.1). The contact between weathered (soil) and unweathered till is commonly a sharp weathering front, and this becomes the slip-plane along which detachment occurs. Where unweathered till is overlain by a thin layer of colluvium, e.g., in "Cv over Mb" terrain units, the colluvium/till contact functions similarly to that between weathered and unweathered till.

Photo 4: Thick, highly consolidated till with few boulders in road cut at Site ST25. Note sharp contact between weathered (soil) and unweathered till (arrow). This contact is usually the lower limit of the rooting zone, as shown here. (Photo S.Tsang)

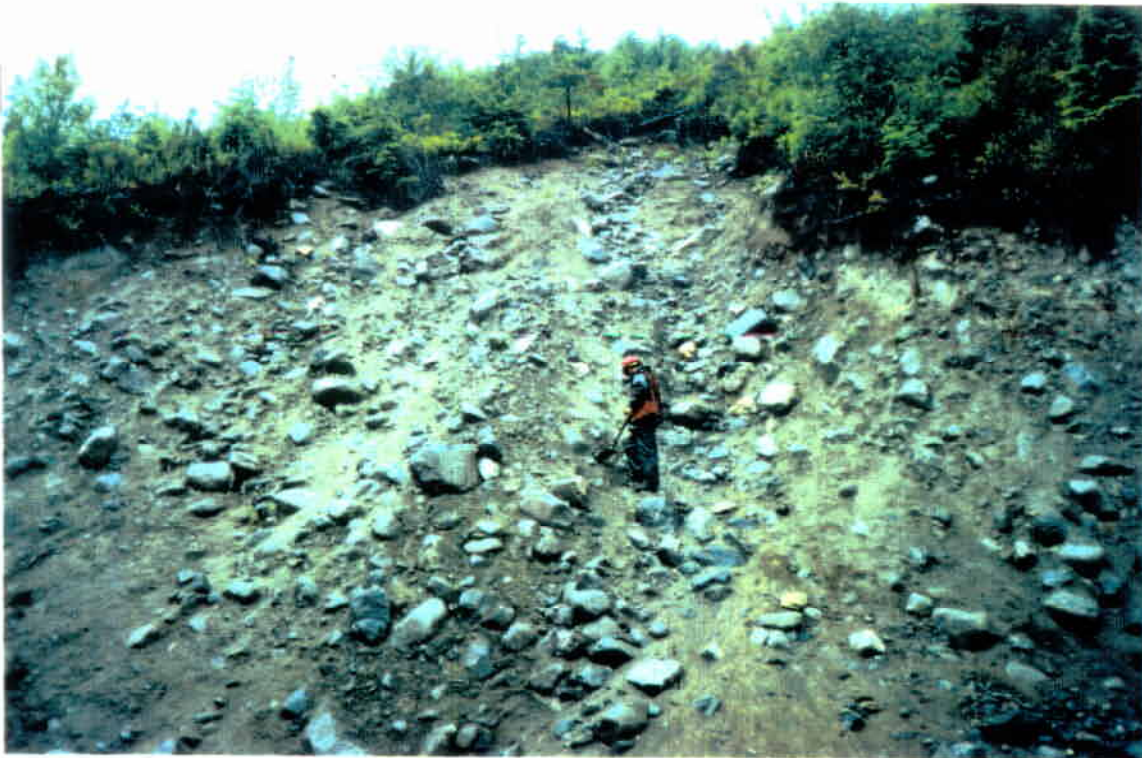
Ablation till in the Squamish basin displays the typical characteristics noted above (Photo 5). Some relatively large areas of ablation till were mapped in the same areas as extensive glaciofluvial deposits, that is, in the vicinity of Shovelnose Creek and along the east side of the upper Squamish River. Ablation till was also mapped adjacent to the glaciolacustrine deposits near the Elaho-Sims confluence. Other, smaller areas of ablation till are scattered throughout the area mapped, and include recessional moraines at the mouths of tributaries, such as Limelite Creek (92J-013).

Slopes underlain by ablation till are typically unstable where they are steeper than about 70%. Road cuts tend to ravel, and falling rocks create a local hazard (Photo 5).

Photo 5: Thick ablation till exposed in roadcuts in Elaho valley (E-600, Site AC37). Material has a much higher proportion of clasts (stones) and less fines than basal till. It is relatively loose and subject to raveling in road cuts. (Photo A. Collett)

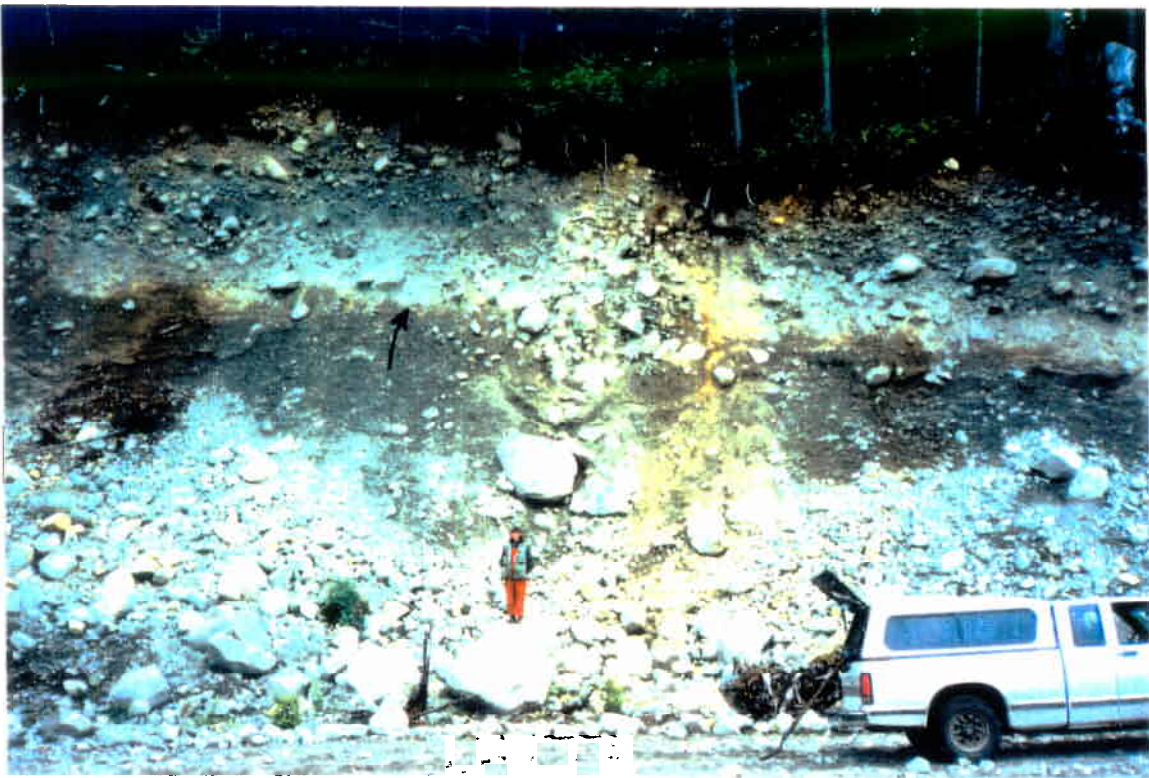
Photo 6: Glaciofluvial gravels overlying till at lower Blakery Creek; (arrow marks gravel/till contact). Note crude stratification in the coarse bouldery gravels. (Photo S.Tsang)

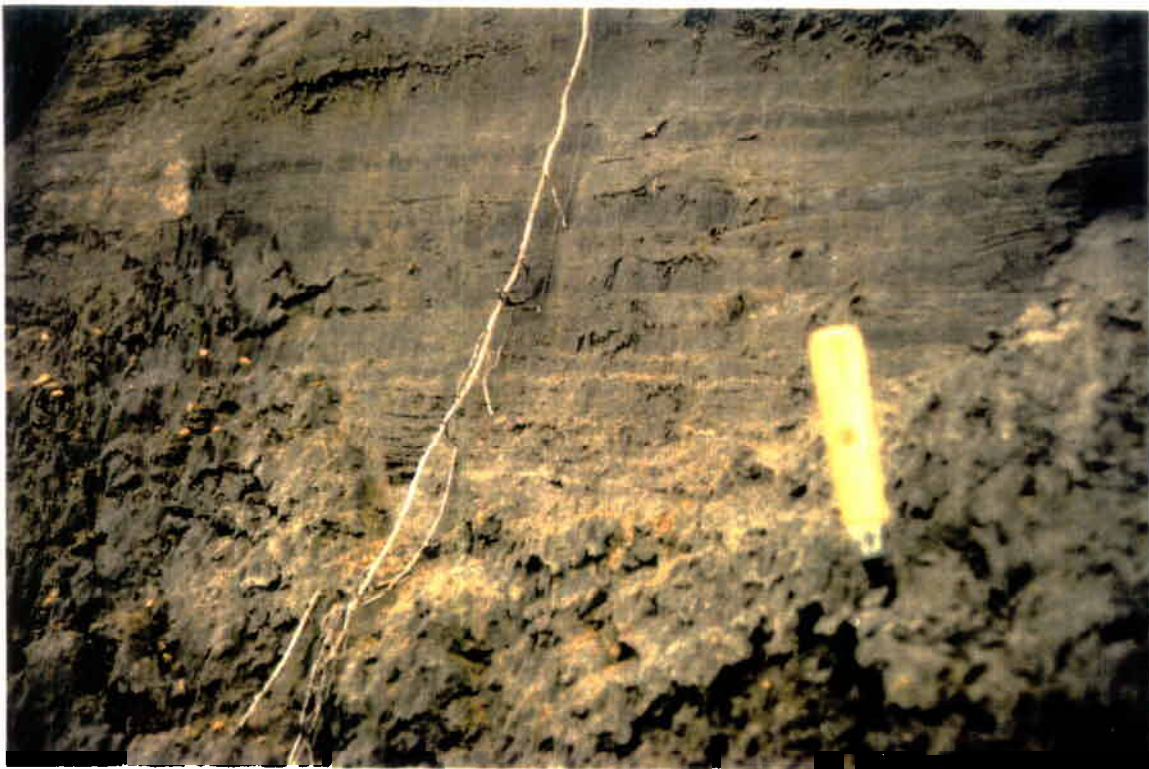
Photo 7: Close up of typical glaciolacustrine sediments (thinly bedded silt and fine sand), upper Squamish area (Site BW 7). (Photo: B.Waddington)

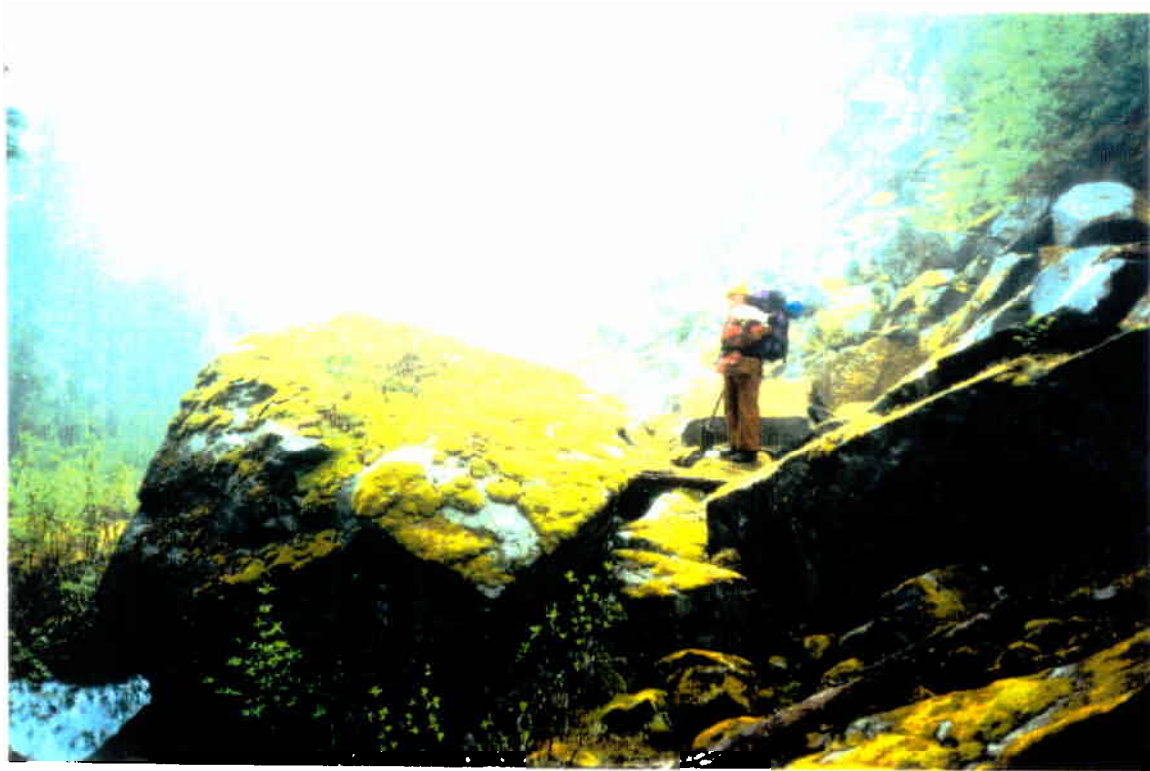
Photo 10: Blocky colluvium, typical of areas underlain by plutonic rocks. This site has not yet been colonized by forest, although vegetation is gaining a foothold on the moss-covered blocks in the foreground. Where forested sites on this kind of substrate are disturbed by logging, they can revert to unproductive, rocky land. (Photo: S. Tsang)

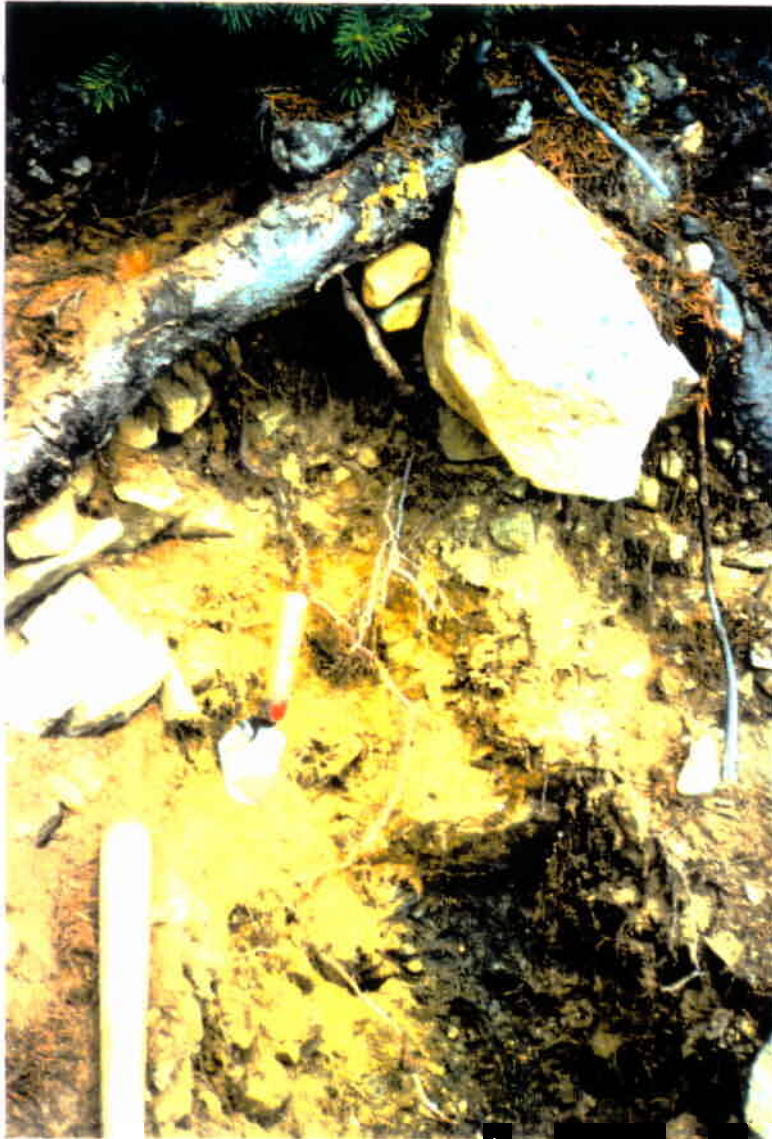
typically consists of loosely packed rubble or blocks with interstitial silty sand (Photo 9).

Photo 9: Colluvium exposed in soil pit: Note angular fragments of plutonic rock and sandy matrix. (Photo S.Tsang)

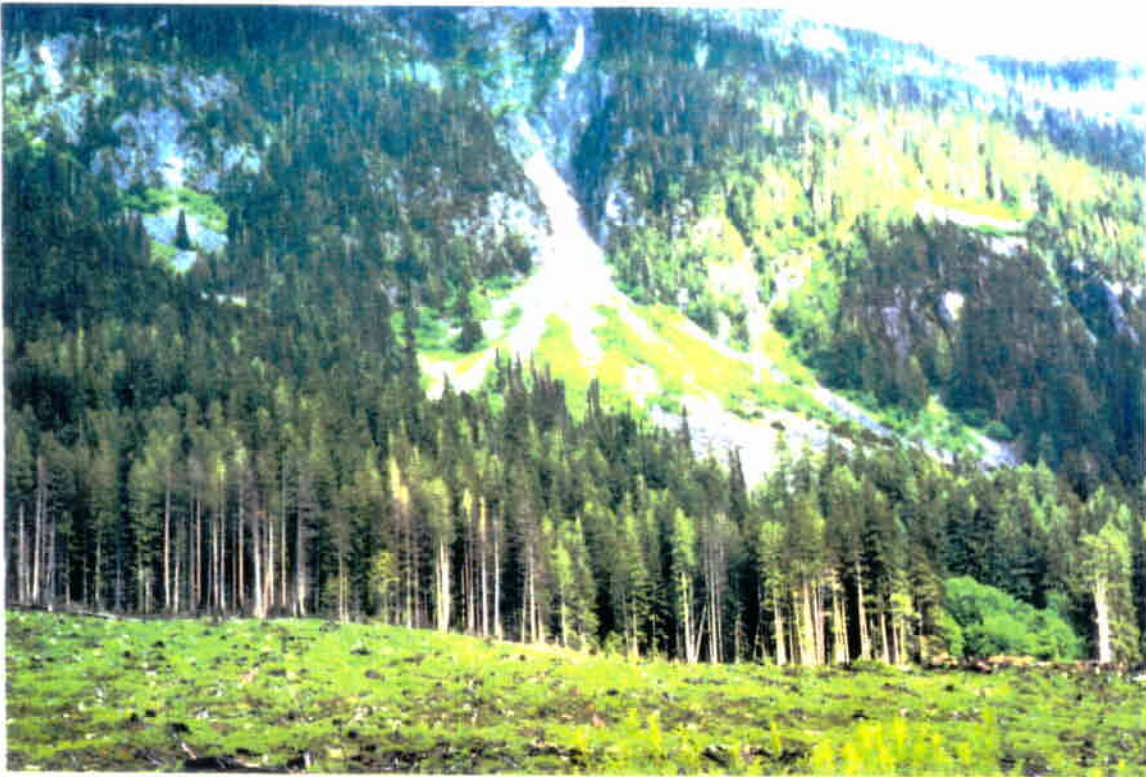
Photo 11: Colluvial cone formed by rockfall, debris flows and snow avalanches. Note fresh debris-flow deposits overlying vegetated surface. Cones with less-active processes are forested. (See also caption to Photo 10). (Photo: S. Tsang)

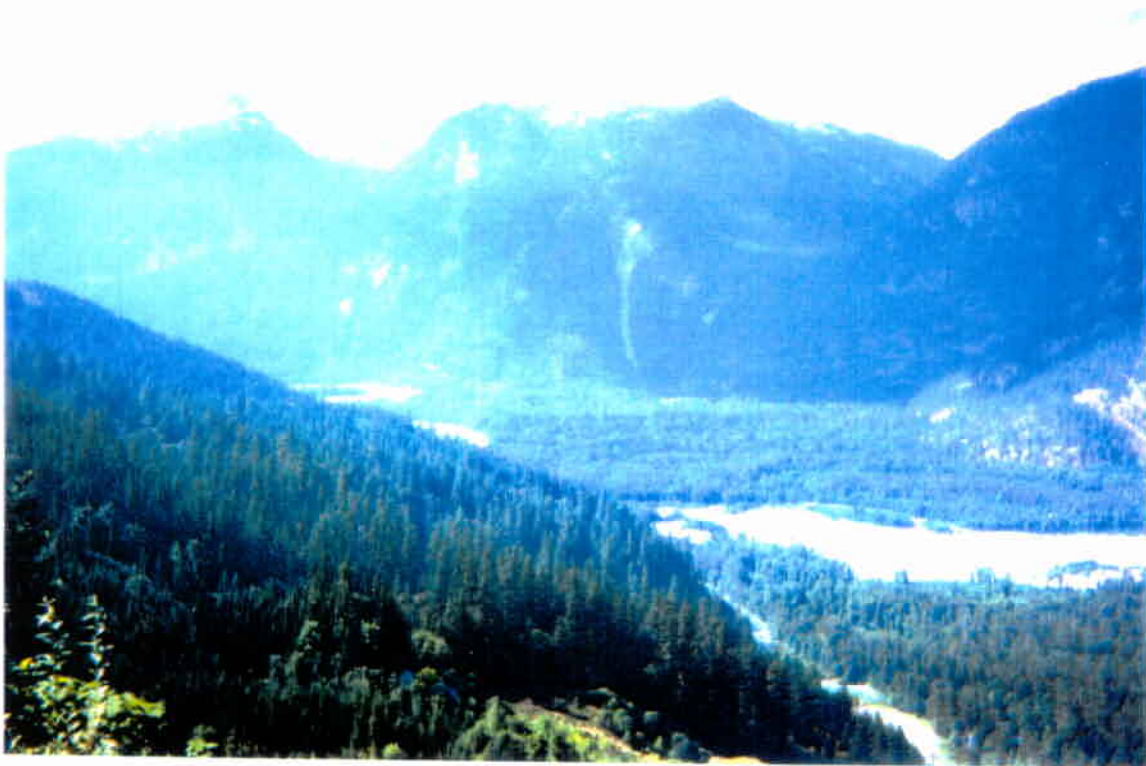
Photo 12: View of Elaho River floodplain. A sandy fluvial veneer overlies fluvial gravels beneath the forested part of the floodplain. Note debris slide/flow on distant hillside at centre photo. (Photo: P. Stokes)

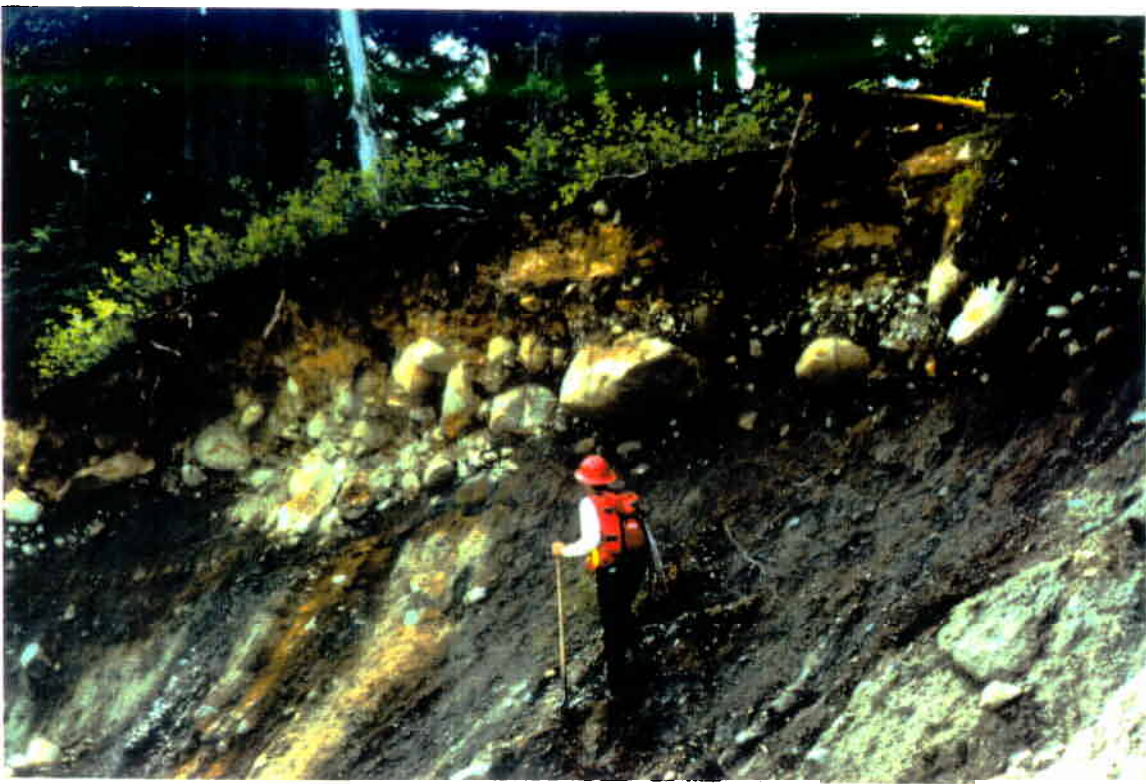
Photo 14. Glassy, fine-grained material on a thick capping terrace with silt and clay near Lava Creek. Note crudely-sorted gravels and bouldery lag deposit (boulders to 1.0 meter) with fine particles, some rounded. (Photo: S. J. Sand)

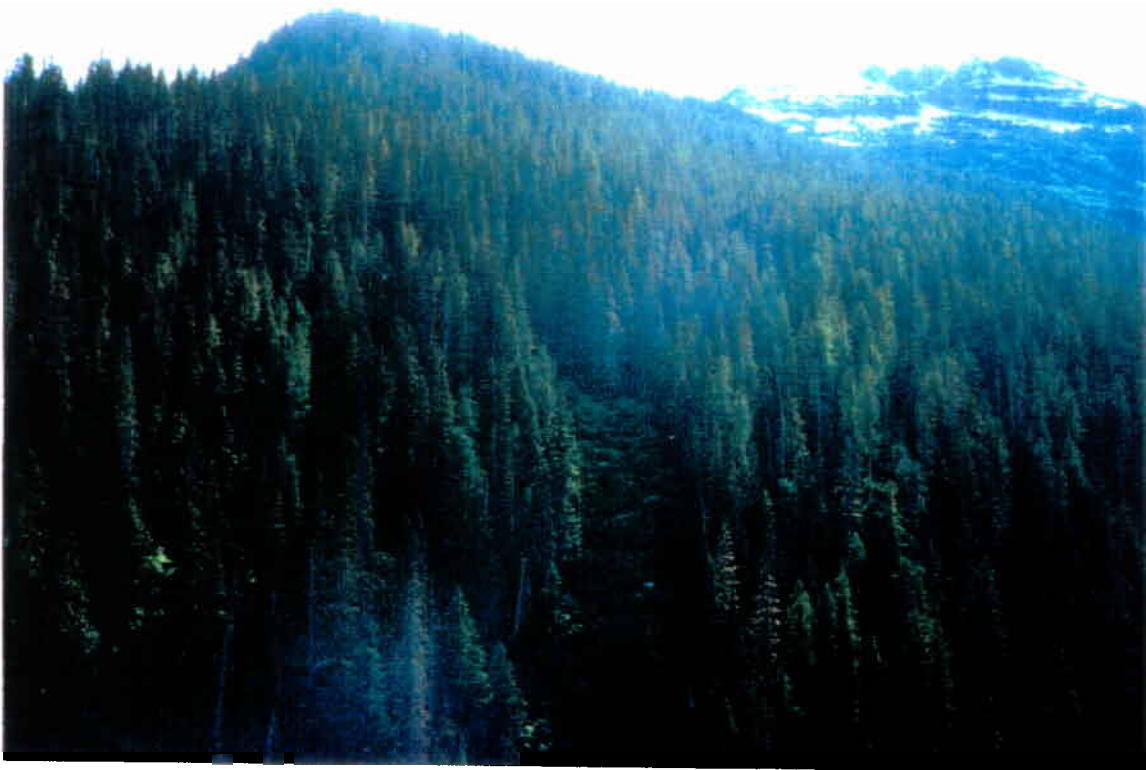
Photo 15. Natural debris slide-flow track on slope undisturbed by logging. Revegetation of scar by deciduous vegetation suggests that the event occurred about a decade ago. (Photo: A. Callett)

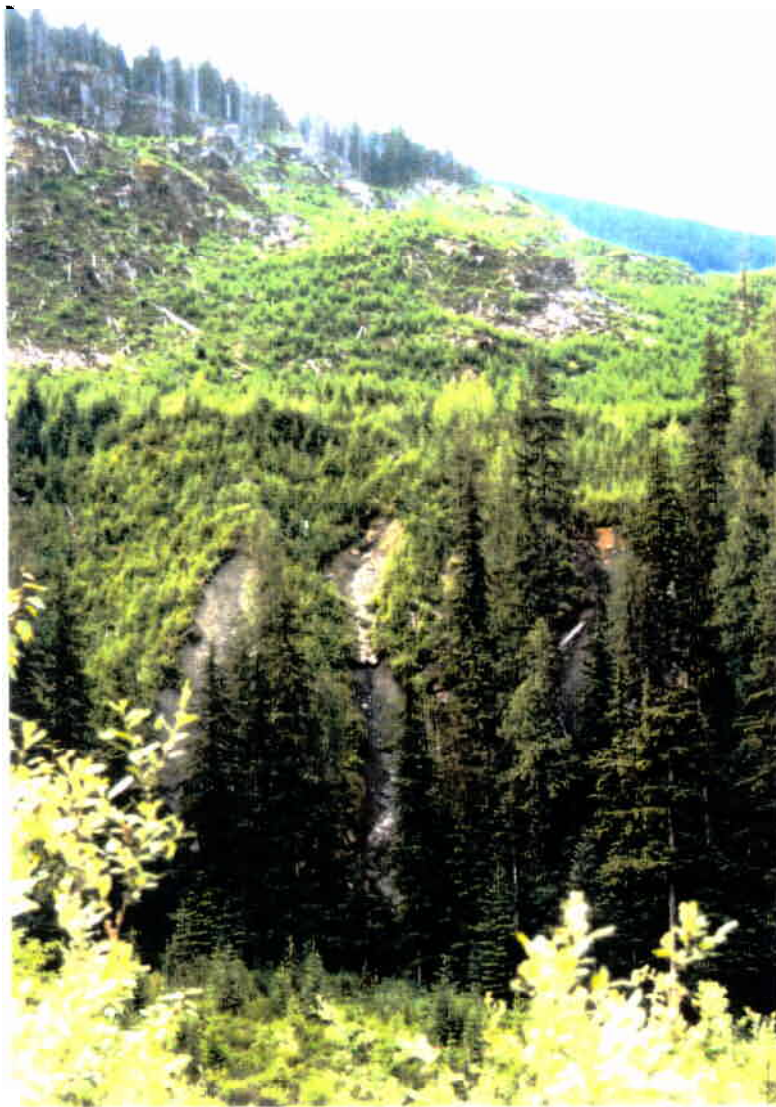
Gullies are small ravines with V-shaped cross section formed in drift and bedrock. The symbol is usually applied to terrain polygons where more than one gully is present. Gullies are formed by the erosive effects of debris flows, small streams, snow avalanches, and rockfall, as already noted. The presence of gullies on drift-covered hillsides (e.g., Mb-V) indicates that the underlying material is susceptible to erosion and/or instability. Consequently, gullied terrain is commonly rated as unstable or marginally unstable (stability class V or IV) because gully side-slopes and headwalls are commonly unstable (Section 3.2) (Photos 2 and 14).

Photo 14: Gullies formed as a result of small debris slides on steep erosional slope in thick till (Ms). Slides appear to have followed logging, and probably resulted from loss of root strength or soil disturbance by yarding. After the slide scar (track) is formed by the initial event, surface erosion by running water continues to enlarge the gullies, a process that is hard to control. (Photo: B.Waddington).

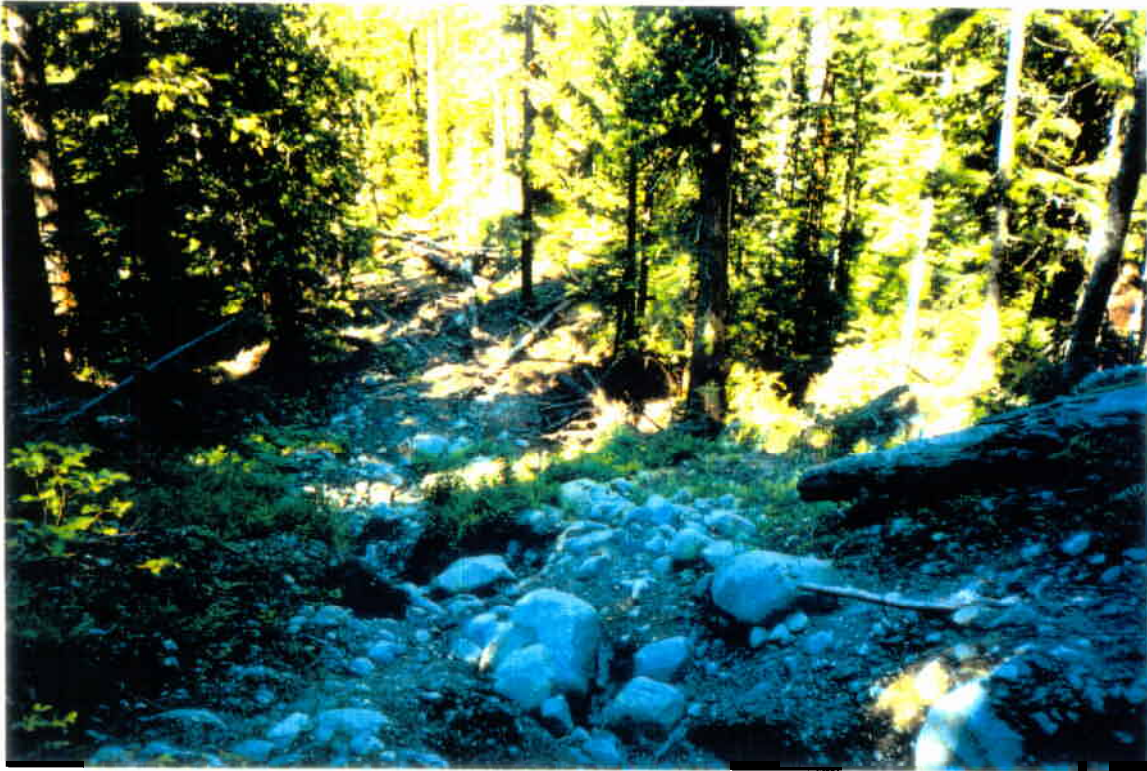
Photo 16: View down a debris flow that resulted from natural slope failure in till. Subsequent erosion by running water has formed a small gully (foreground). (Photo: A. Collett)
