**Re: Mine Inspection June 7, 2008**  
**Property: Mount Polley Mine**

**Report of Inspector of Mines**

**Geotechnical**

Inspection No.: 15354  
File: 18040-02-07  
Mine No.: 1101163  
Emp/Cont: 0 / 0  
Orders H&S: 2 RECL 0  
Stop Work: 0

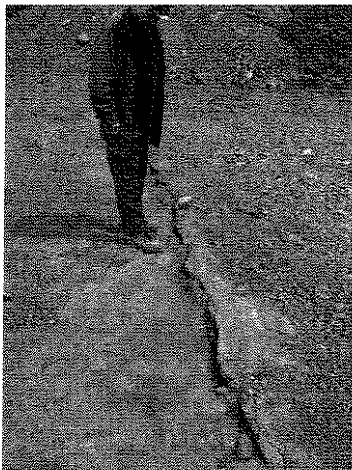
Fig. 1

Tension crack was noticed developing on the south west crest of the pit (Fig. 1). It appeared the crack was aligned with the main

fault structure striking North-West direction. The movement of the tension crack shall be monitored with both prism monitoring and by inserting steel pins on both side of the crack and monitoring the displacements.

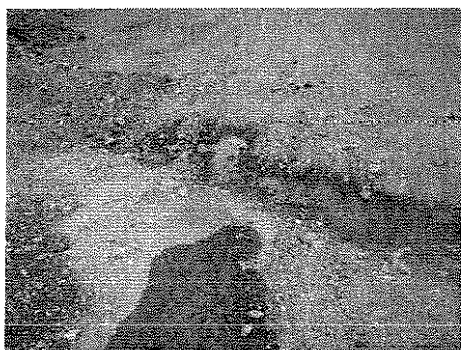
Fig. 2

It was observed that some water runoff was noticed to be feeding the main fault. The observed water runoff shall be diverted away or above the main fault.

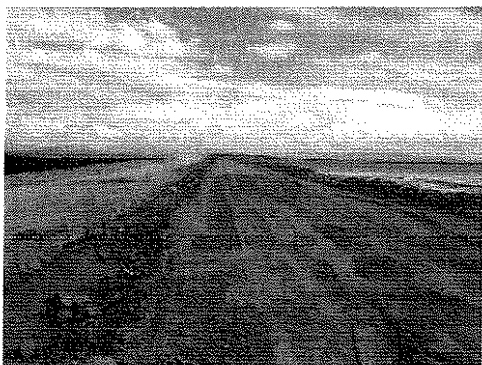
Fig. 3

#### **SECTION :10.1.11 Departure From Approval**

The specification for till used in the construction of the dam core (Zone S) requires that rock inclusions larger than 4 inches be removed prior to compaction. Rock boulders over 12 inch in size were noted in the till core and shall be removed by machine or by hand.
