Haul truck light duty vehicle fatality

Synopsis

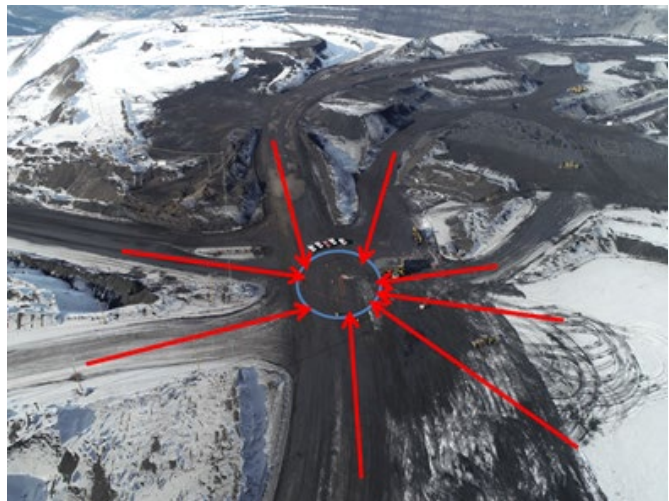
The accident occurred at a complex intersection, which was comprised of six roads and a laydown yard. Visibility challenges such as dust obscuring salient objects and a driver-side pillar impacted the site-line of the haul truck. Investigators believe the haul truck became visible just seconds before impact, as the operator maintained speed and used the radio right up until moments before impact.

FIGURE 1. The multi-lane Intersection

- It discussed the continuous evaluation of traffic management plans at mine sites and evaluating the efficacy of relying solely on right-of-way rules as administrative controls and advocates for engineered controls to eliminate or significantly reduce vehicle interactions.

- It also encouraged road design modifications and consideration of behavioral controls in these environments.
2. Independent Traffic Survey - Recommended an independent traffic survey due to uncertainty about the effectiveness of current traffic safety practices.

3. Temporary Speed Limit Reduction - A temporary reduction of the speed limit to 70 km/h at the mine for light vehicles in dynamic areas such as intersections, operating areas, near pit faces, and loading areas.

4. Reassess Radio Usage at the mine - The operator's frequent radio use during critical haul truck operation diverted their attention significantly.
 - To minimize distraction for safer driving practices.
