Worker trapped in crusher surge bin

Synopsis

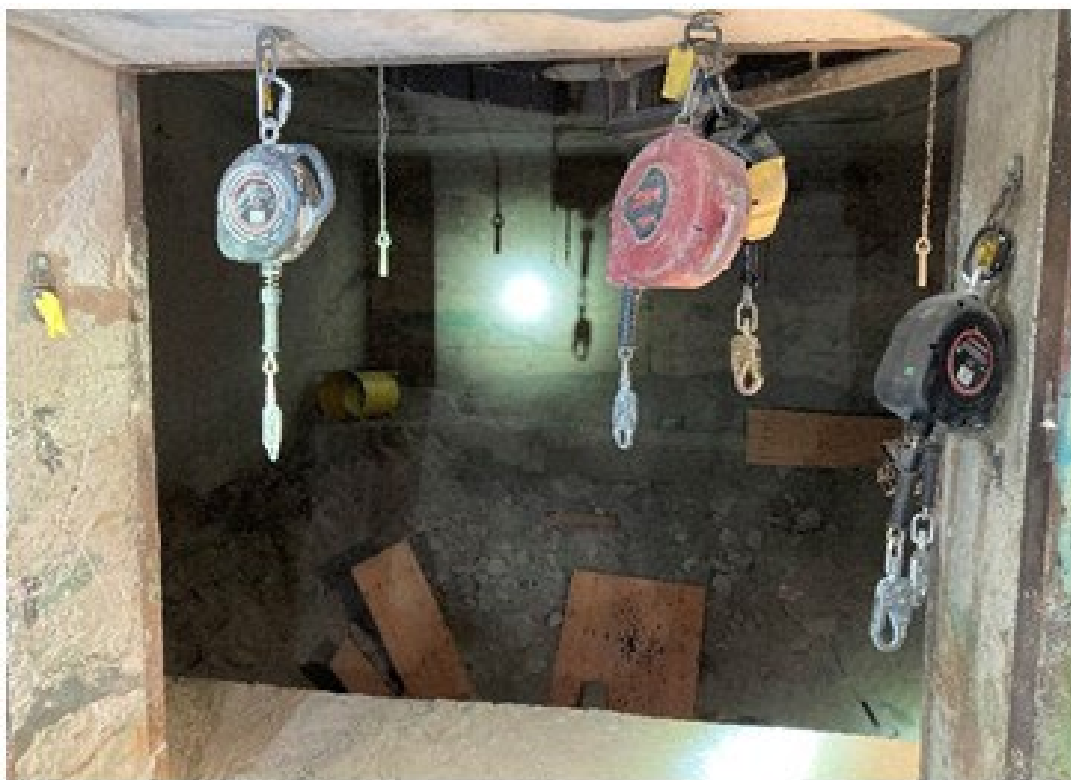
On 2022-05-03, at approximately 21:00 hours at an open pit hard rock mine in British Columbia, two contract workers were inside the surge bin of a crusher scaling the materials using shovels and air lances, for maintenance purposes. Workers then exited the surge bin and started the conveyor underneath the surge bin to remove the loosened materials. It was observed that no material was dropping onto the conveyor indicating the materials were stuck (“bridged”) inside the surge bin. One of the contract workers re-entered the surge bin. The bridged materials collapsed trapping the worker up to his thighs.

FIGURE 1. Surge Bin Door with Collapsed Materials.

A [Section 18](#) Order was issued to the mine manager for an independent engineering report for safety of the surge bin scaling task. The mine manager also submitted an investigation report. Both reports identify corrective actions to the task and safety management.
