Failure of Langley Lake Dam, Union Bay (1912)

Excerpted from:

The Unexpected in Dam Safety

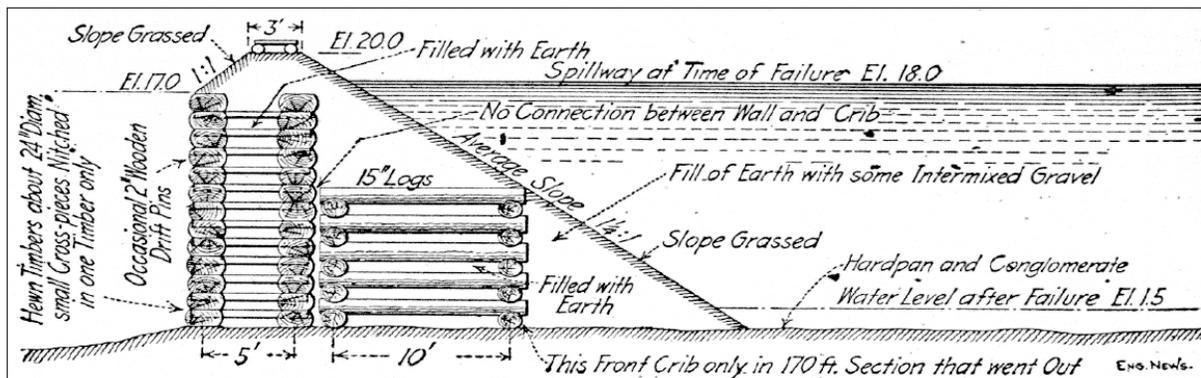
As shown in Figure 1, the dam was comprised of a timber wall downstream of a timber crib both filled with earth and with earth on the upstream face. There was no connection between the timber crib and the foundation, or between the crib and the wall. The Engineering News of 1912 reported, “The earth fill was of wretched surface scrapings and apparently no attempt had been made to deposit it properly or to compact it” (Mitchell, 1912)

Figure 1: Union Bay Dam Timber Crib Cross-Section (Mitchell, 1912)

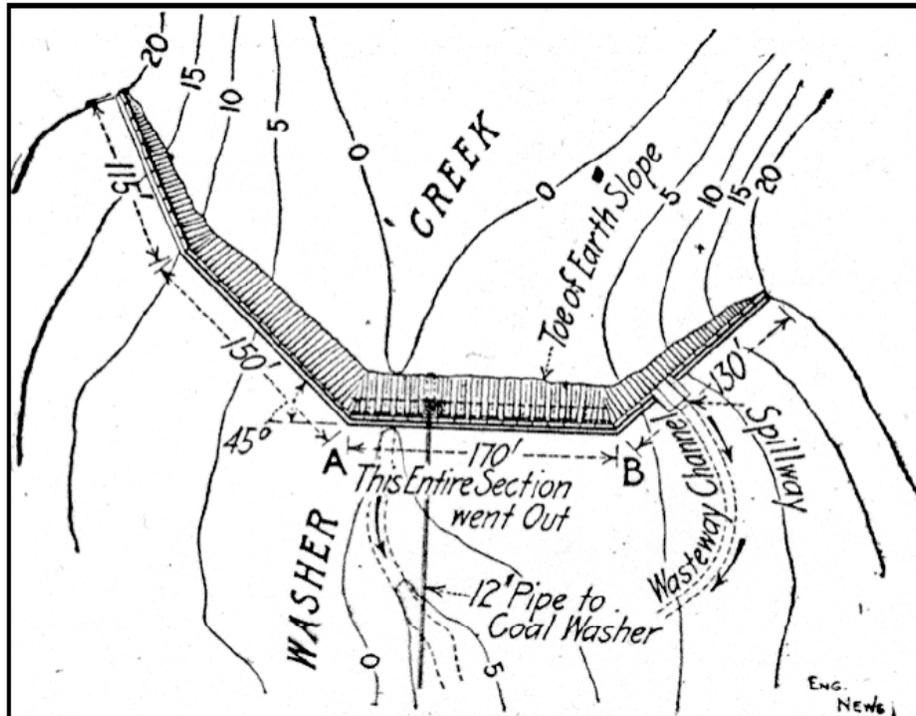
In plan, the dam had had four straight sections that formed an arch shape, as shown in Figure 2. The arch bulged out of the reservoir instead of into it, and the weight of the water tended to pull the sections apart. There was no connection between the sections as the timbers merely overlapped. Within each section, 50 mm diameter drift pins joining some of the timbers but only about half of the holes drilled for these pins had pins installed.

Figure 2: Union Bay Dam Plan View (Mitchell, 1912).

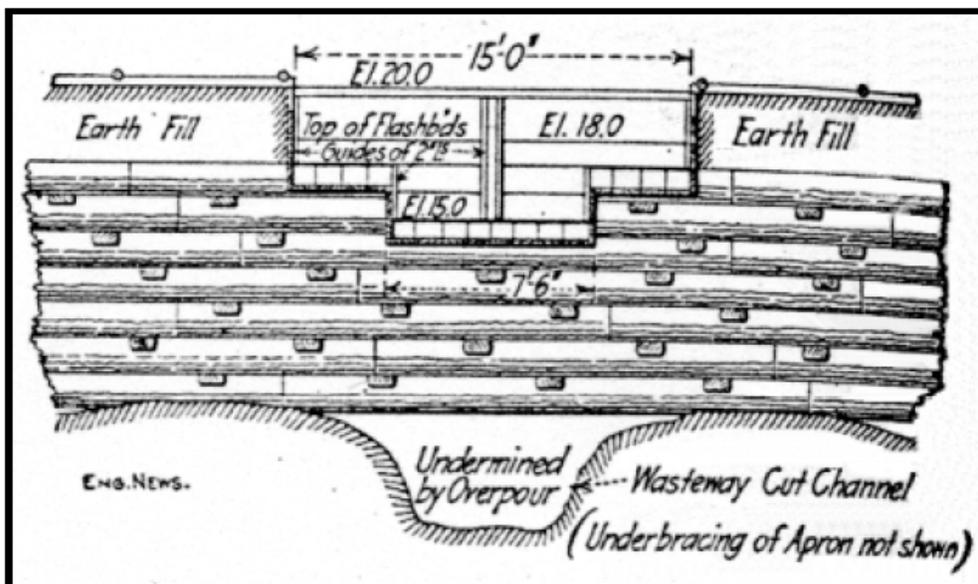
The spillway, seen in Figure 3, was an opening in the crib of the right wing wall with short flashboards and a centre post. Prior to the failure, heavy rain had raised the reservoir too close to the crest, the flashboards were not removed from the spillway and debris blocked the narrow opening.

Figure 3: Union Bay Dam Spillway (Mitchell, 1912).
