QC-7001

HONNA MAIN 1.7km

2015 Inspection

Crossing Name Turundle Creek

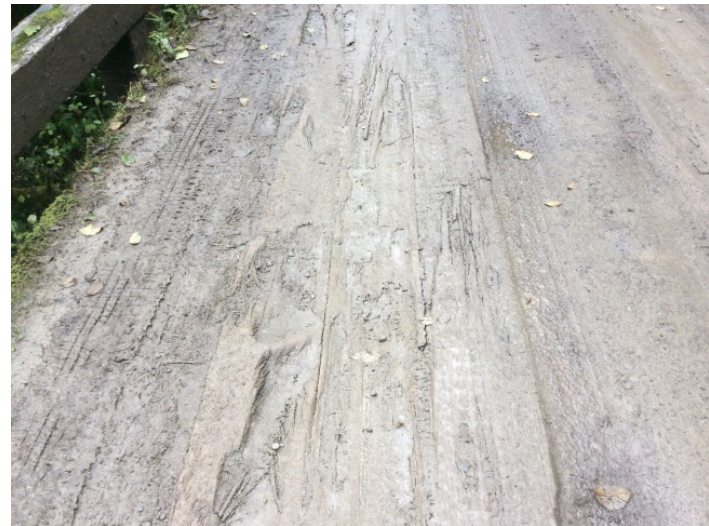
Running Surface	Fair	
Running Planks	Poor	Replace running planks, 2x12 timbers
Sub Deck	Good	found to be sound
Ties	Good	found to be sound
Nails	Poor	Running plank nail heads exposed
Deck to Girder Bolts	Good	
Concrete Deck		
Grout Pockets		
Deck Joints		
Steel Deck Plate		
Gravel Surface		
Curb Rail/Blocks/Posts	Poor	Guardrails and blocks at end of service life. Replace
Hand Rails/Walkouts		
Hardware		
Overall Deck Condition	Fair	
Gravel Depth (mm)

Repair Item	Priority	Repair Description
1	High	Replace running planks

2	High	Replace Guardrails and blocks
---	------	-------------------------------
